Vacuum B.O. EOL

**RICE OPERATING COMPANY  
JUNCTION BOX FINAL REPORT**

# Vacuum B.O. EOL

Unit 'G', Sec. 12, T18S, R34E

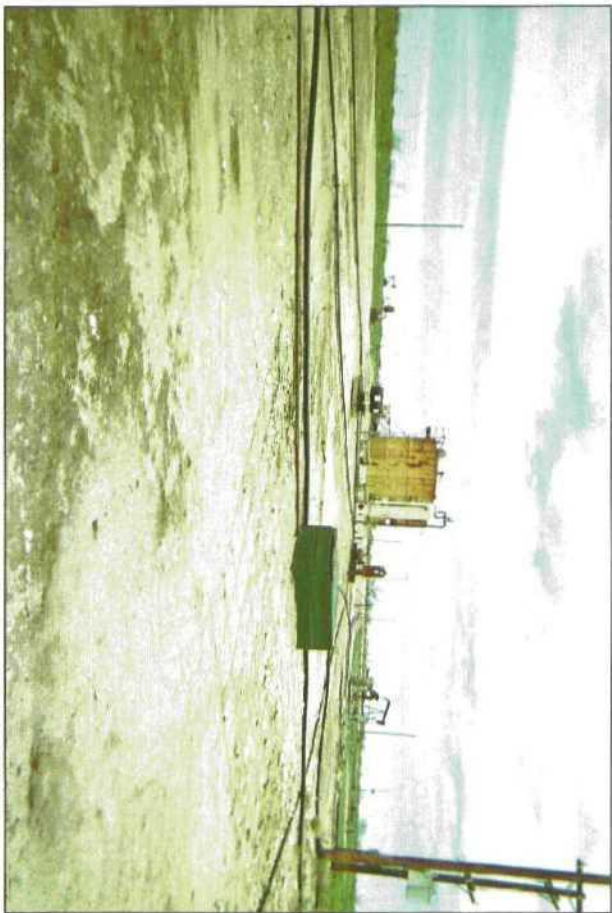
4/23/2002

undisturbed junction box

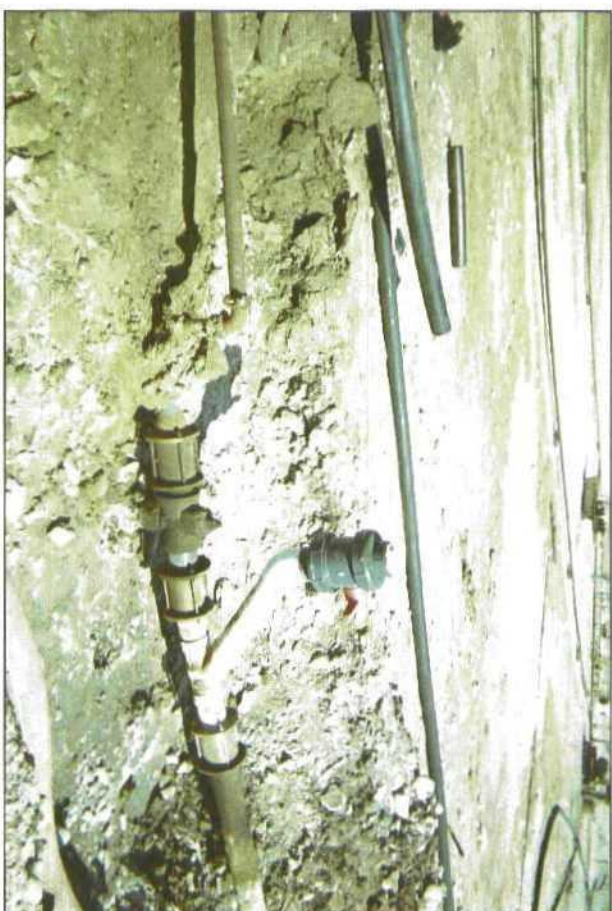
4/25/2002

junction box removed; old plumbing

General Description of Remedial Action: This junction was eliminated and the Vacuum SWD system is to be abandoned in 2005. The box lumber was removed and a delineation trench was made with a backhoe directly under the junction site. Chloride field tests and PID screenings were performed on samples collected every vertical foot at 4-12 ft BGS.

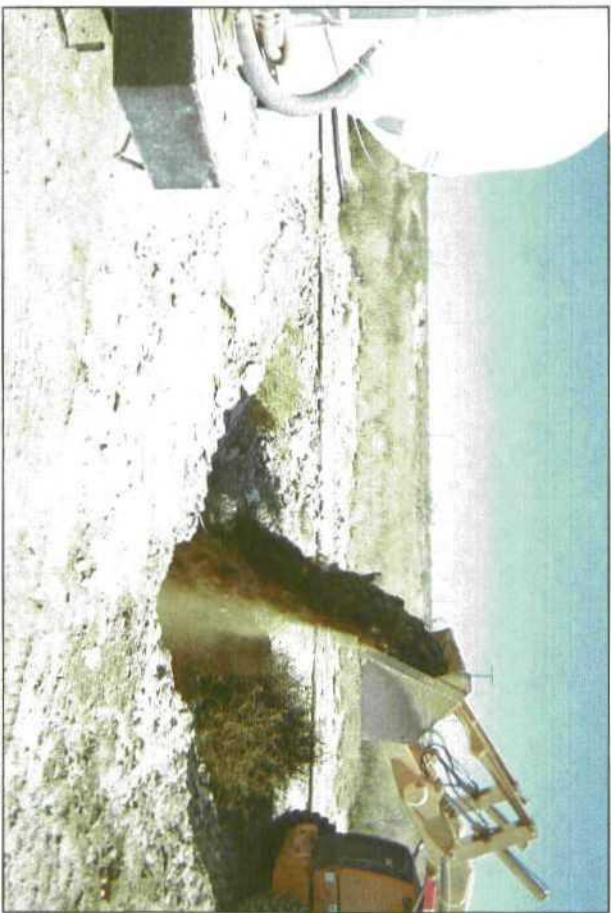
11/10/2004

backfilling delineation trench

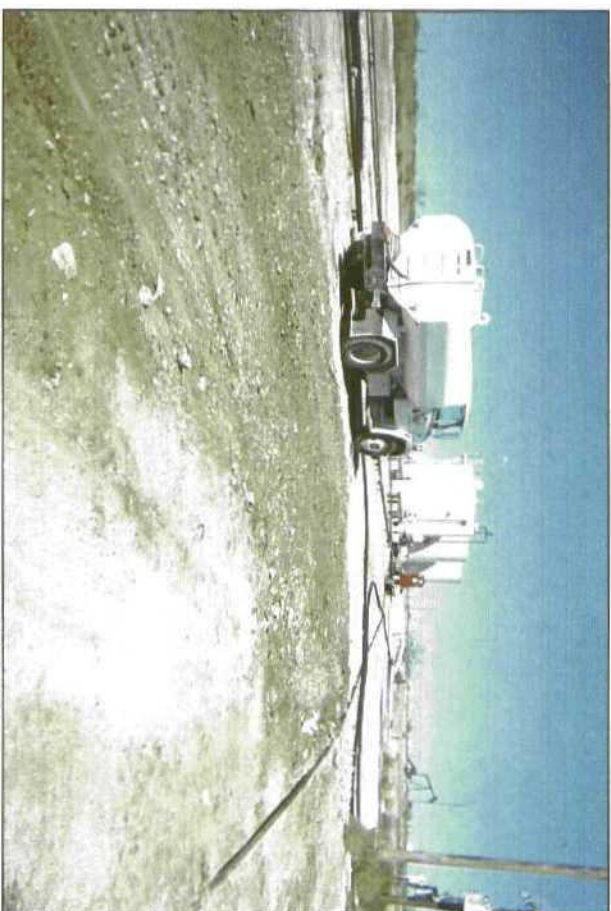
11/10/2004

backfilled trench

Chloride field test concentrations were low and exhibited a general trend of decline with depth, indicative of non-saturated historical vadose conditions. PID levels were also low and concentrations were 0.0 ppm at every foot at 6-12 ft BGS. Soil observed in the delineation trench was a light tan sand and did not exhibit any signs of contamination. The trench was backfilled with the excavated soil and contoured to the surrounding surface. The disturbed surface is expected to return to productive capacity at a normal rate.
