Final Report

**RICE OPERATING COMPANY
JUNCTION BOX FINAL REPORT**

Vacuum Mack Energy EOL

Unit 'F', Sec. 7, T18S, R35E

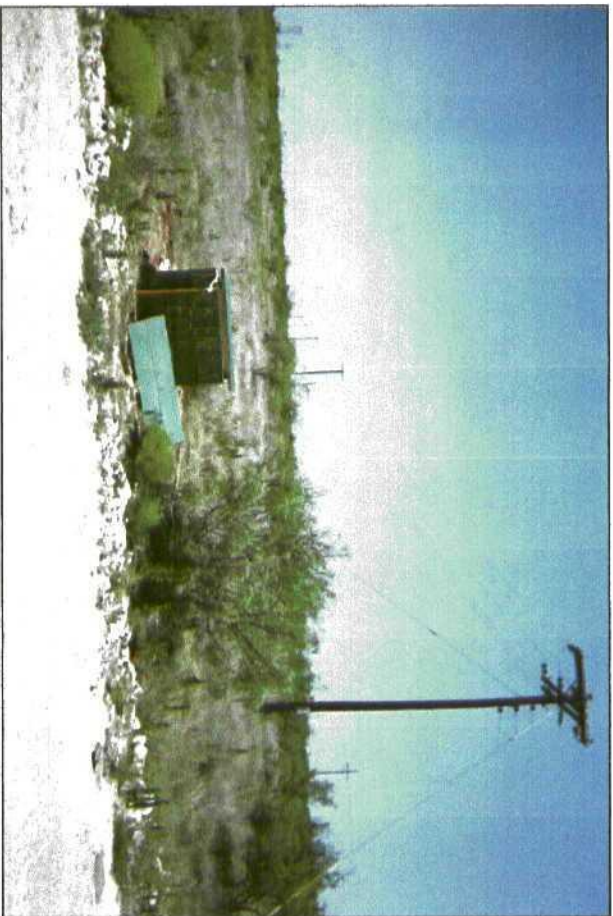
undisturbed junction box

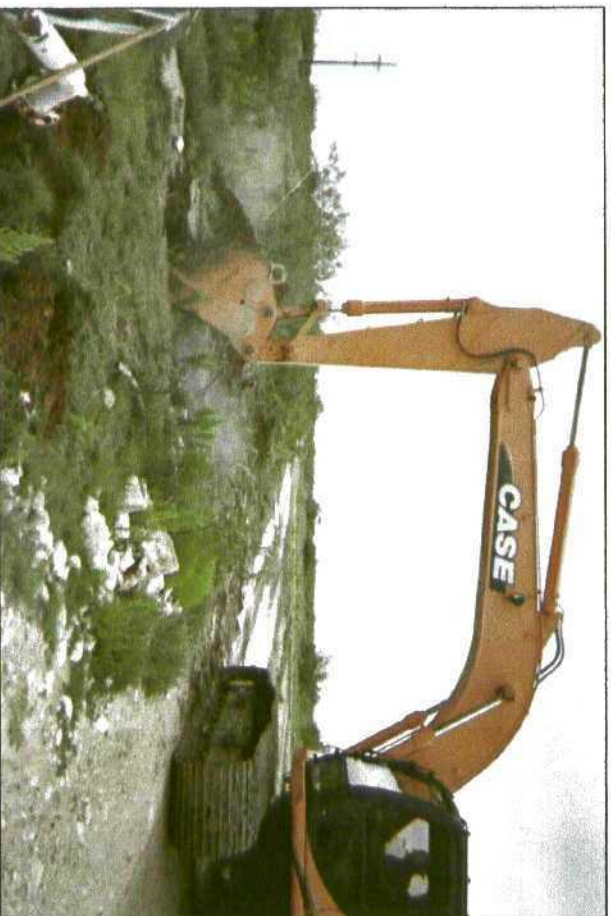
beginning excavation

part of the Vacuum System Abandonment. The junction site was delineated using a backhoe while soil samples were collected at regular intervals, creating a 30 x 20 x 12-ft-deep excavation.

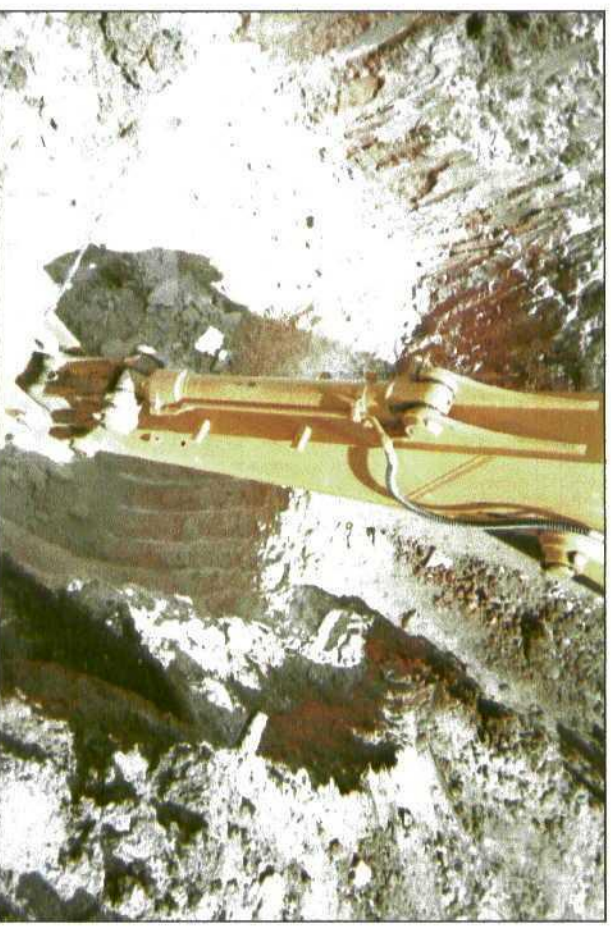
delineation & excavation

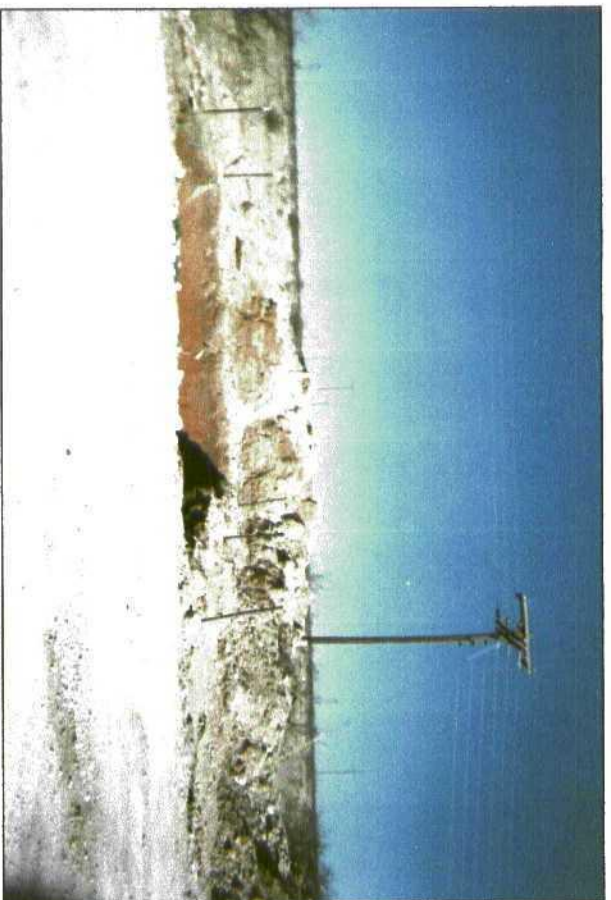
excavation

Composite samples were collected from the 12-ft bottom, walls, and backfill of the excavation; laboratory analyses were performed on these samples for confirmation. TPH was not detectable within the laboratory limits (<10.0), meeting NMOCD guidelines. Chloride concentrations were also relatively low and confirmed the field tests. The excavated soil was blended on site and then backfilled into the excavation and contoured to the surrounding surface. The disturbed surface was seeded with a blend of native vegetation and is expected to return to productive capacity at a normal rate. Since the Vacuum SWD System has been abandoned, a junction box is no longer required at this location.
