EME M-35-1 boat
(east)

FINAL REPORT

**RICE OPERATING COMPANY
JUNCTION BOX CLOSURE REPORT**

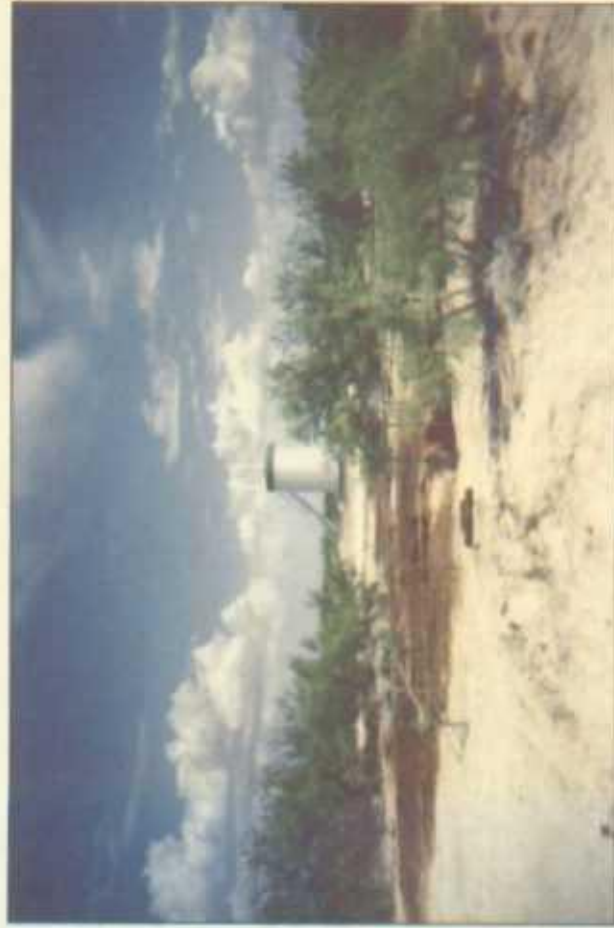
EME jct. M-35-1

Box site prior to excavation; lumber removed

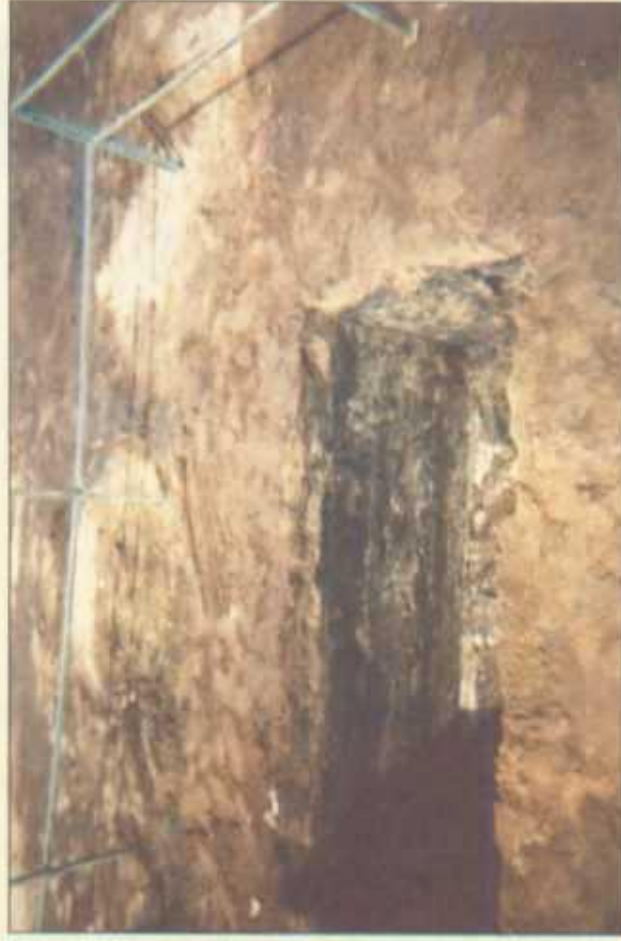
Close-up of box in foreground

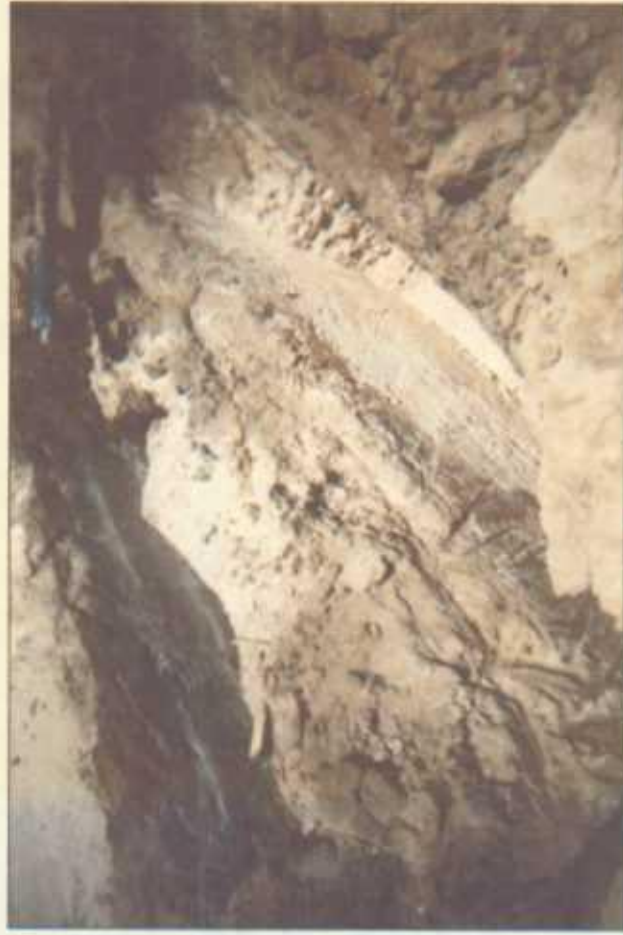
Vertical Excavation trench

General Description of Remedial Action: M-35-1 was a junction box that was next to a boot (M-35-2). A vertical delineation trench was initiated at this box to determine the extent of chloride impact. Field tests indicate that chloride concentrations exhibit a conclusive decline with depth, indicative of non-saturated conditions (see graph). TPH concentrations at 12 ft BGS were well below NMOCD guidelines. No further excavation was conducted because the adjacent M-35-2 box had a chloride concentration curve that did not decline with depth and will need further delineation in the future. The trench was backfilled with the excavated soil and was capped with approximately 3 ft of clean topsoil.

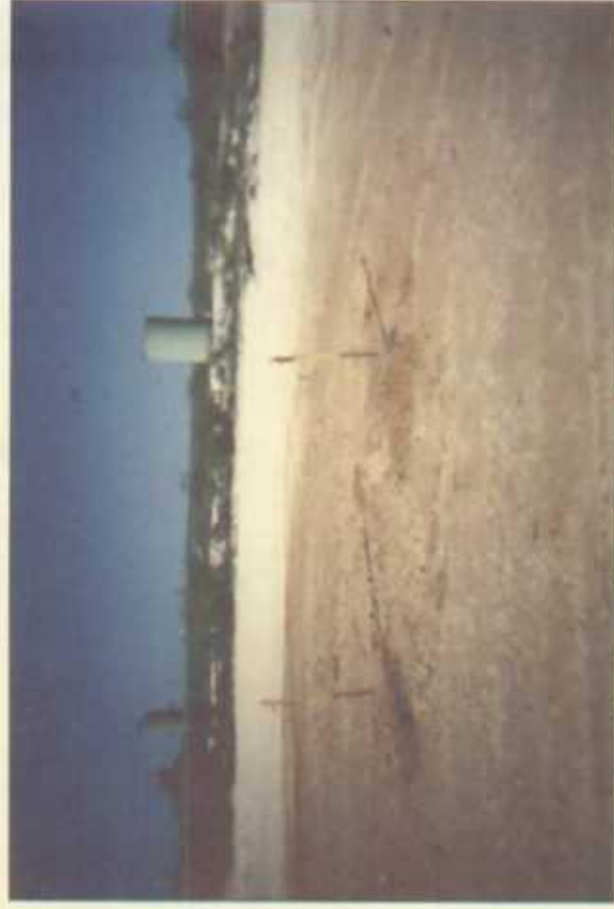
Identification plates marking locations of the boxes

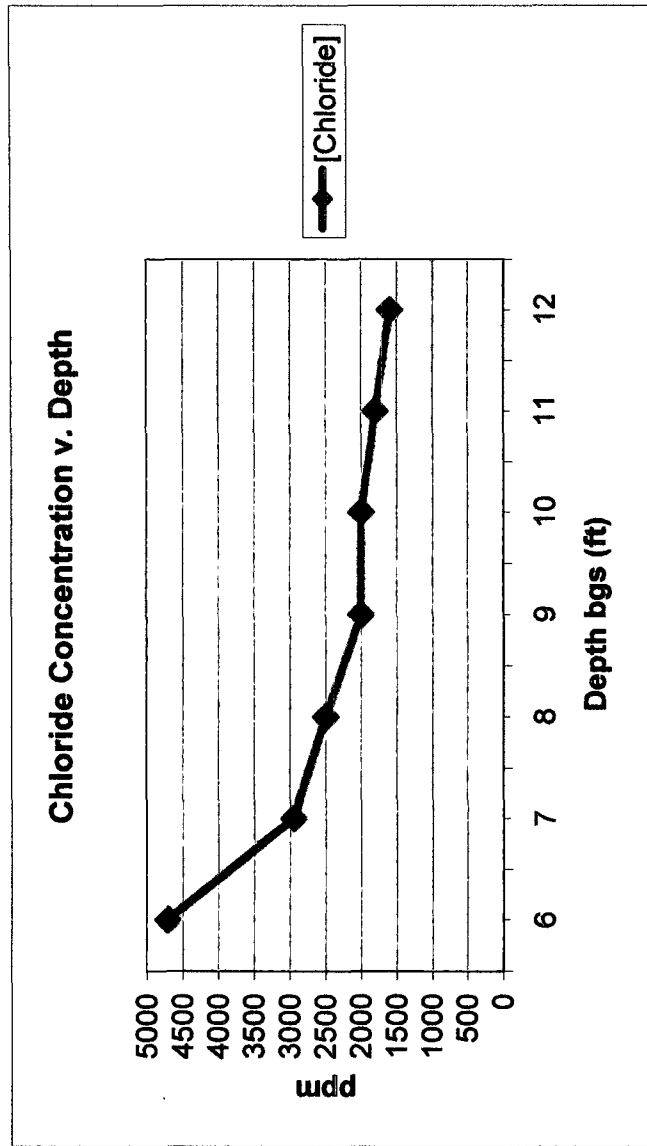
CHLORIDE CONCENTRATION CURVE

Depth bgs (ft)	[Cl-] ppm
6	4711
7	2950
8	2500
9	2000
10	2000
11	1800
12	1600

Groundwater = 35 ft

LOCATION	DEPTH (ft)	ppm
Vertical	6	4711
	7	2950
	8	2500
	9	2000
	10	2000
	11	1800
	12	1600
