FINAL REPORT

**RICE OPERATING COMPANY
JUNCTION BOX FINAL REPORT**

BD jct. L-25

unit 'L', sec. 25, T21S, R37E

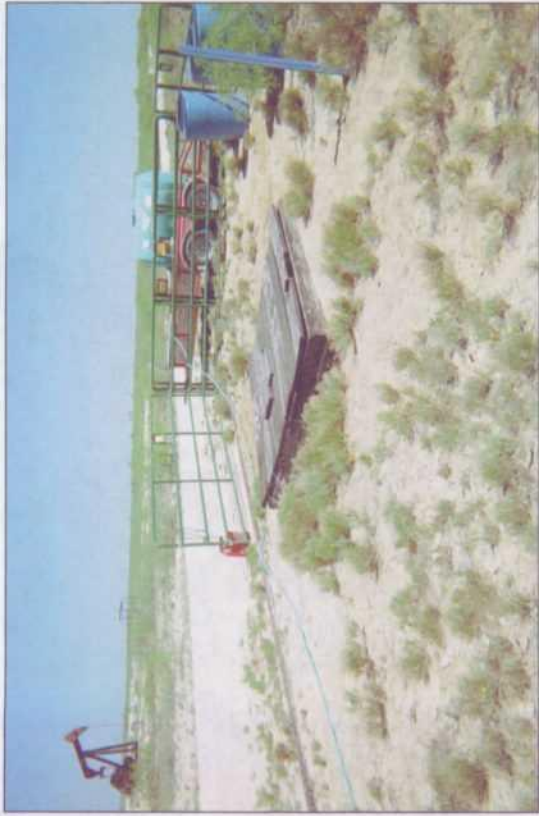
4/28/2003

undisturbed junction box (looking NW)

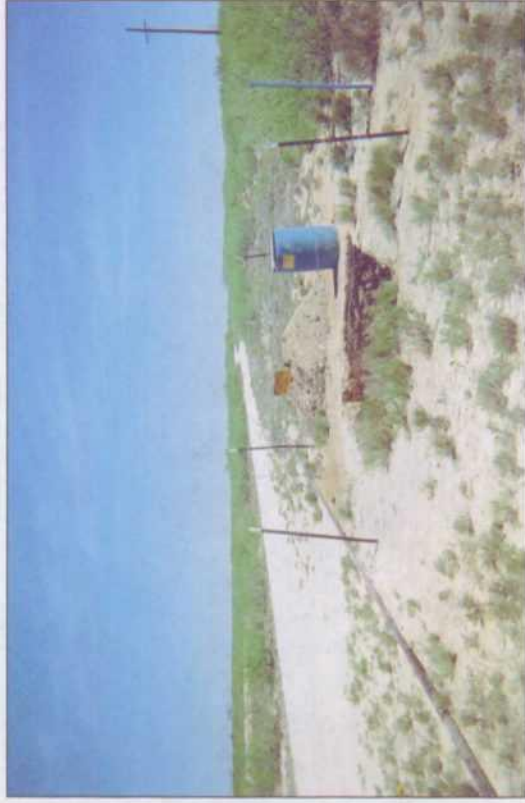
5/8/2003

box site after NORM decon. (looking North)

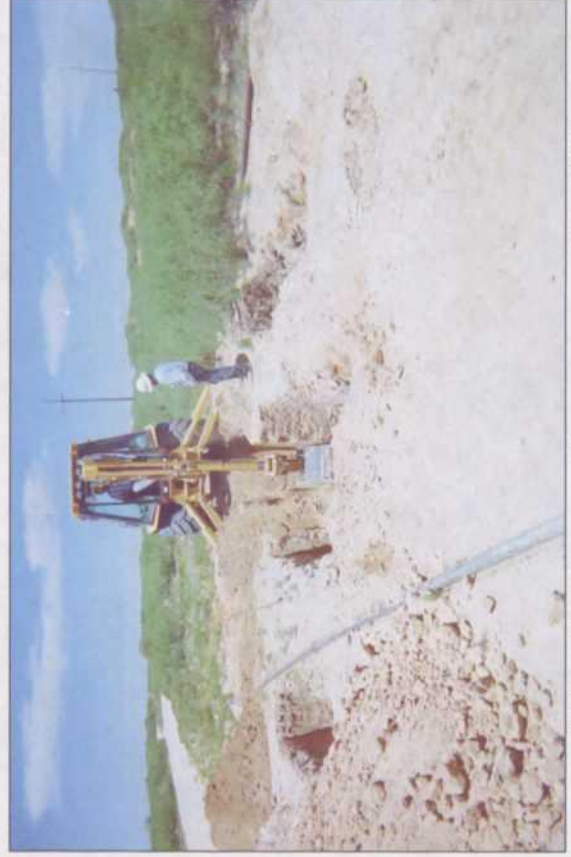
May 2004

delineation & excavation

This junction box was located approx. 12 ft east of an active lease road. The junction was removed and re-plumbed straight through with a new 3-inch poly pipeline. The site was delineated using a backhoe while PID field screenings and chloride field tests were conducted at regular intervals. Chloride concentrations exhibited significant trends of decline with depth (see graph), indicative of non-saturated vadose conditions. PID levels remained relatively low throughout the excavation and concentrations only exceeded 100 ppm at 7-9 ft BGS directly below the junction box. A 20 x 20 x 6-ft-deep excavation was created during the delineation activities with some trenches extended to down to 15 ft BGS (see diagram). Composite samples were collected for lab analysis. NMOCD TPH guidelines were met. At the bottom of the excavation at 6 ft BGS, a 1-ft-thick compacted clay barrier was installed to inhibit further downward migration of chloride. The remaining spoils were blended on site and backfilled into the excavation on top of the clay. The soil was contoured to the surrounding surface and the disturbed surface will be seeded with a blend of native vegetation and is expected to return to productive capacity at a normal rate. Although the extent of lateral chloride impact was not contained within the 20 x 20 ft area, the established vegetation at the excavation perimeter acts as a hindrance to vertical migration of remaining chloride due to effect of evapo-transpiration. Although the junction was eliminated, a metal identification plate has been placed on the surface at the former box location to mark the presence of a clay barrier below at 6 ft.

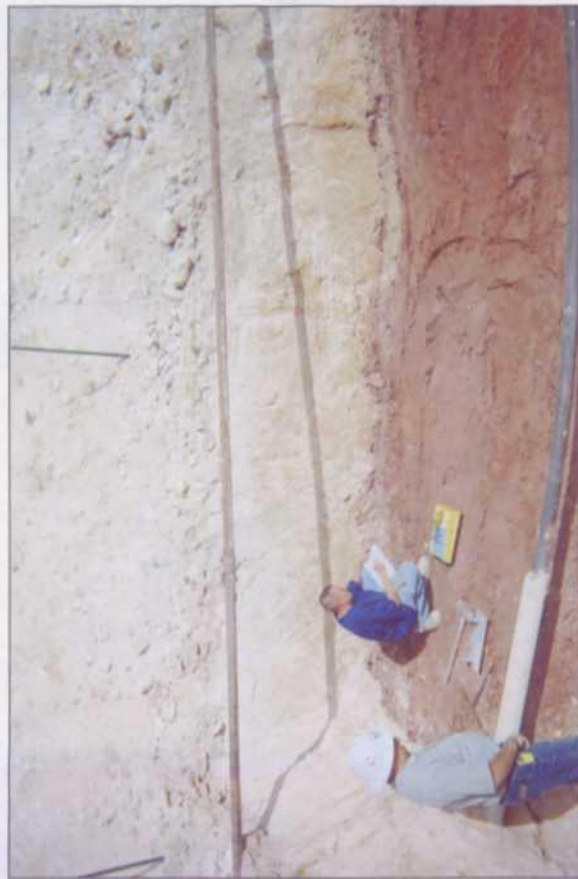
6/9/2004

testing compacted clay at 6 ft BGS

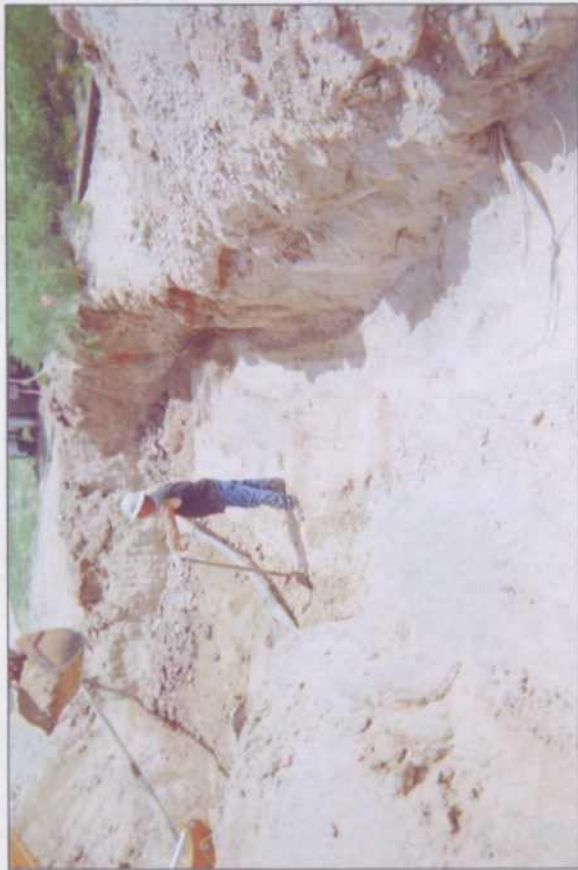
6/9/2004

backfilling excavation

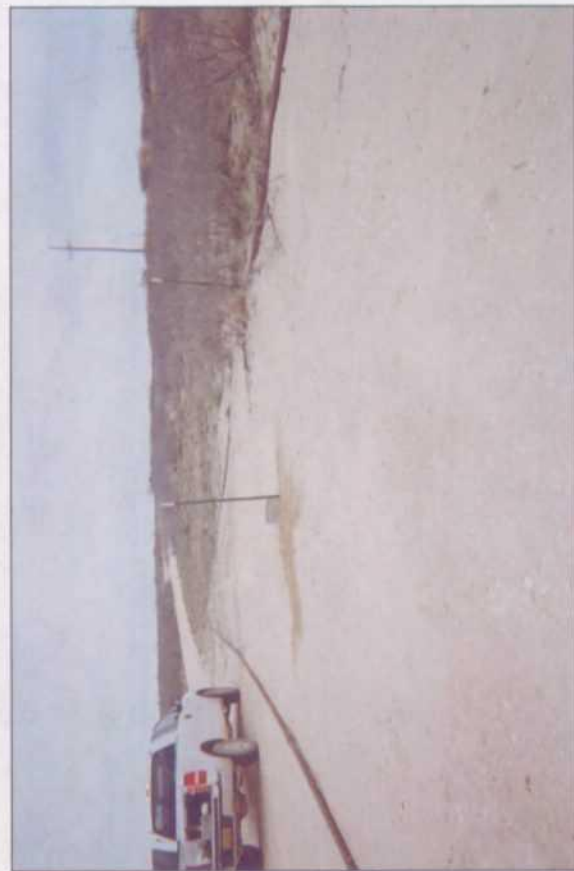
2/15/2005

backfilled; clay identification plate on surface at former junction box site
