# Final Report

**RICE OPERATING COMPANY  
JUNCTION BOX FINAL REPORT**

# Vacuum Chevron 4-27 EOL

Unit 'J', Sec. 27, T17S, R35E

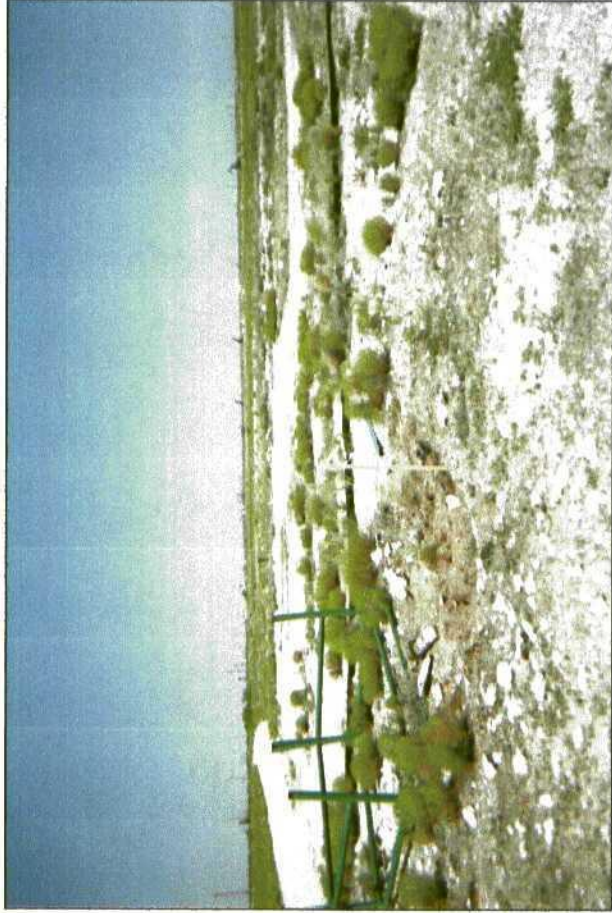
7/11/2005

former junction box site

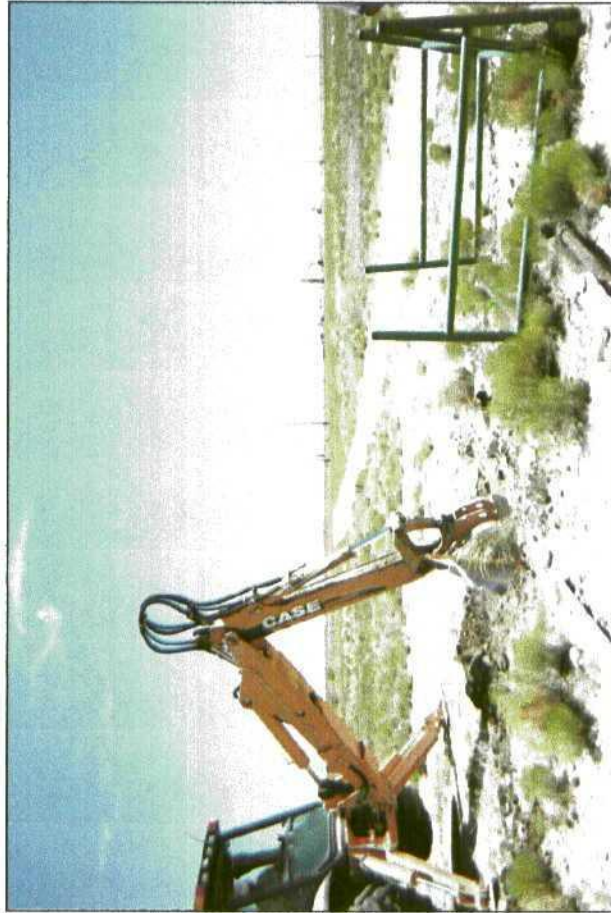
7/25/2005

delineation trench at former box site

This junction box was addressed  
as part of the Vacuum SWD System Abandonment. After the box materials were removed,  
a delineation trench was made at the junction while soil samples were collected every ft of depth  
to 10 ft BGS. Chloride field tests were performed on the samples and concentrations exhibited  
a conclusive trend of decline, indicative of non-saturated historical vadose conditions. PID screenings were also performed on the samples and yielded  
very low concentrations. A grab sample at 10 ft BGS was collected for laboratory analysis and confirmed the field tests. TPH concentrations were not  
present within the lab's detection limits (<10.0 ppm), meeting NMOCD guidelines. The excavated soil was blended on site and then backfilled  
into the trench and contoured to the surrounding surface. The disturbed area was seeded with a blend of native vegetation and is expected to return to

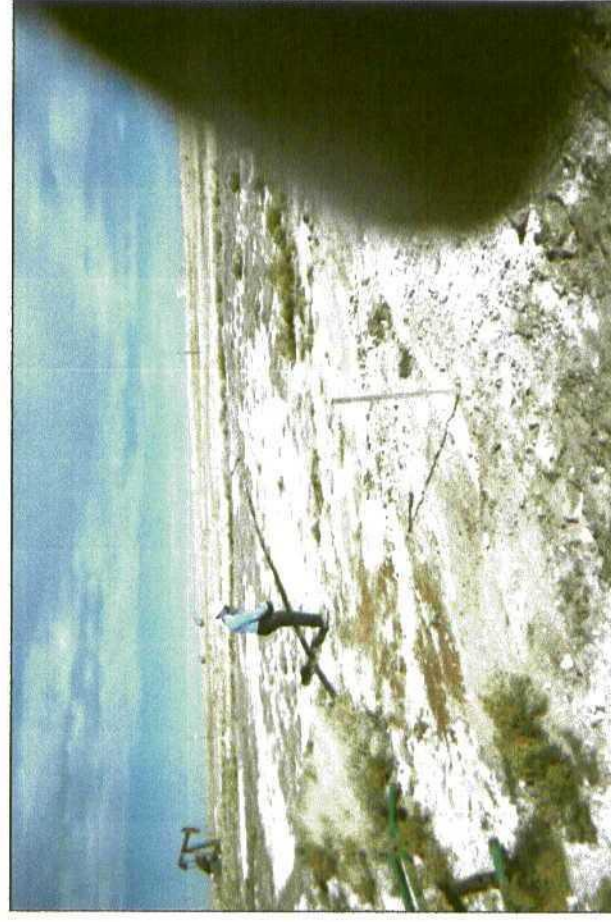
12/23/2005

seeding backfilled site

productive capacity at a normal rate.
