EME J.H. Day EOL

FINAL REPORT

**RICE OPERATING COMPANY
JUNCTION BOX FINAL REPORT**

SWD SYSTEM	JUNCTION	UNIT	SECTION	TOWNSHIP	RANGE	COUNTY	BOX DIMENSIONS - FEET		
EME	J. H. Day EOL	K	6	22S	36E	Lea	Length	Width	Depth
							moved to southeast side of battery

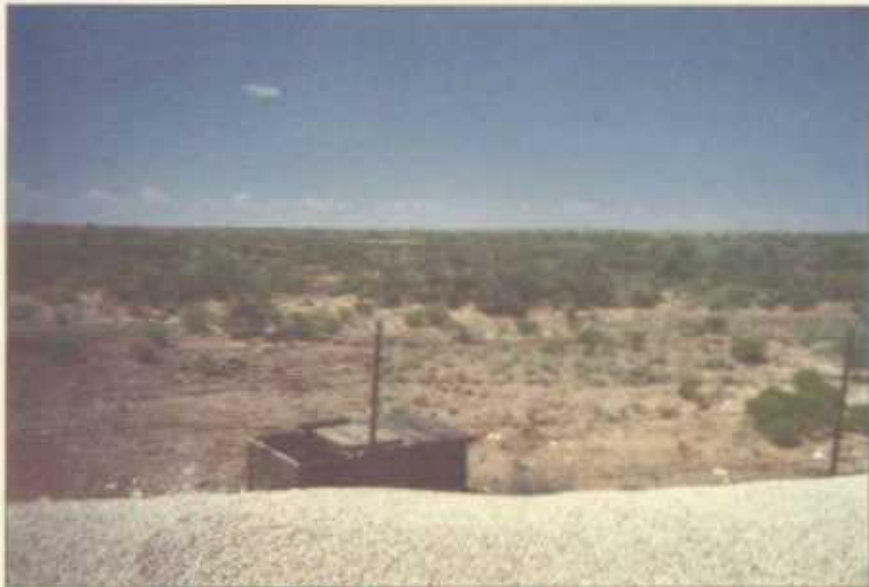
Undisturbed Old Junction Box 7/22/2003

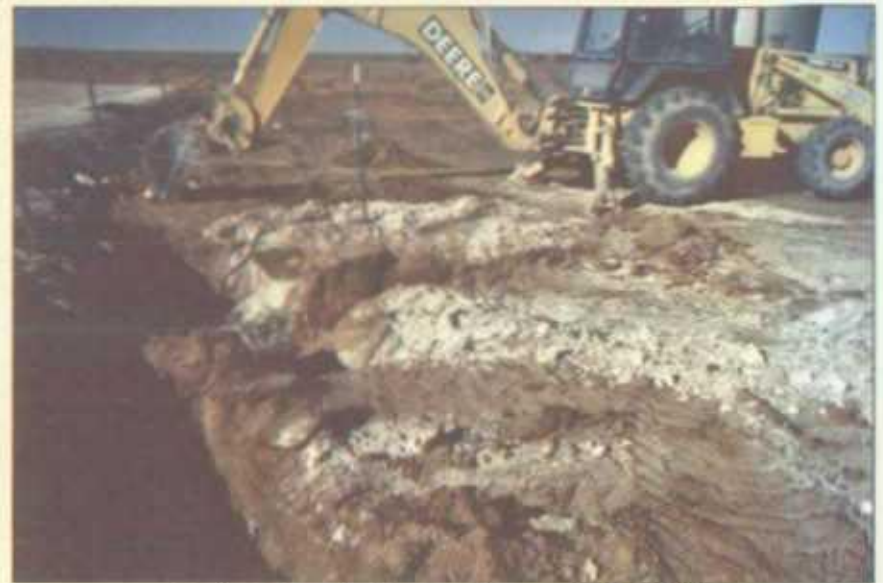
Delineation & Excavation 12/16/2003

General Description of Remedial Action: This EOL box is located just outside the north fence of a production battery. Vertical and lateral delineation with a backhoe yielded conclusive declines in chloride concentrations with depth and distance from the box.

There was no indication of TPH impact and lab results confirmed concentrations well below NMOCD guidelines. The excavated soil was land farmed on-site and then backfilled into the hole. The surface was contoured to the surrounding terrain and vegetation is expected to return at a normal rate. A new watertight box has been built on the southeast site of the battery.

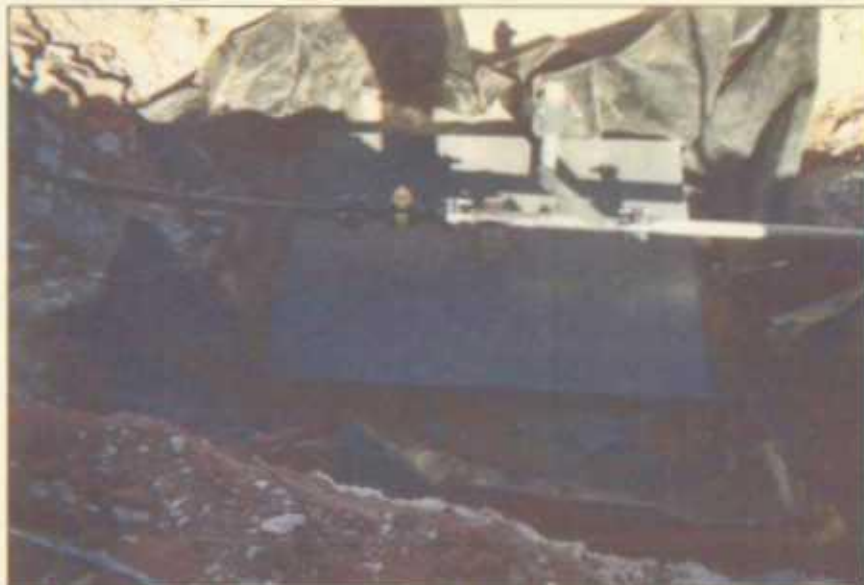
Construction of New Junction Box on Southeast side of Battery

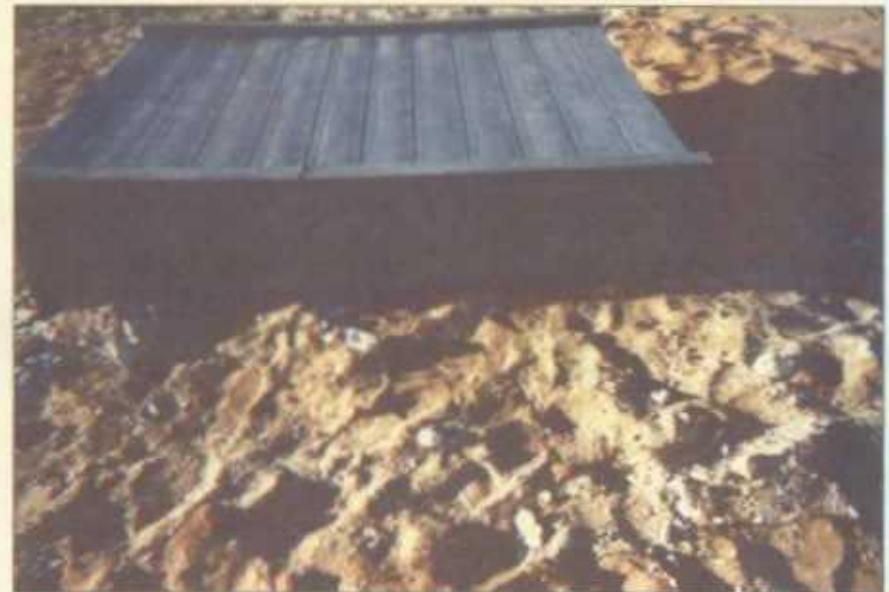
Completed Junction Box 11/26/2003

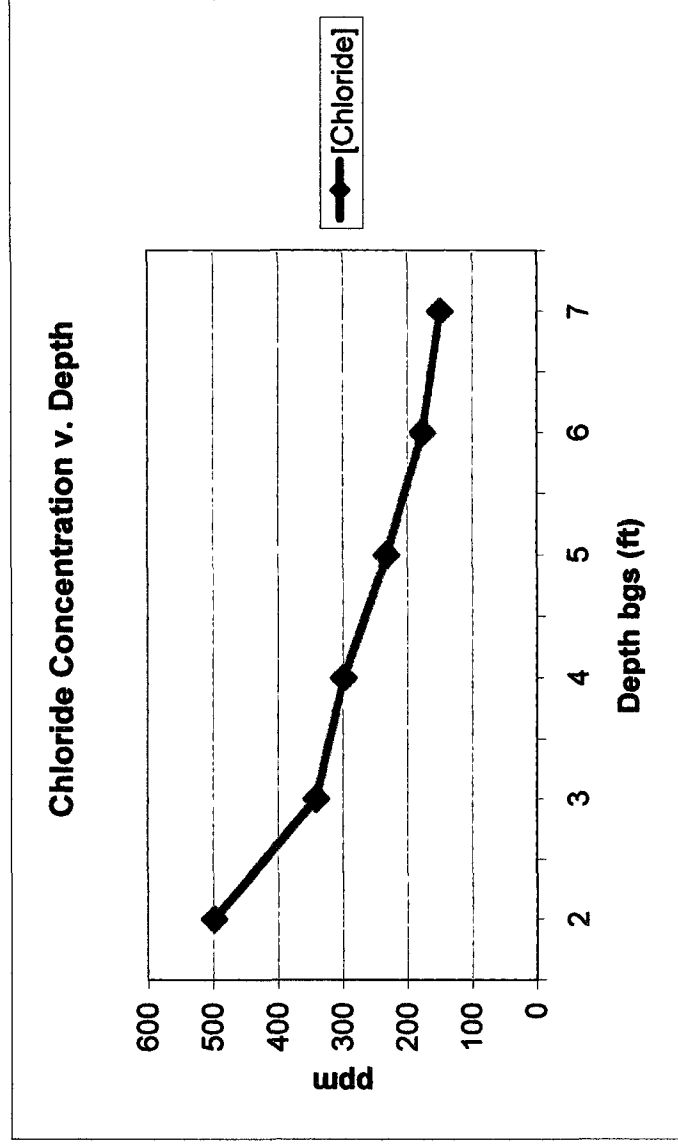
Vertical Delineation at Source

Depth bgs (ft)	[Cl ⁻] ppm
2	499
3	341
4	299
5	232
6	177
7	150

Groundwater = 180 ft

LOCATION	DEPTH (ft)	ppm
Vertical	2	499
	3	341
	4	299
	5	232
	6	177
	7	150
10 ft East	4	145
10 ft North	4	115
10 ft West	4	115
