EME G-9

FINAL REPORT

**RICE OPERATING COMPANY
JUNCTION BOX FINAL REPORT**

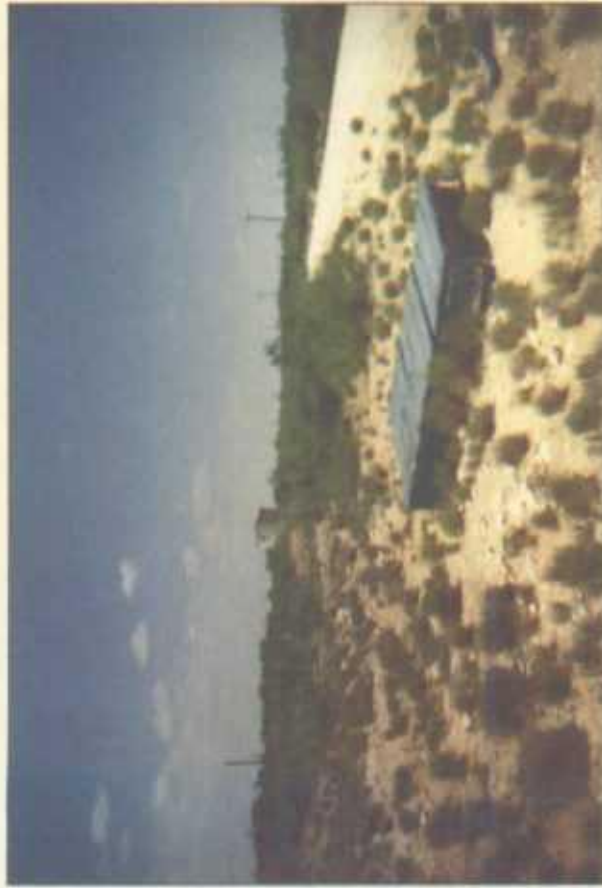
Undisturbed junction box 6/26/2003

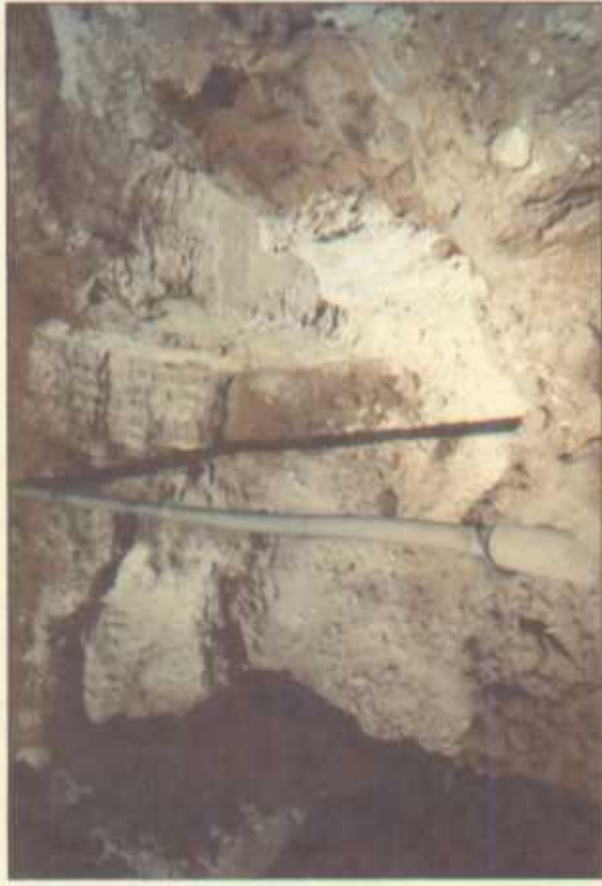
Excavation Sept. 2003

General Description of Remedial Action: This junction box site was excavated

and delineated for chloride and TPH impact to 25 x 30 x 14 ft deep. Chloride concentrations decreased vertically and laterally. TPH concentrations were well below NMOCD guidelines.

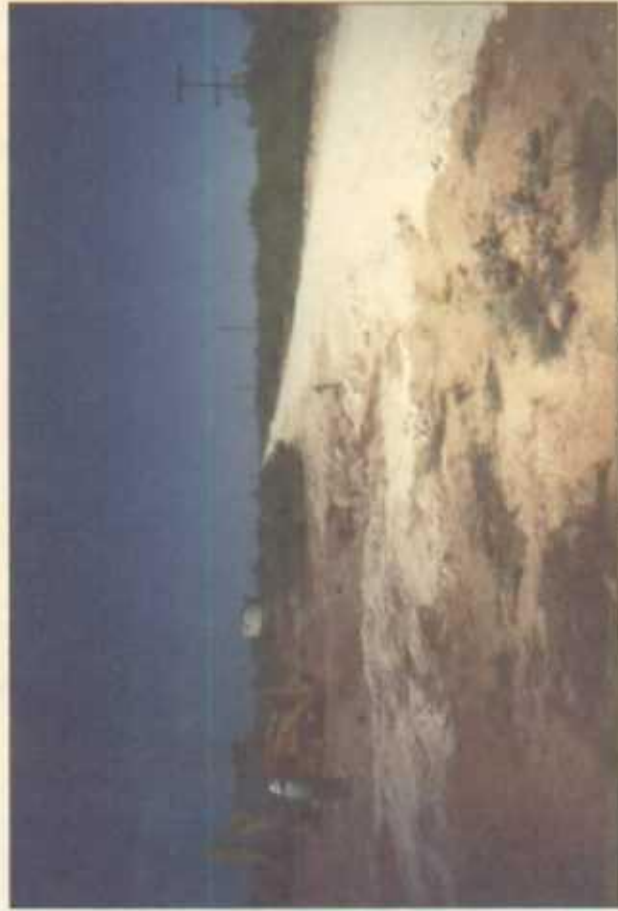
Excavation Sept. 2003

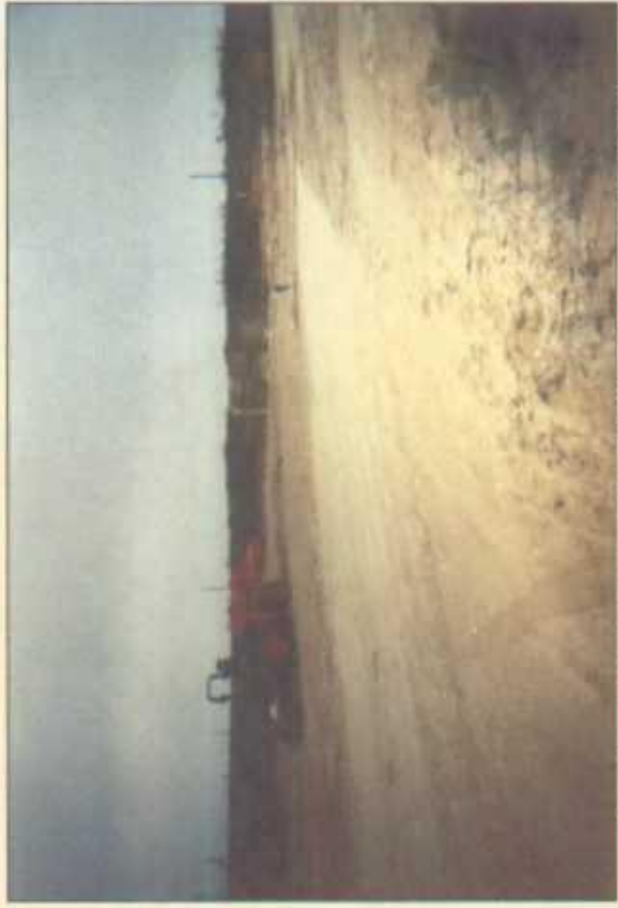
Seeding disturbed area of backfilled site 12/12/2003

The excavated soil was blended and then backfilled into the hole, the surface was contoured to the surrounding landscape. The surface has been re-seeding with a blend of native vegetation and will be monitored for growth. This junction has been eliminated so a new box is not required at this site.
