Final Report

RICE OPERATING COMPANY JUNCTION BOX FINAL REPORT

Vacuum Marathon Warn State 1 EOL

Unit 'F', Sec. 31, T17S, R35E

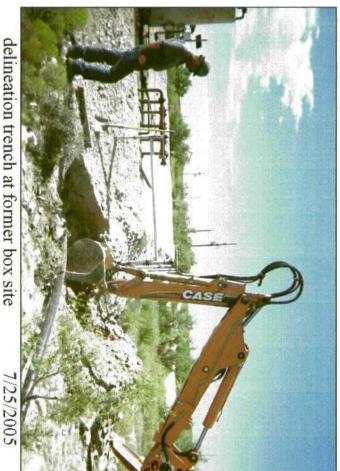
delineation trench at former box site

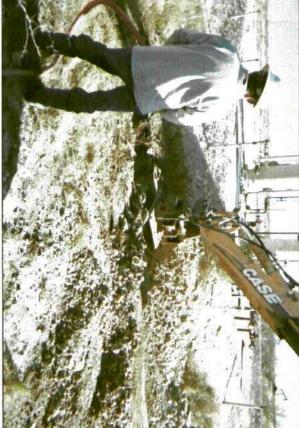
delineation trench at former box site 7/25/2005 b
