# Final Report

**RICE OPERATING COMPANY  
JUNCTION BOX FINAL REPORT**

# Vacuum K-33 vent

Unit 'K', Sec. 33, T17S, R35E

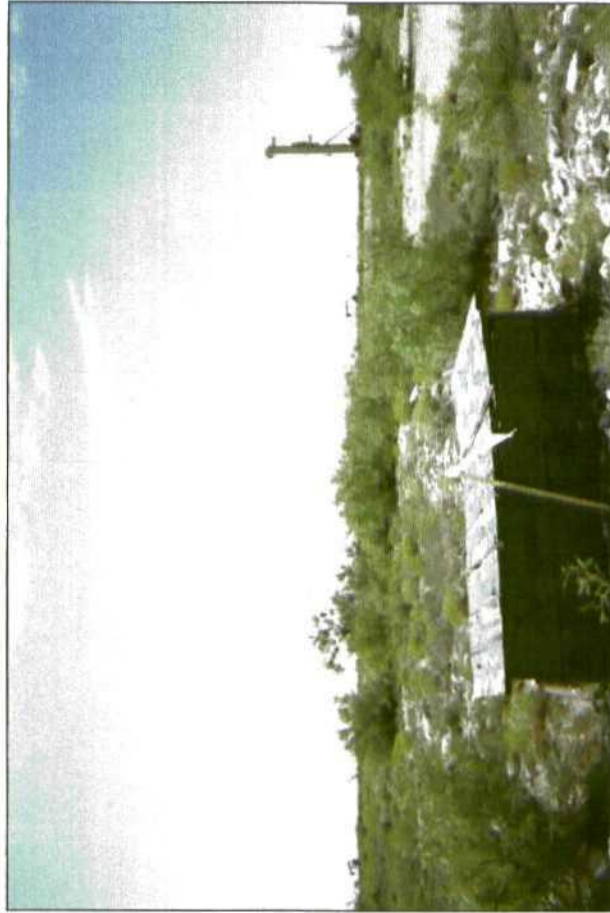
6/30/2005

undisturbed junction box

part of the Vacuum SWD System Abandonment. After removing the box materials, a delineation trench was made using a backhoe while soil samples were collected at regular intervals to 7 ft BGS. Chloride field tests were conducted on each soil sample and exhibited low concentrations similar to background level. PID screenings were also performed on the samples and were also very low. A grab sample at 7 ft BGS was analyzed at a laboratory for confirmation of field tests. NMOCD TPH guidelines were met. The excavated soil was blended on site and then backfilled into the trench and contoured to the surrounding terrain. The disturbed surface was seeded with a blend of native vegetation and is expected to return to productive capacity at a normal rate.

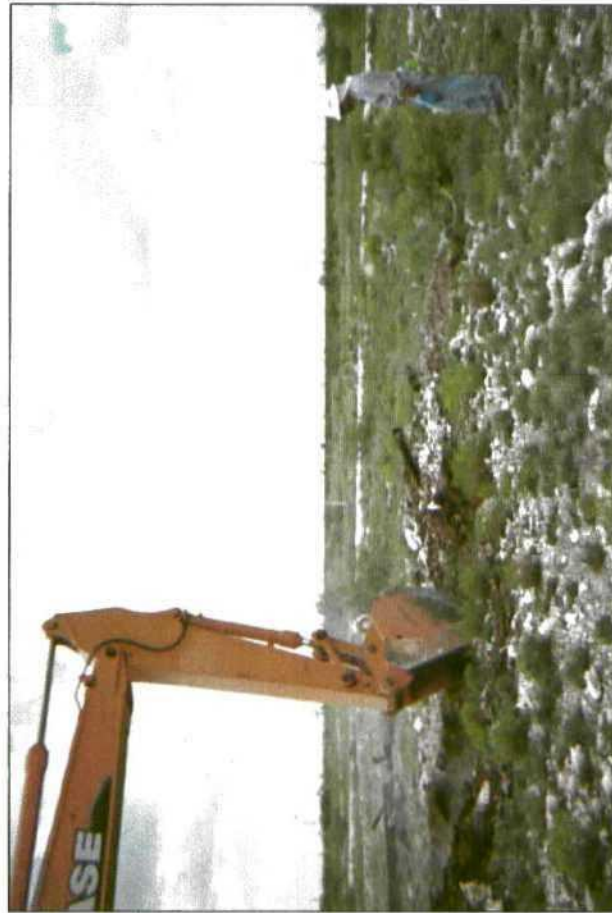
8/12/2005

delineation trench at former box site

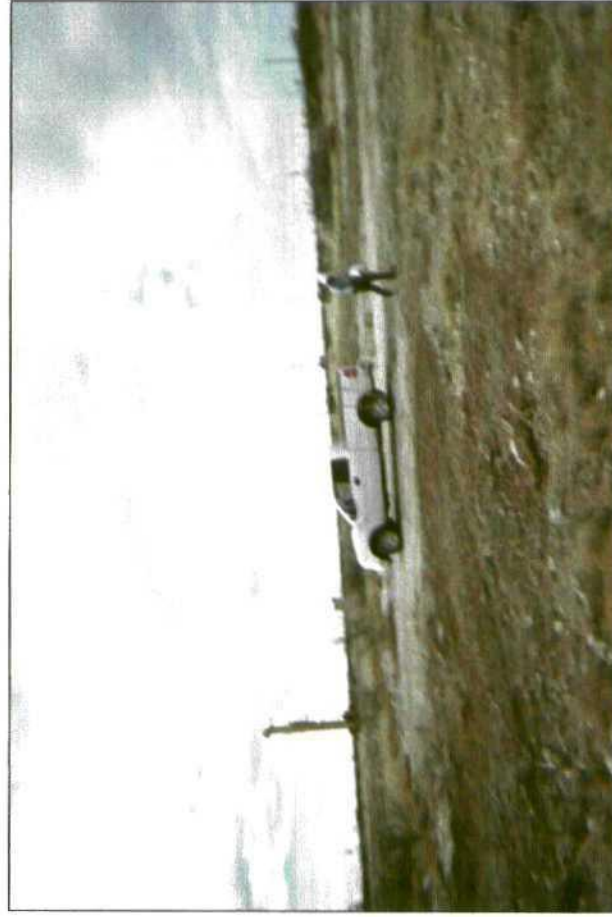
12/23/2005

seeding backfilled site
