EME Oil & Gas State  
W (nech)

**RICE OPERATING COMPANY  
JUNCTION BOX DISCLOSURE\* REPORT**

## EME State 'H' 17 EOL North & South Boxes

# Oil & Gas State 'H' North EOL

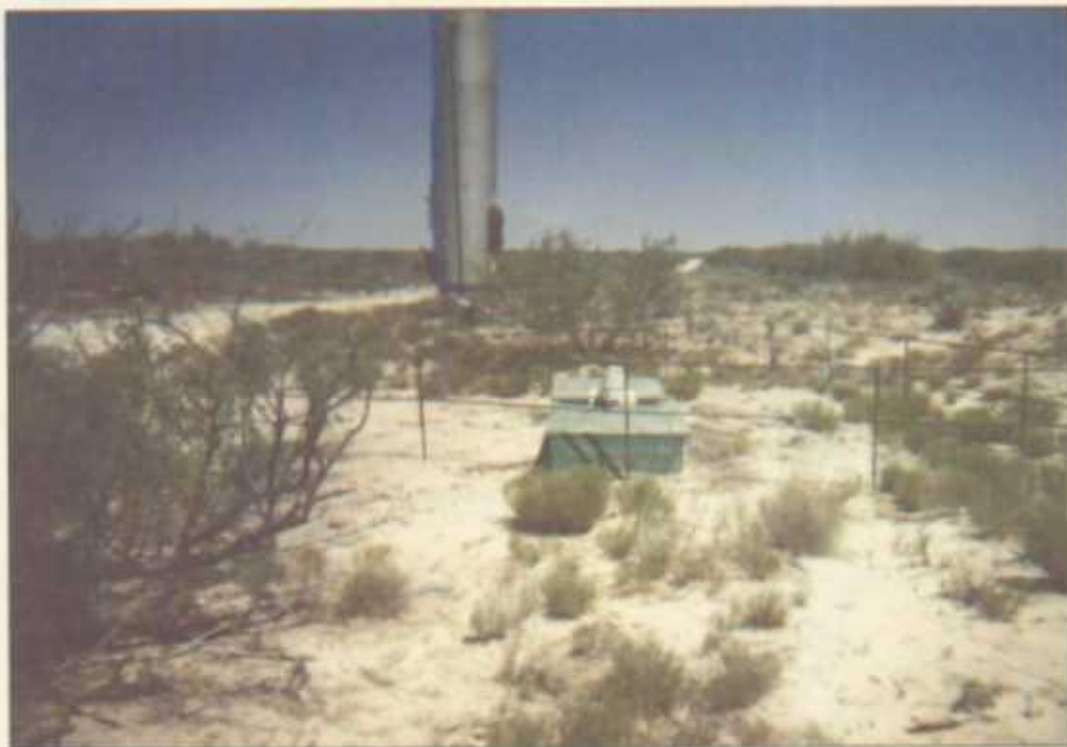
8/6/2003

Undisturbed north and south boxes

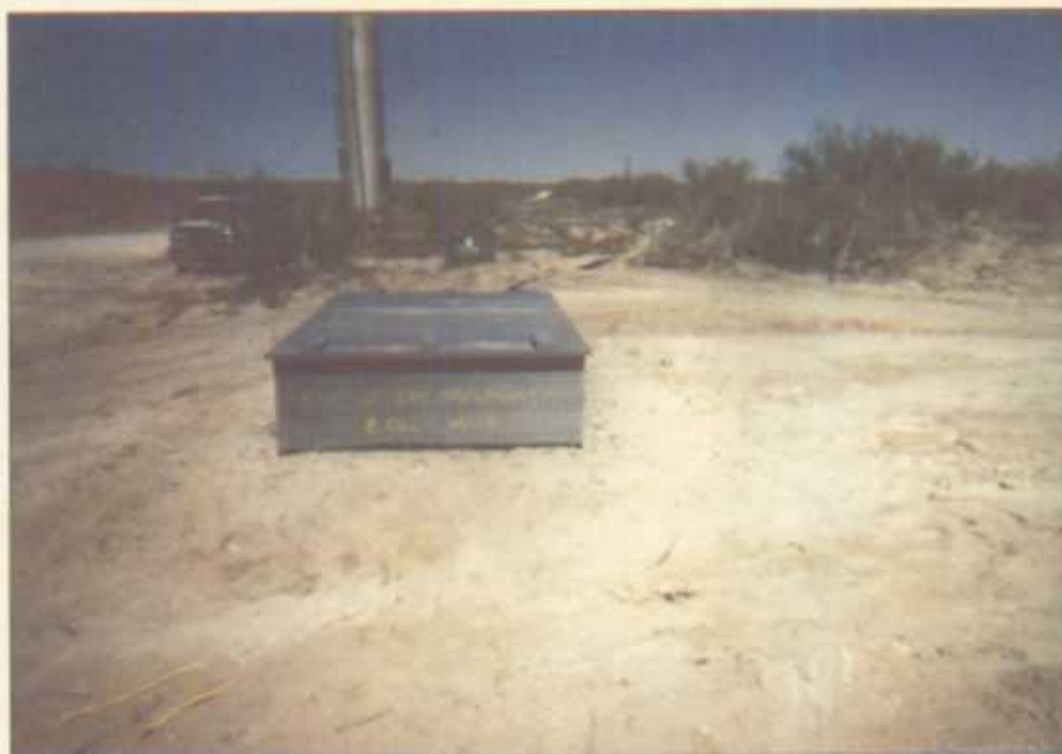
10/15/2003

Completed new box 50 ft south of old boxes in background

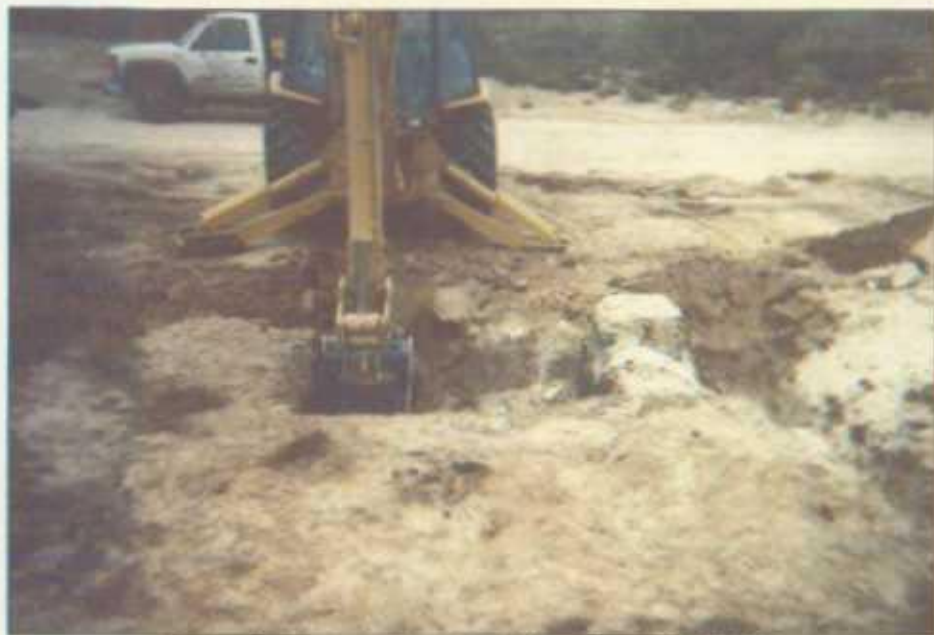
Beginning excavation & delineation 11/6/2003

General Description of Remedial Action: This site was composed of two boxes that were approximately 5 ft apart. Vertical delineation at each box did not result in a conclusive decline of chloride impact (see graph). All PID readings were 0.0 ppm and TPH concentrations were well below NMOCD guidelines. A 20 x 20 x 4-ft deep excavation was made around the boxes and at 4 ft bgs, a 1.5 ft compacted clay barrier was installed to inhibit further chloride migration. The excavated soil was landfamed on site and then backfilled on top of the clay and the surface was contoured to the surrounding terrain. The disturbed surface has been seeded with a blend of native vegetation. A new EOL box has been built approximately 50 ft south of this location.

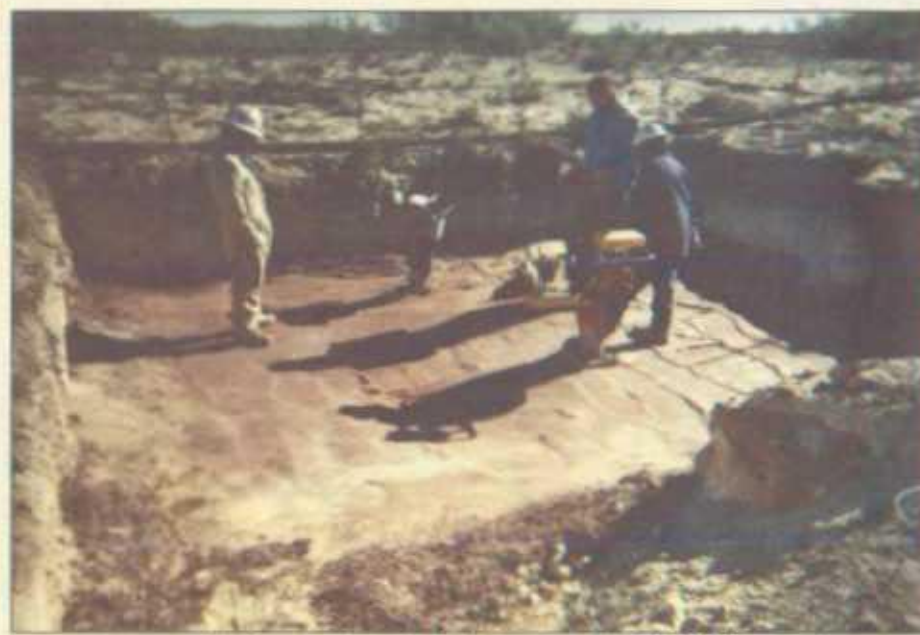
Testing compacted clay 11/20/2003

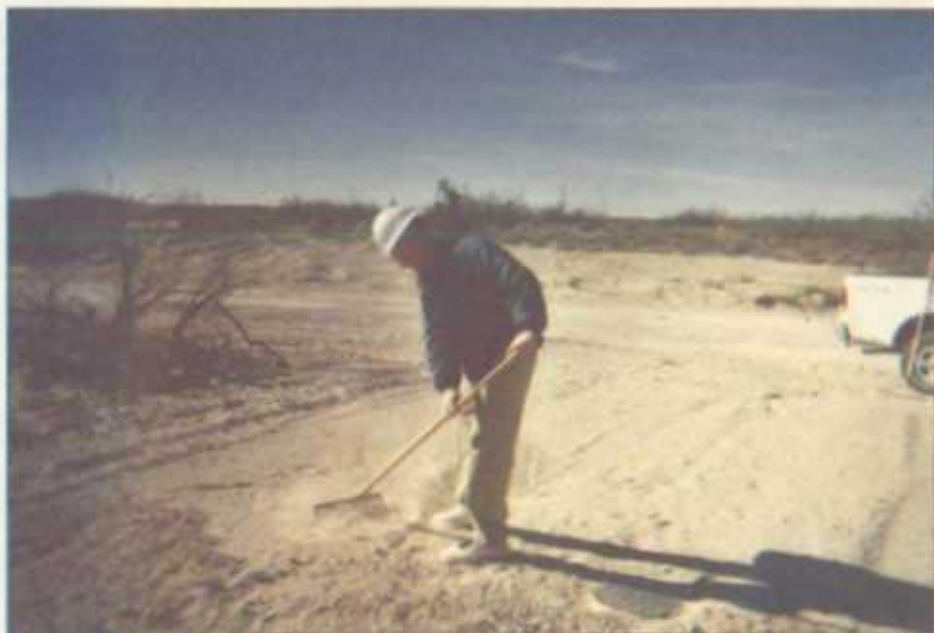
Seeding disturbed surface

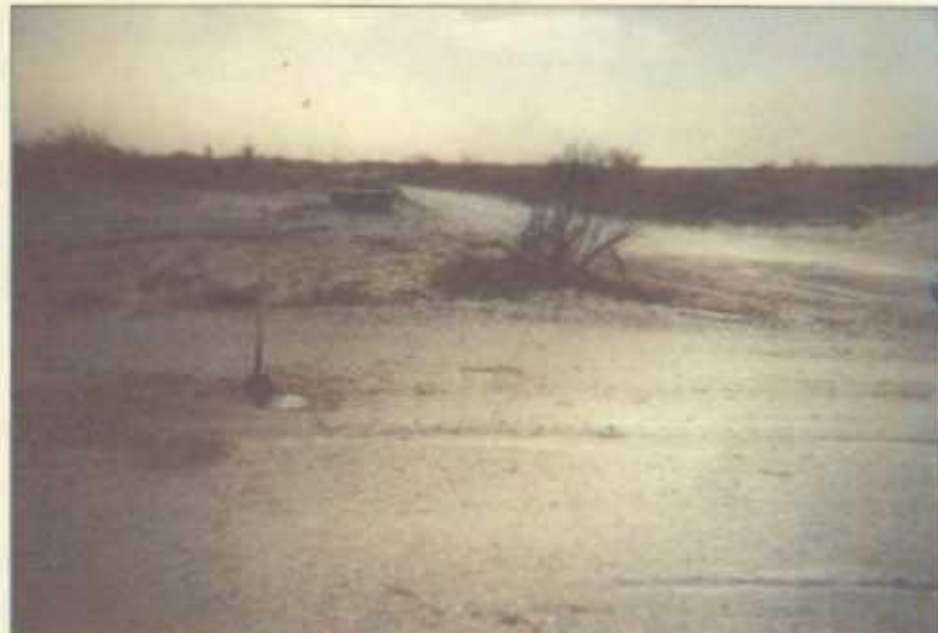
Identification plate marking clay liner
