FINAL REPORT

**RICE OPERATING COMPANY
JUNCTION BOX FINAL REPORT**

SWD SYSTEM	JUNCTION	UNIT	SECTION	TOWNSHIP	RANGE	COUNTY	BOX DIMENSIONS - FEET		
EME	H-12	H	12	21S	35E	Lea	Length	Width	Depth
							No Box (eliminated)

EME jct. H-12

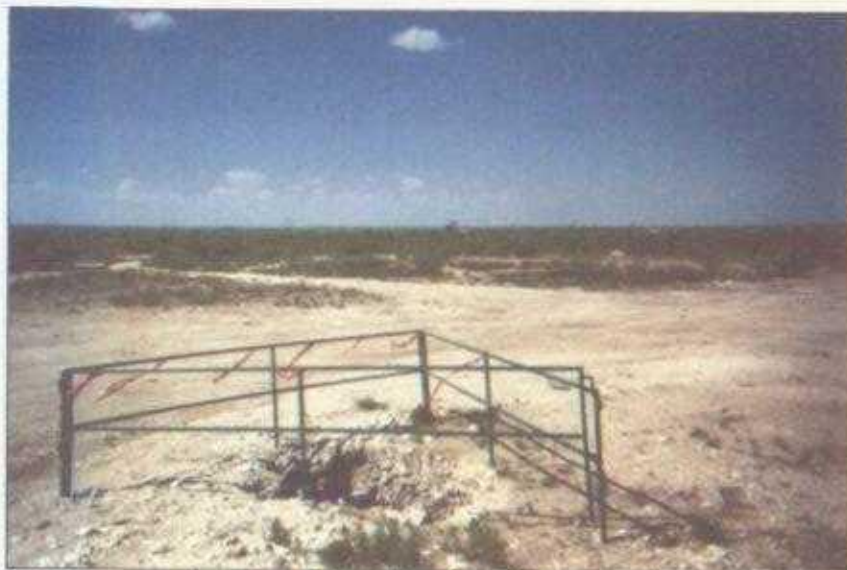
Jct. Box Site (after NORM removal)

chloride concentration declines vertically and laterally in relation to the original junction. There was no evidence of TPH impact. PID readings were taken regularly which consistently yielded minimal readouts. The excavated soil from the 23 x 14 x 13-ft-deep hole was blended and then backfilled and contoured to the surrounding surface. A new junction box will not be re-built over the location as it was re-plumbed straight through with a new poly pipeline. The disturbed surface will not be re-seeded due to the site's proximity to active oilfield facilities, structures, and a road (see photos). The site is expected to naturally re-vegetate at a normal rate.

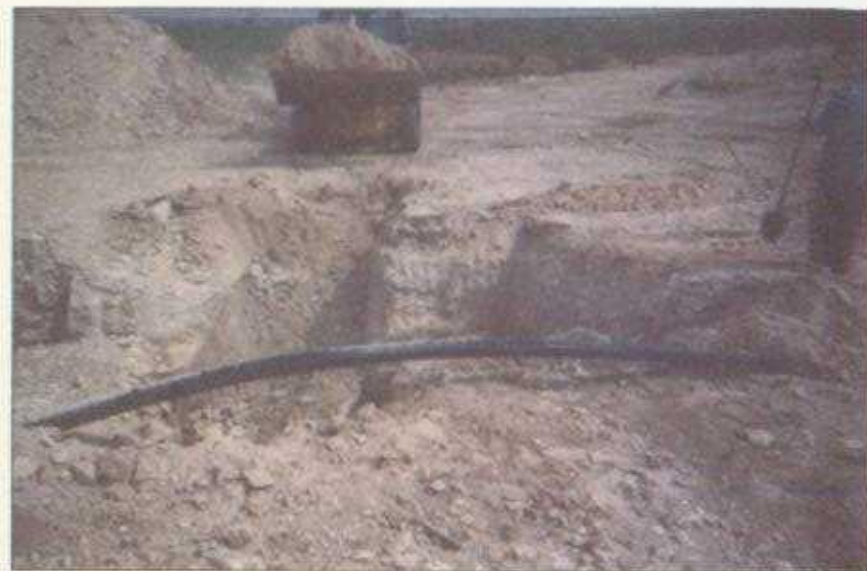
Excavation

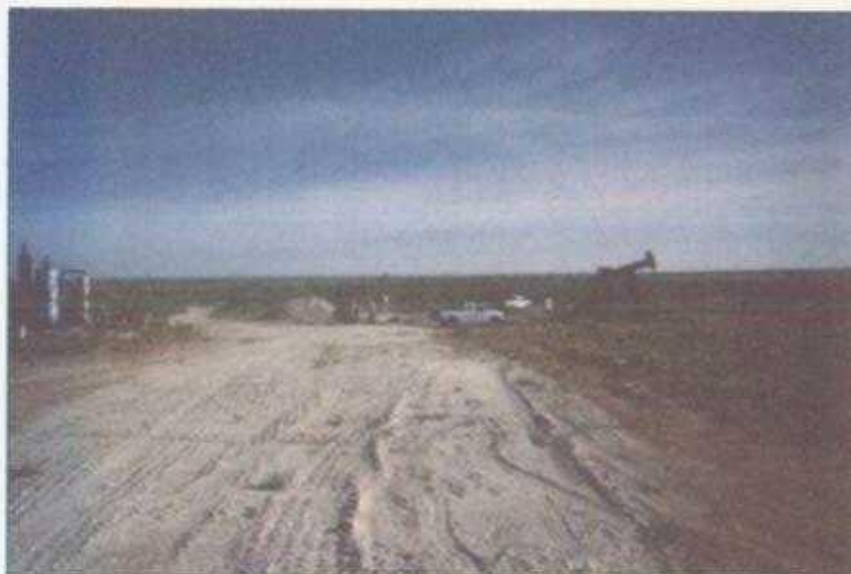
Excavation (looking North)

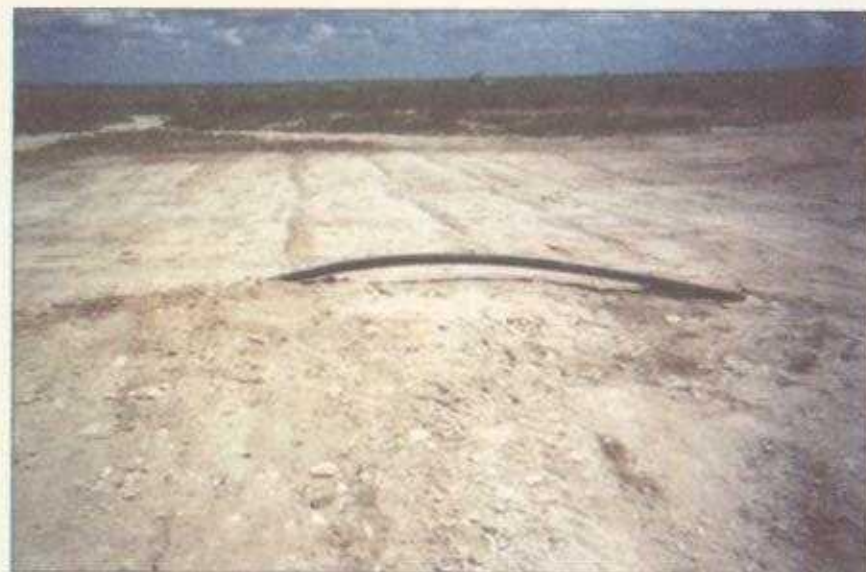
Backfilled

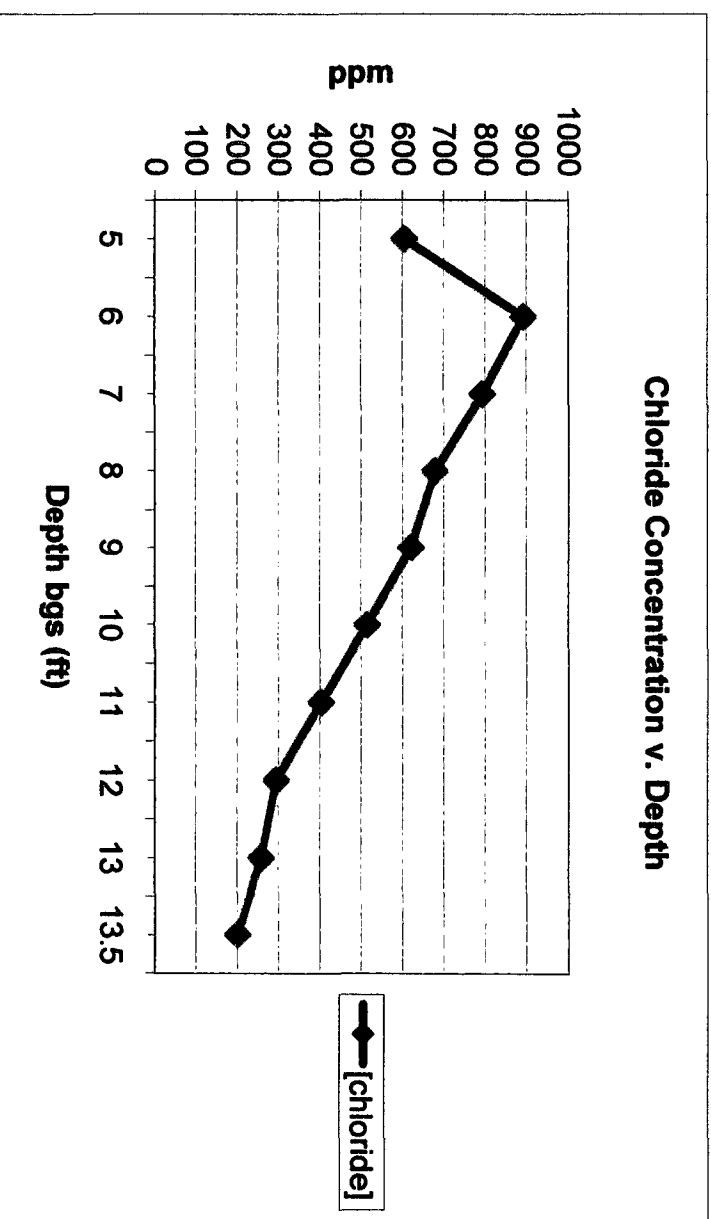
CHLORIDE CONCENTRATION CURVE

Vertical at center of jct.

Depth bgs (ft)	[Cl-] ppm
5	605
6	893
7	794
8	679
9	621
10	515
11	403
12	294
13	259
13.5	201

Groundwater = 133 ft

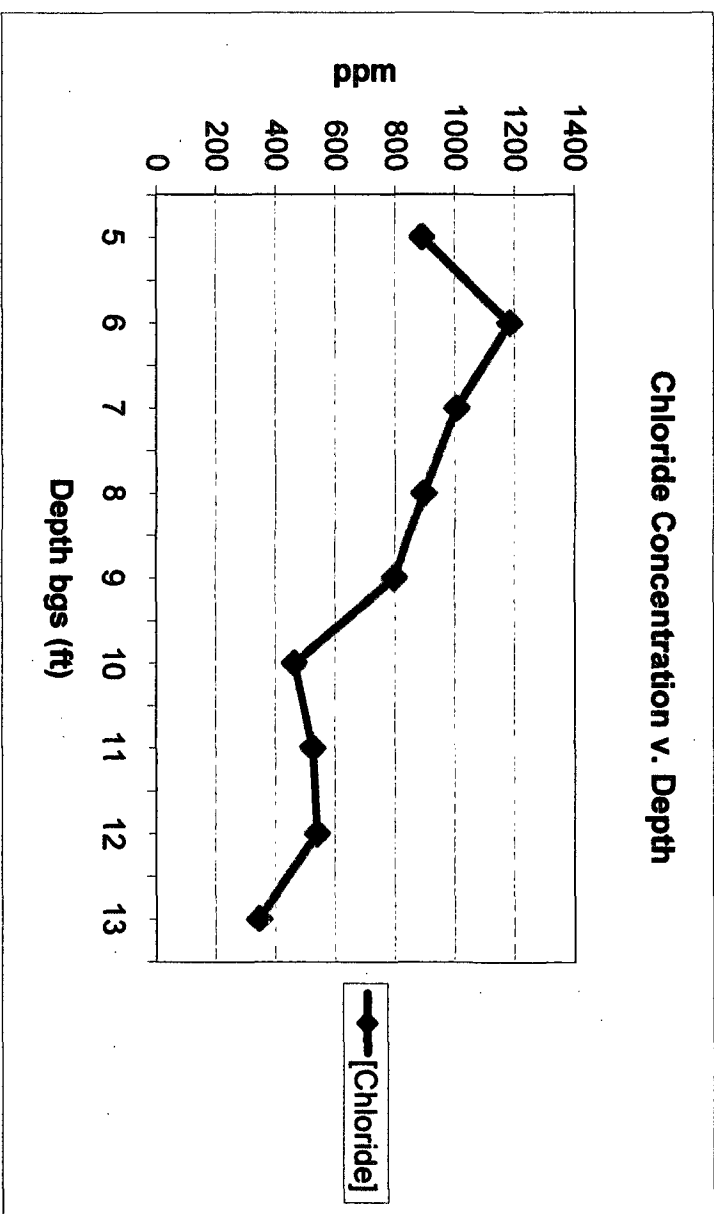
CHLORIDE CONCENTRATION CURVE

5 ft east from center of jet.

Depth bgs (ft)	[Cl-] ppm
5	891
6	1184
7	1008
8	896
9	799
10	464
11	525
12	540
13	345

Groundwater = 133 ft

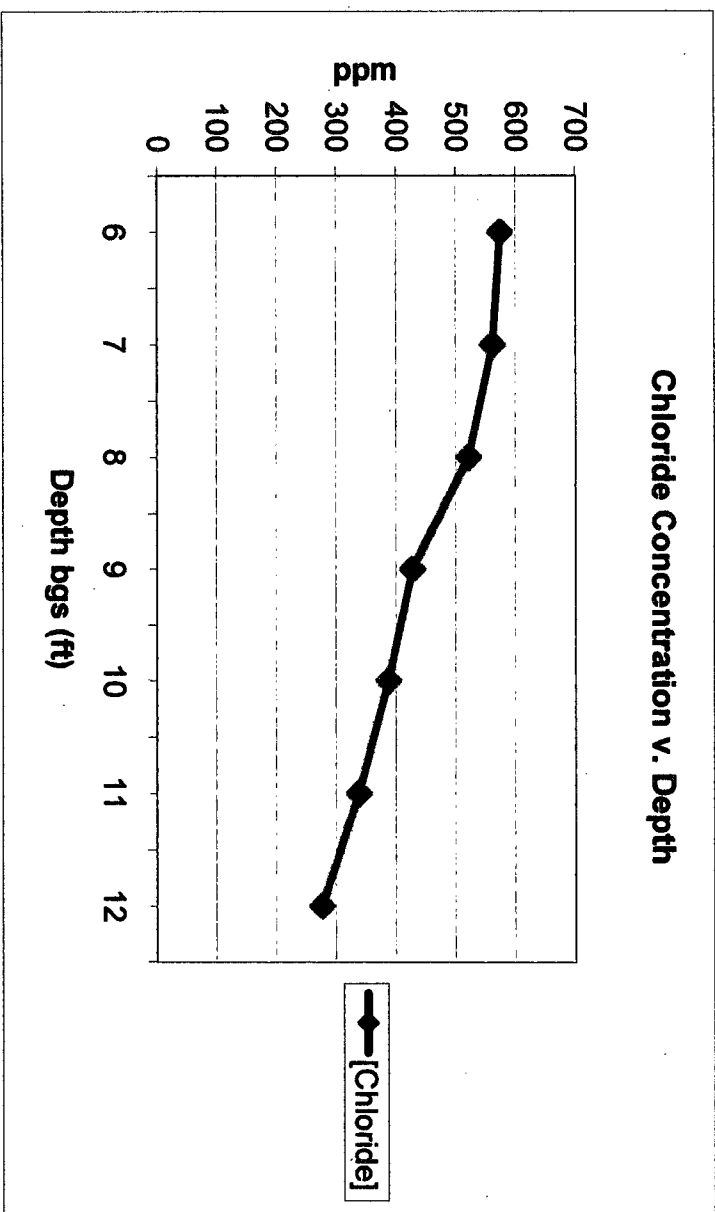
CHLORIDE CONCENTRATION CURVE

10 ft east from center of jct.

Depth bgs (ft)	[Cl-] ppm
6	575
7	562
8	522
9	428
10	388
11	338
12	277

Groundwater = 133 ft
