BD Texaco Clifton ECL

FINAL REPORT

**RICE OPERATING COMPANY
JUNCTION BOX FINAL REPORT**

BD Clifton EOL

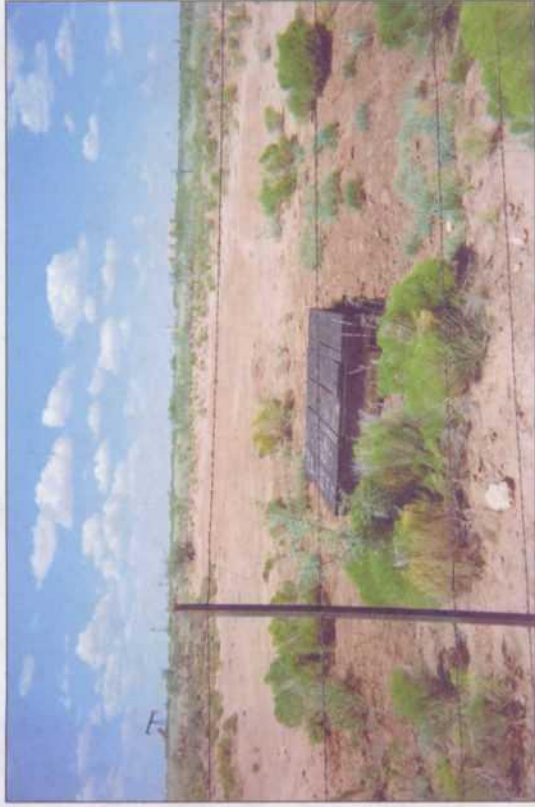
8/8/2003

Undisturbed box

General Description of Remedial Action: This junction was eliminated and plumbed straight through with a new pipeline. The box lumber was removed after the NORM survey and the hole was backfilled immediately due to rainwater and cattle gathering near the site. Environmental excavation and delineation was conducted using a backhoe as chloride field tests and PID screenings were performed at regular intervals. Two trenches (one at the junction and another 5 ft west) were made and samples collected yielded very low chloride concentrations similar to background levels. PID levels were minimal and laboratory tests confirmed BTEX and TPH concentrations that were non-detect, meeting NMOCD's guidelines. The trenches were then backfilled and leveled to the surrounding terrain. The disturbed surface area is expected to return to productive capacity at a normal rate.

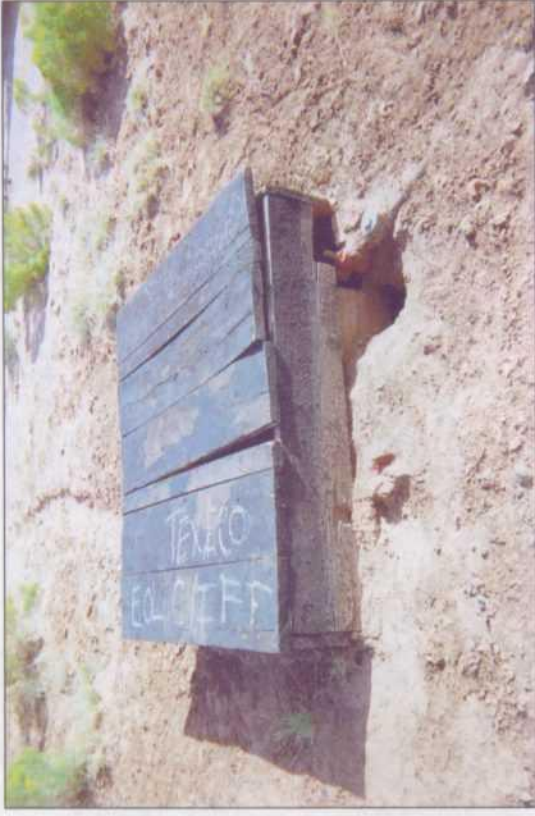
9/19/2003

Close-up of box

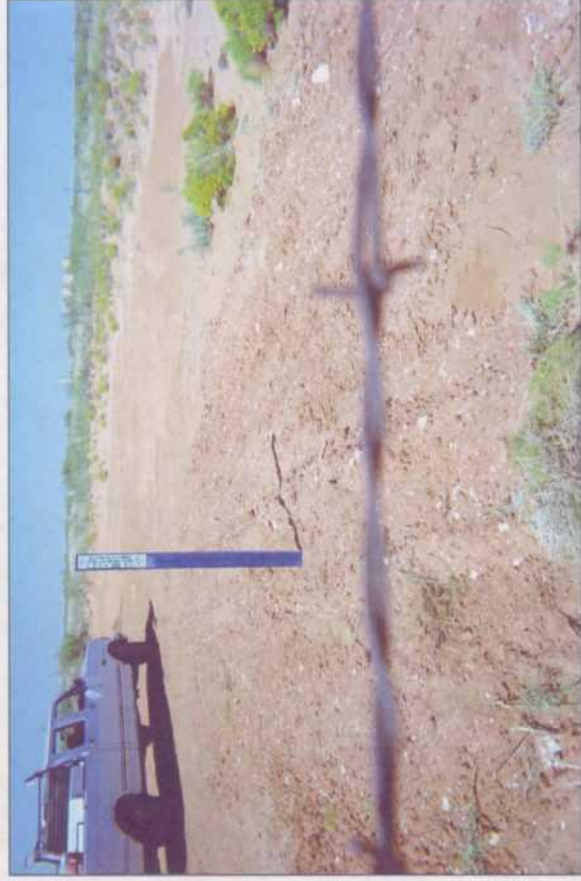
9/19/2003

backfilled
