**RICE OPERATING COMPANY  
JUNCTION BOX FINAL REPORT**

SWD SYSTEM	JUNCTION	UNIT	SECTION	TOWNSHIP	RANGE	COUNTY	BOX DIMENSIONS - FEET		
							Length	Width	Depth
EME	M-10-1	M	10	21 S	36 E	Lea	7	5	10

## EME jct. M-10-1

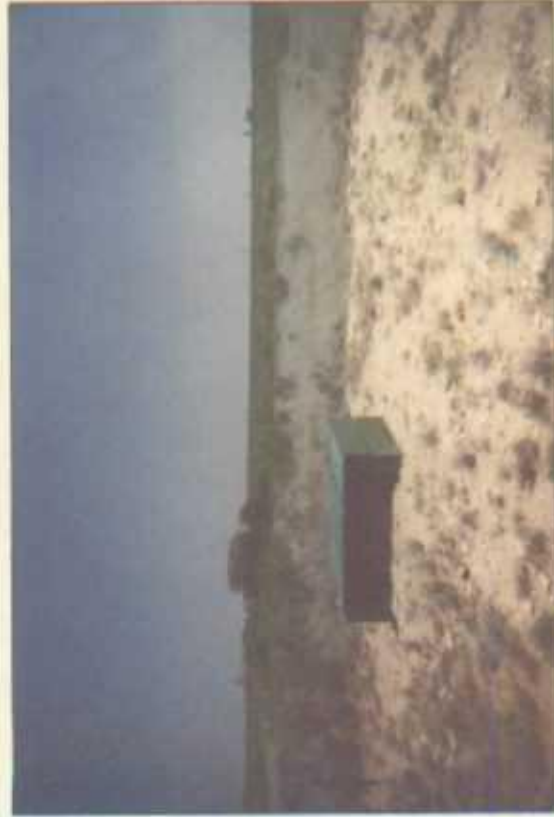
Old wooden box prior to excavation

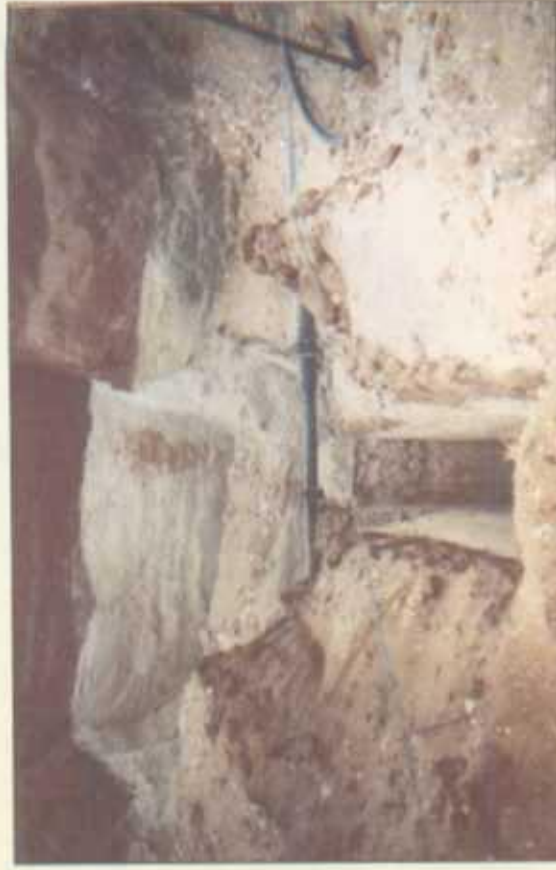
Backhoe excavation & delineation

General Description of Remedial Action: Delineation with a backhoe did not  
yield a sufficient decline in chloride concentrations with depth. PID readings were minimal  
and lab results confirmed that TPH concentrations are well below NMOCD guidelines.  
The location was bored to determine the vertical extent of chloride impact and tests of the  
returns conclusively indicate that chloride ceases well above groundwater depth (see graphs).  
A 1.5 ft compacted clay barrier was installed at the bottom of the 25 x 24 x 12-ft-deep excavation  
to inhibit further downward migration of chloride. The excavated soil was landfarmed at the  
location and then backfilled into the hole and leveled. The disturbed surface has been  
re-seeded with a blend of native vegetation and will be monitored for growth. A new watertight  
junction box has been built over this site.  
enclosed: lab results, chloride graphs, diagram, photos, clay compaction test

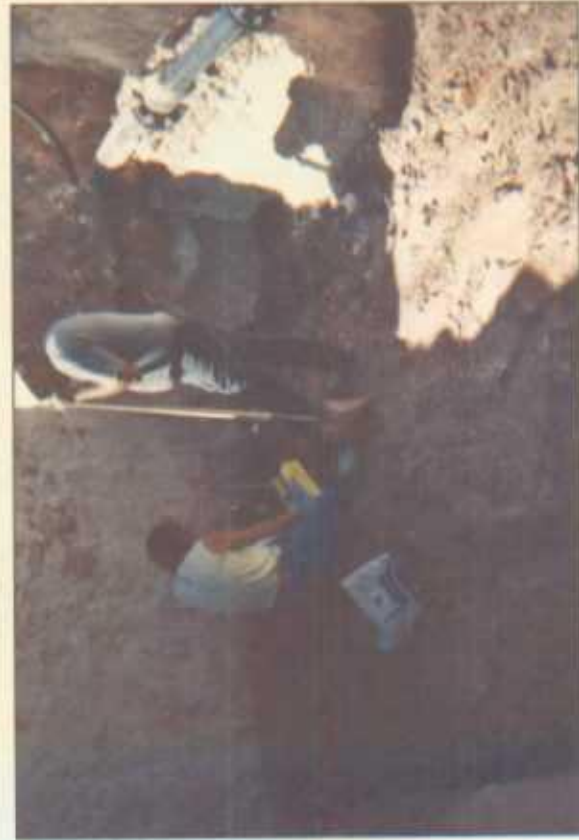
Density & compaction test of clay

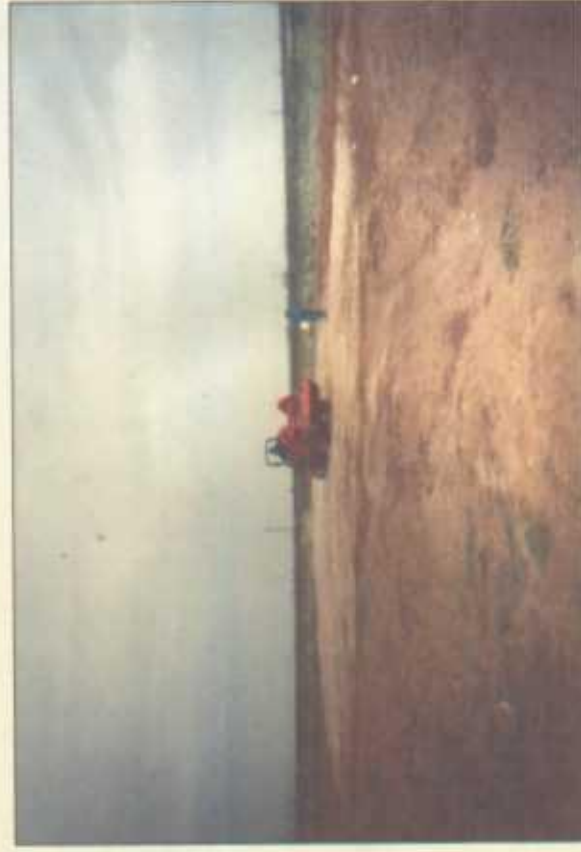
Seeding disturbed area; new plastic junction box in background

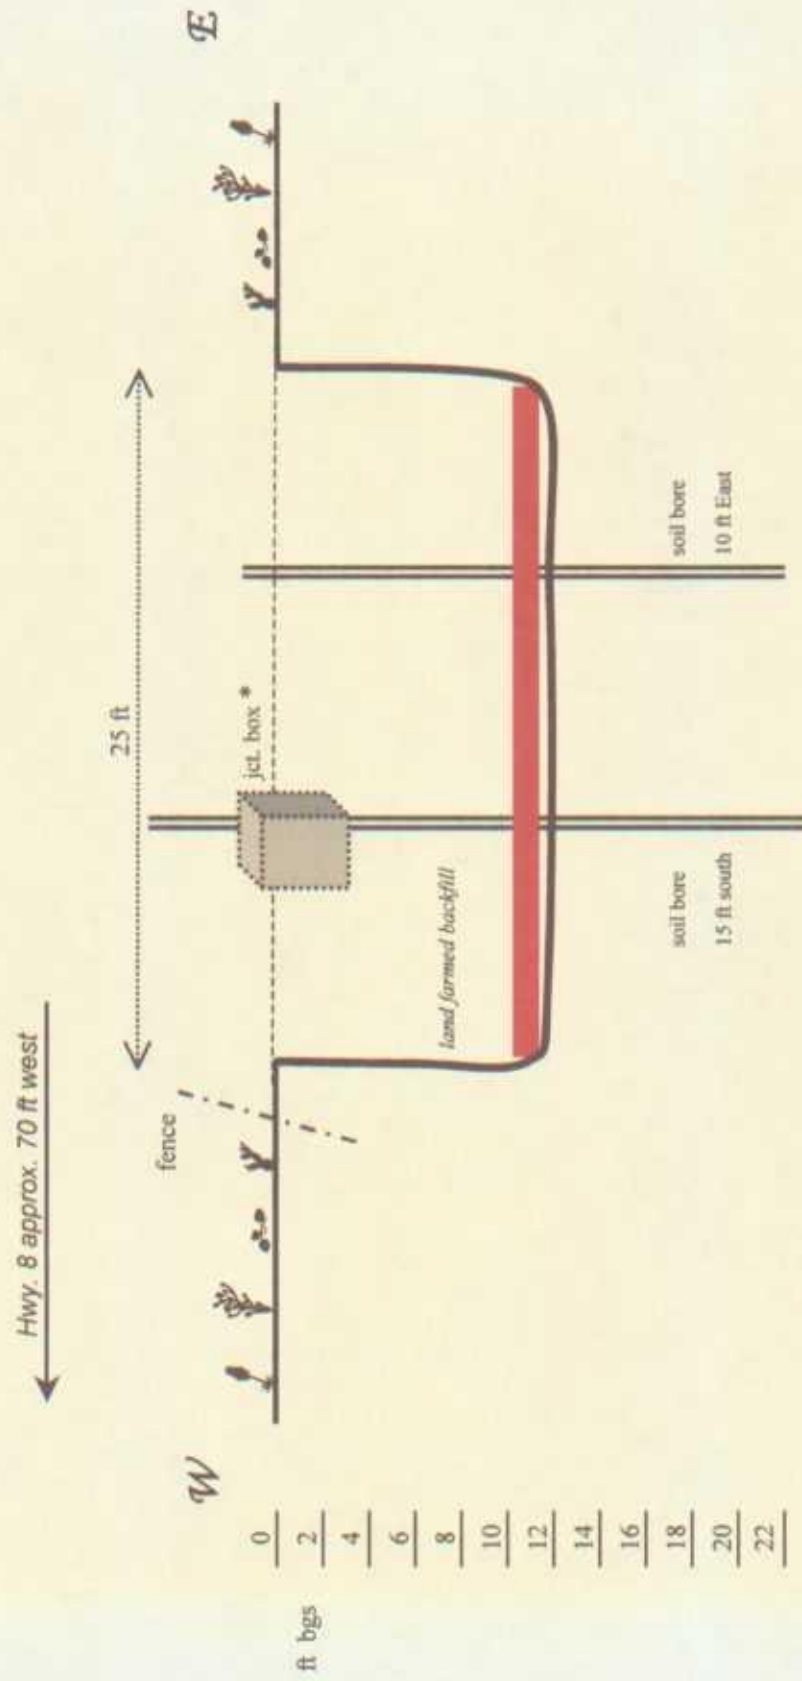
# EME jct. M-10-1 Impact Excavation Cross-Section

\* New water-tight junction box is re-built in the same location.

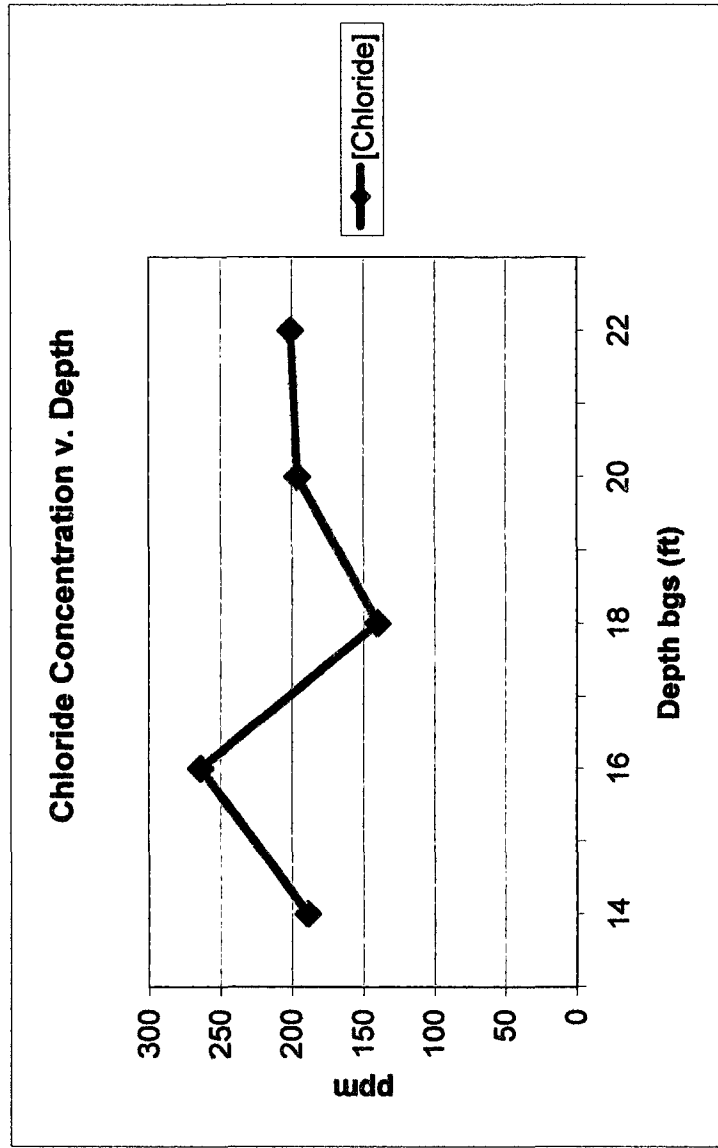
Soil Bore 15 ft South

Depth bgs (ft)	[Cl <sup>-</sup> ] ppm
14	189
16	264
18	140
20	196
22	201

Groundwater = 200 ft

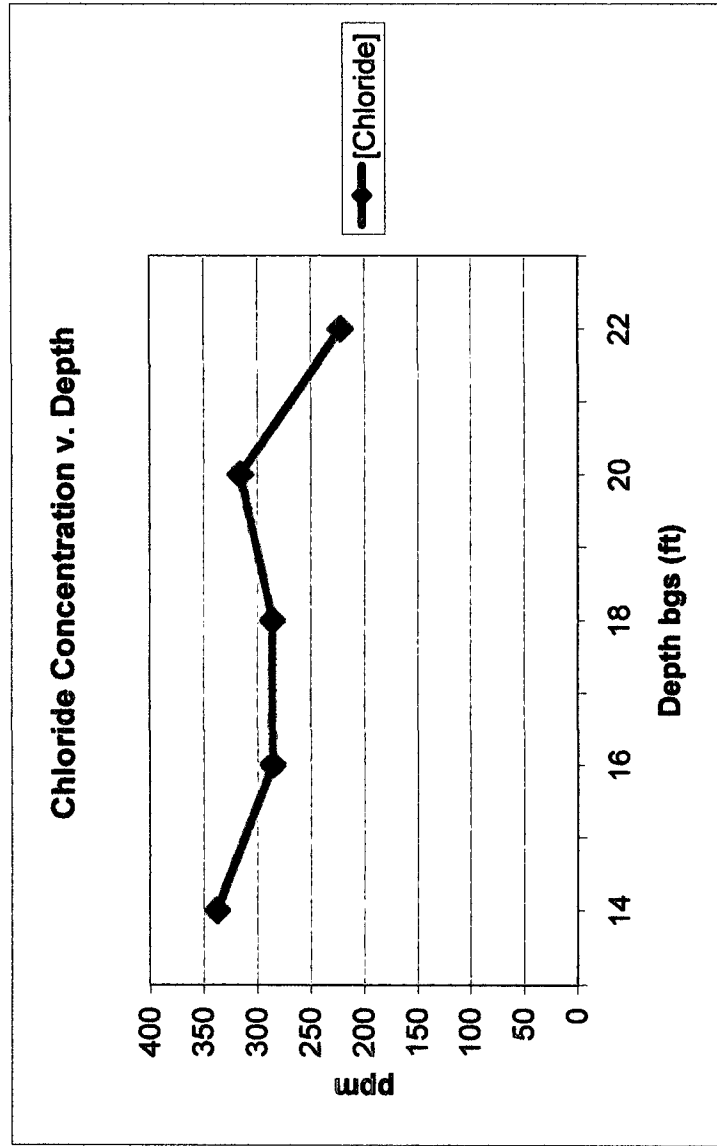
Soil Bore 10 ft East

Depth bgs (ft)	[Cl <sup>-</sup> ] ppm
14	338
16	286
18	286
20	316
22	222

Groundwater = 200 ft
