FINAL REPORT

**RICE OPERATING COMPANY
JUNCTION BOX FINAL REPORT**

SWD SYSTEM	JUNCTION	UNIT	SECTION	TOWNSHIP	RANGE	COUNTY	BOX DIMENSIONS - FEET		
EME	L-15	L	15	20 S	37 E	Lea	Length 9	Width 7	Depth 5

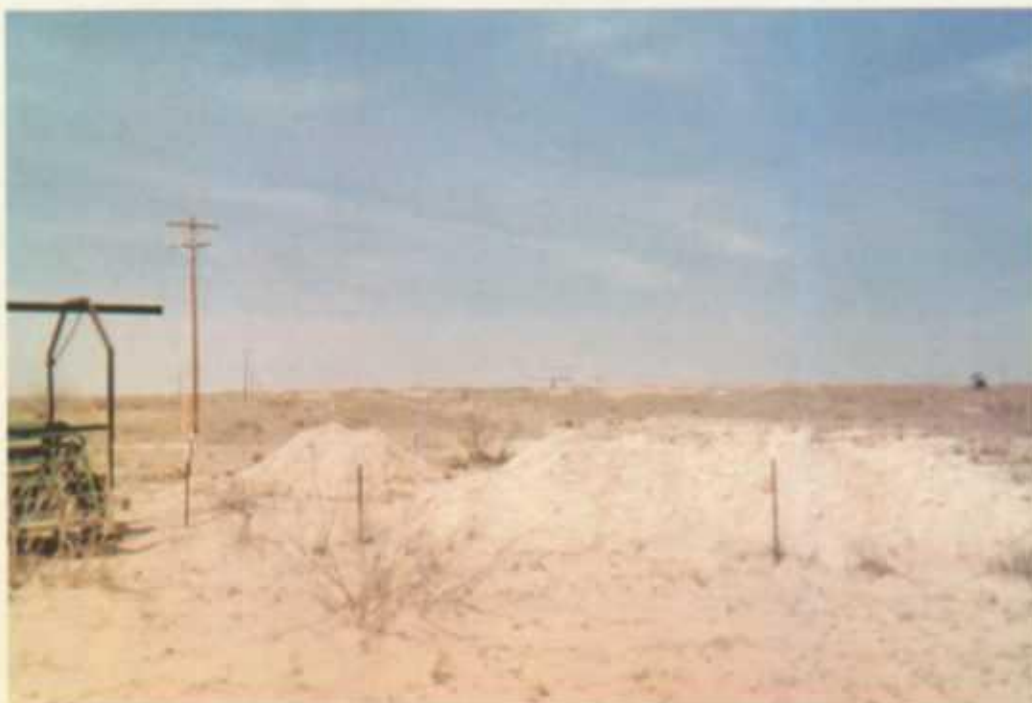
EME L-15 Re-plumbing Excavation

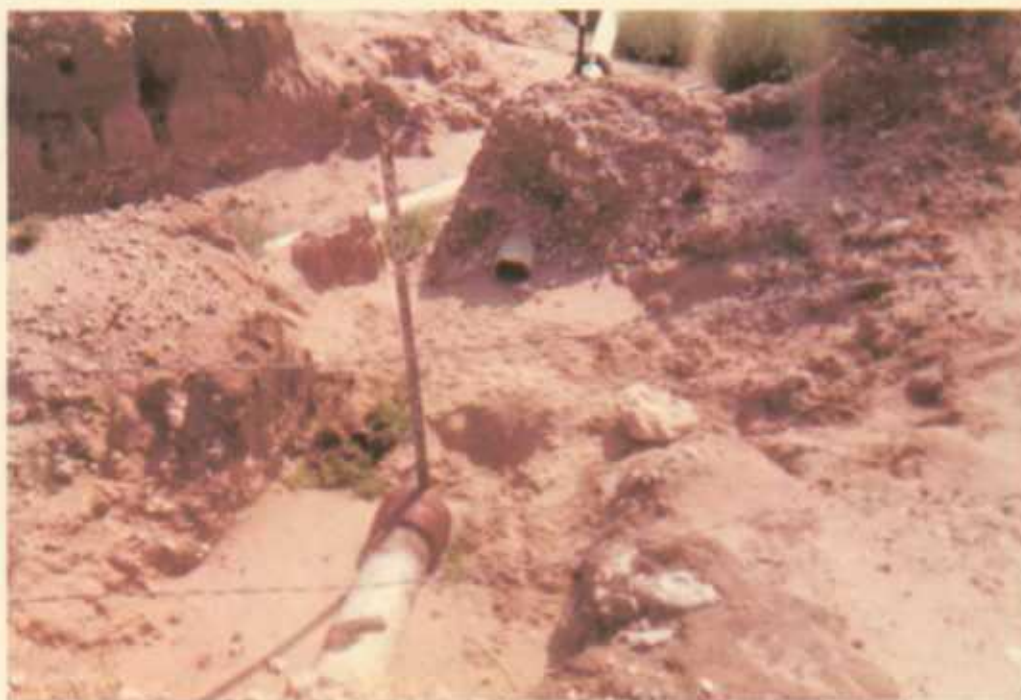
Old Junction Box Location

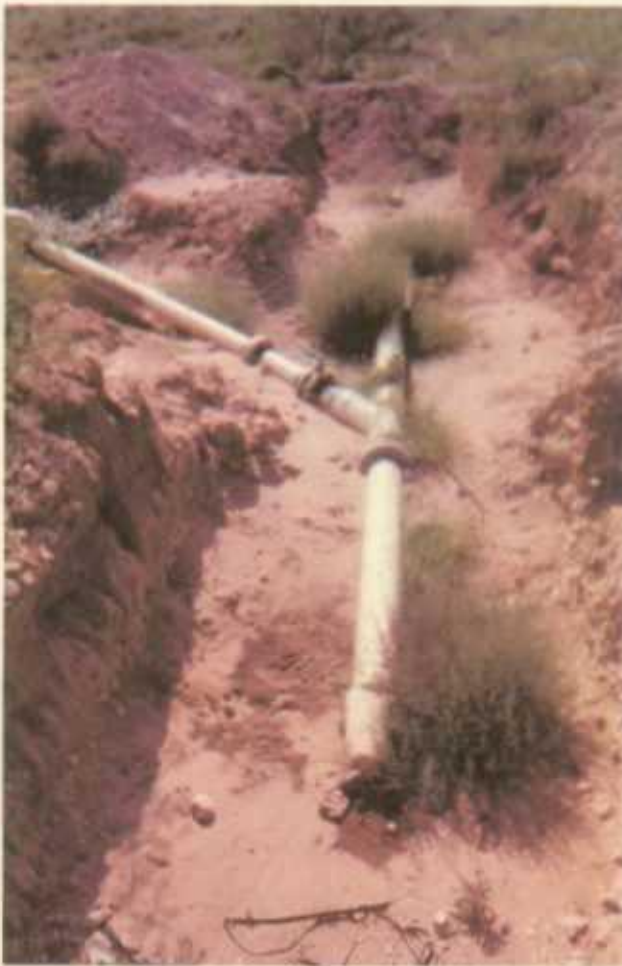
Ditch with New Plumbing
And Vegetation Growth

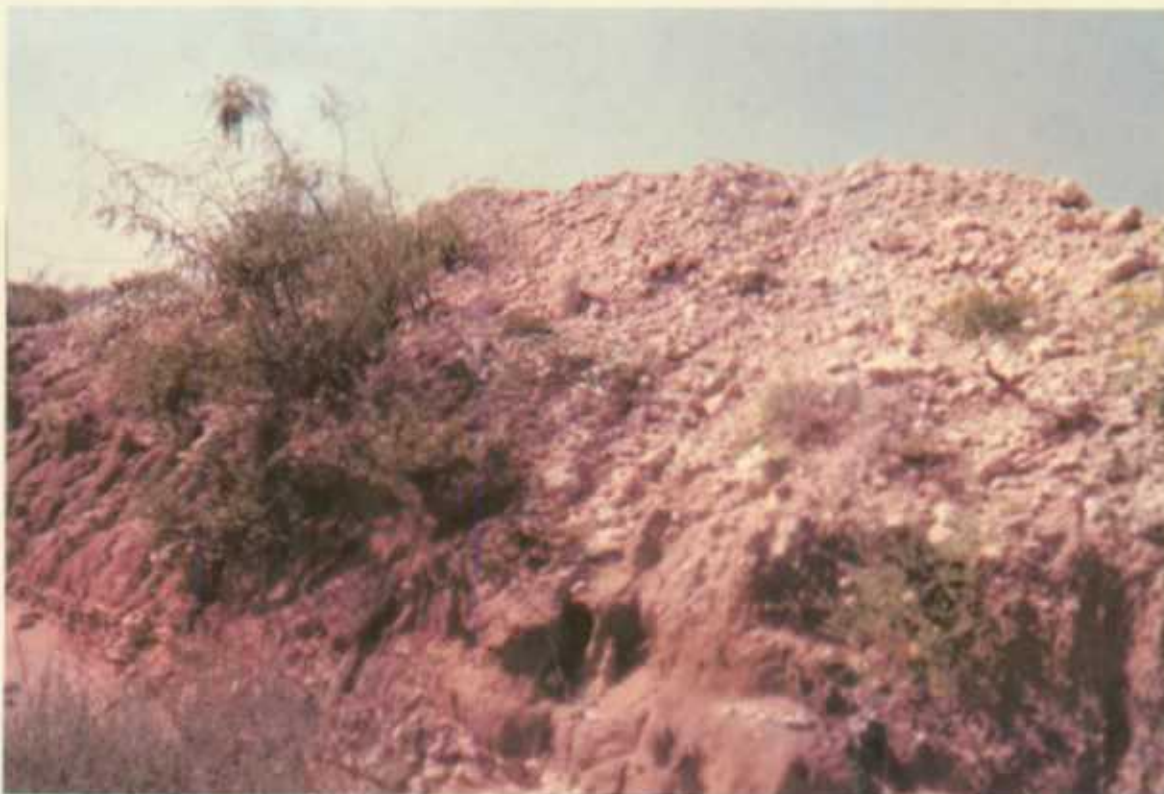
Side of Ditch with Vegetation

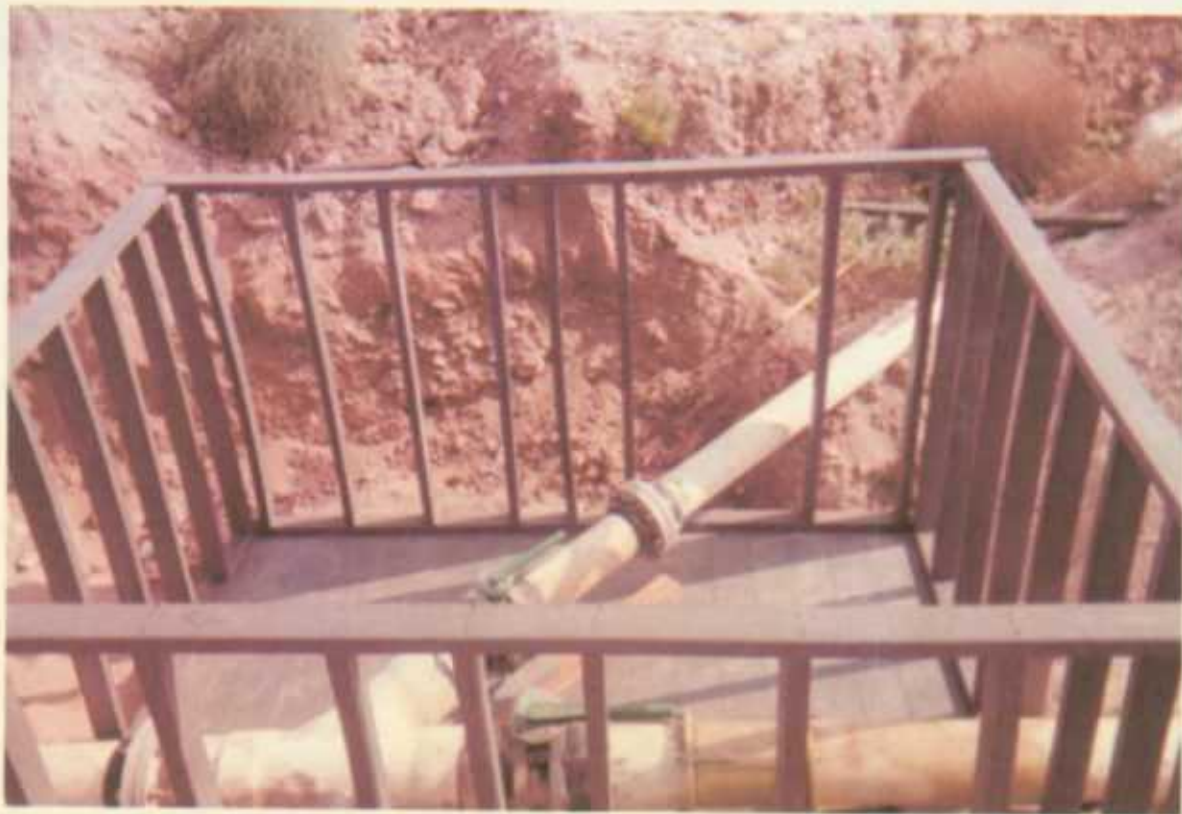
New Junction Box Construction

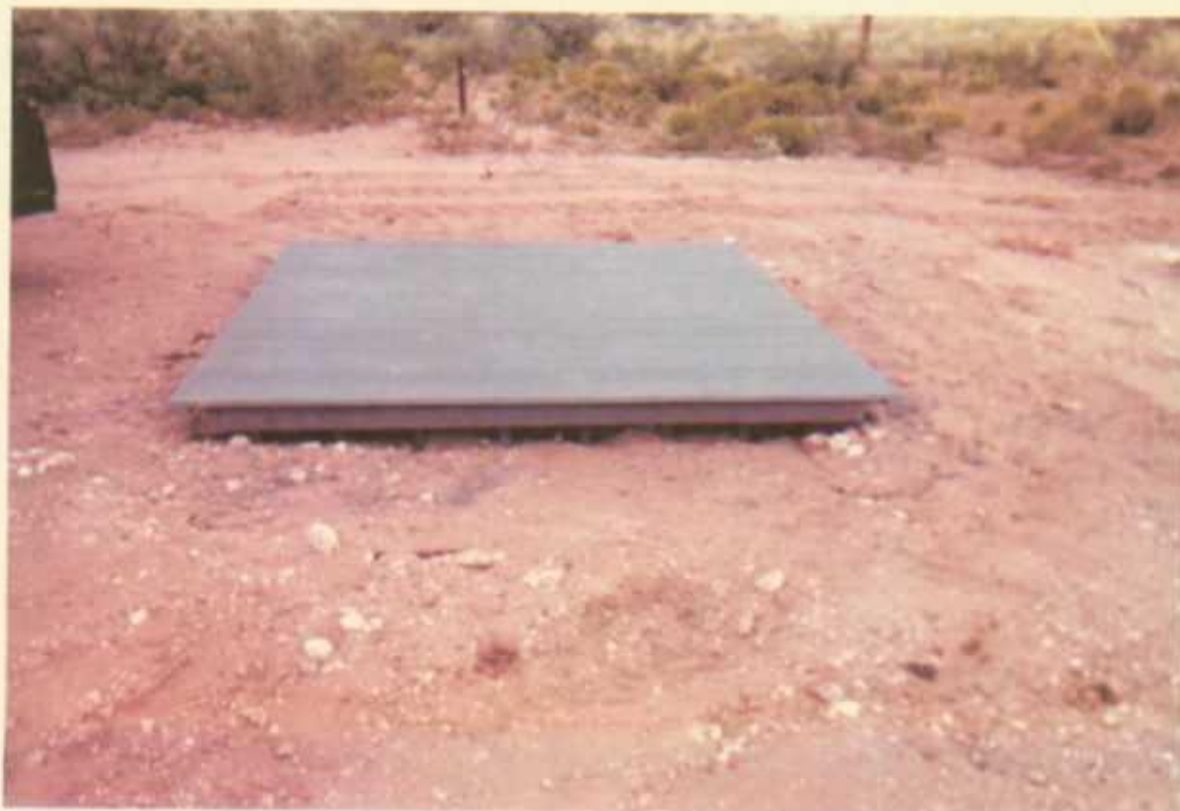
Finished Junction Box
