BD Vent 0-23-1

DISCLOSURE REPORT

**RICE OPERATING COMPANY
JUNCTION BOX DISCLOSURE* REPORT**

BD O-23-1 vent

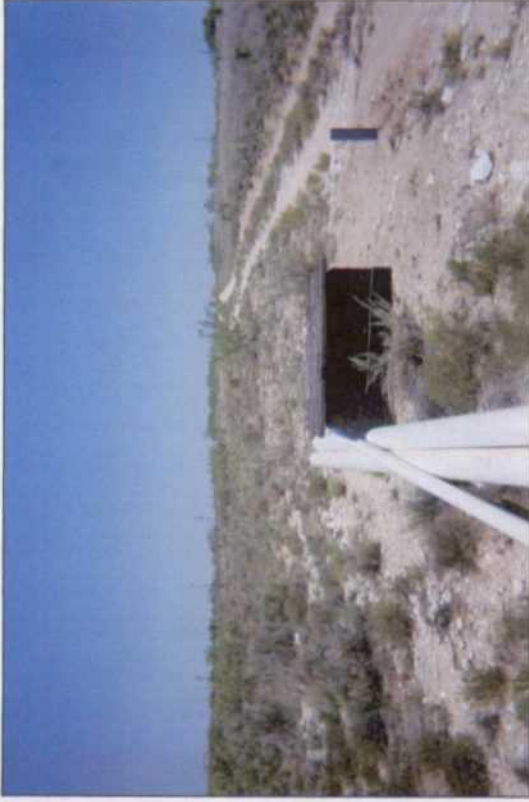
Before Excavation 7/14/2003

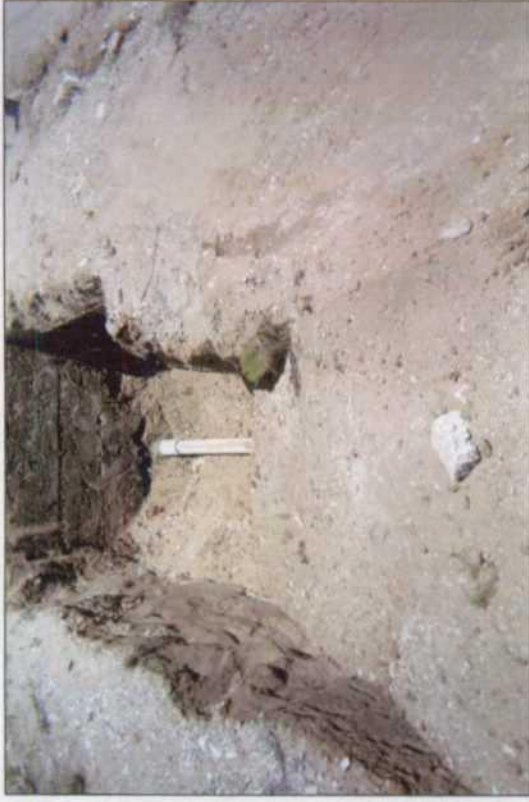
After plumbing; box removed 7/16/2003

General Description of Remedial Action: Vertical delineation with a backhoe at this vent box yielded consistent chloride concentrations down to 12 ft BGS. Deeper excavation was not possible due to rock encountered at 13 ft. Vertical delineation samples at the source yielded odors of hydrocarbon. All PID readings were 0.0 except at 9 ft, where a reading of 231 ppm was recorded. Samples taken 15 ft west of the box also exhibited elevated chloride concentrations. The delineation trenches were backfilled with the excavated soil. An identification plate has been placed on the surface to mark the location of the former junction box for further consideration in the future. No samples from this site were taken to a laboratory for analysis. An identification plate has been placed on the surface where the junction was located for future consideration.

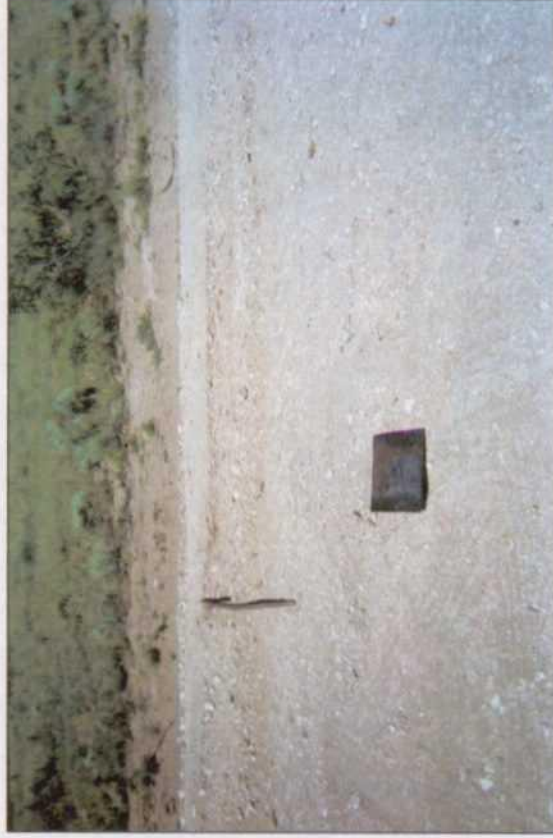
Backfilled with identification plate 5/11/2004
