BD F-35 Boot

**RICE OPERATING COMPANY
JUNCTION BOX DISCLOSURE* REPORT**

BD F-35 vent & boot

Unit 'F', Sec. 35, T21S, R37E

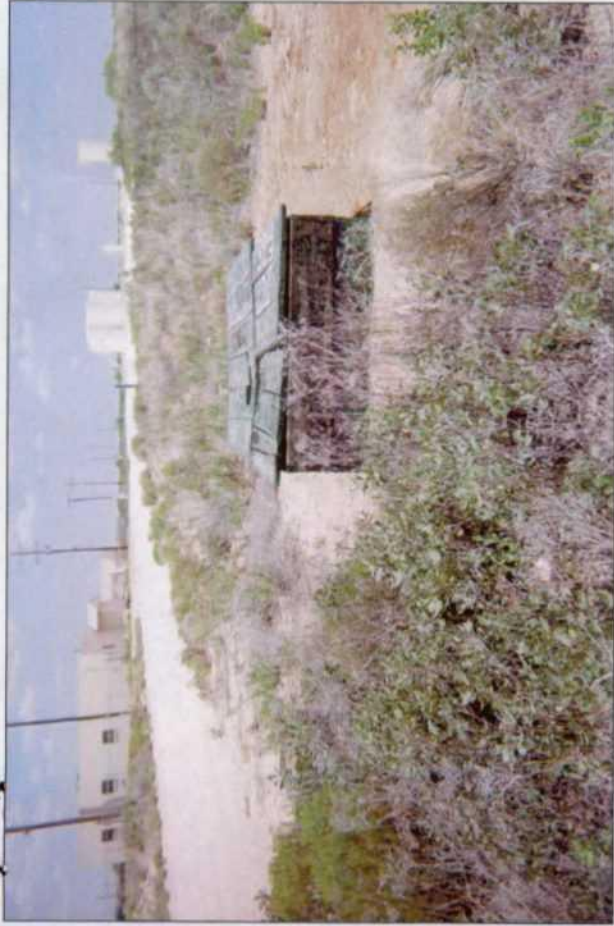
7/23/2003

undisturbed junction box

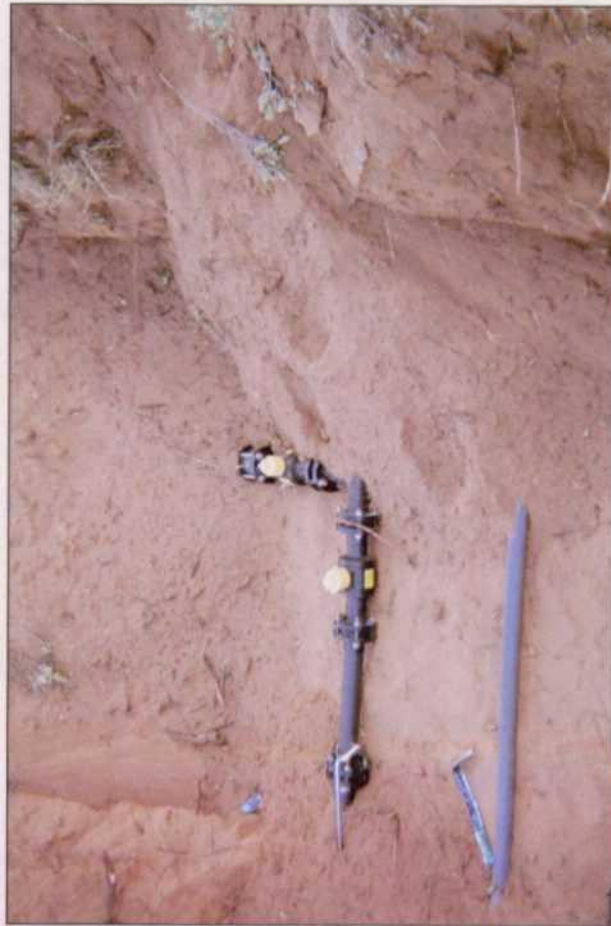
new poly plumbing for new junction box 30 ft west of former

contained a gas-releasing boot. The junction was moved 30 ft west with the pipeline replacement program. The box from the former junction was removed when the site was decontaminated for NORM. On 4/27/2005, a delineation trench was excavated at the site of the former junction with soil samples collected every vertical foot to 12 ft BGS. Sandy soils from the trench exhibited odors and stains of hydrocarbon impact. Chloride concentrations were very low and similar to that of the background sample (84 ppm). On 4/28/2005 a 12 ft grab sample was collected for lab analysis from the trench before it was backfilled. 12 cubic yards of clean soil was imported to complete the backfill and to contour the surface. An identification plate was placed on the surface of this site to mark the location of the former junction for future environmental considerations. NMOCD has been notified of potential groundwater impact at this location. A new water-tight junction box was built 30 ft west of this site.

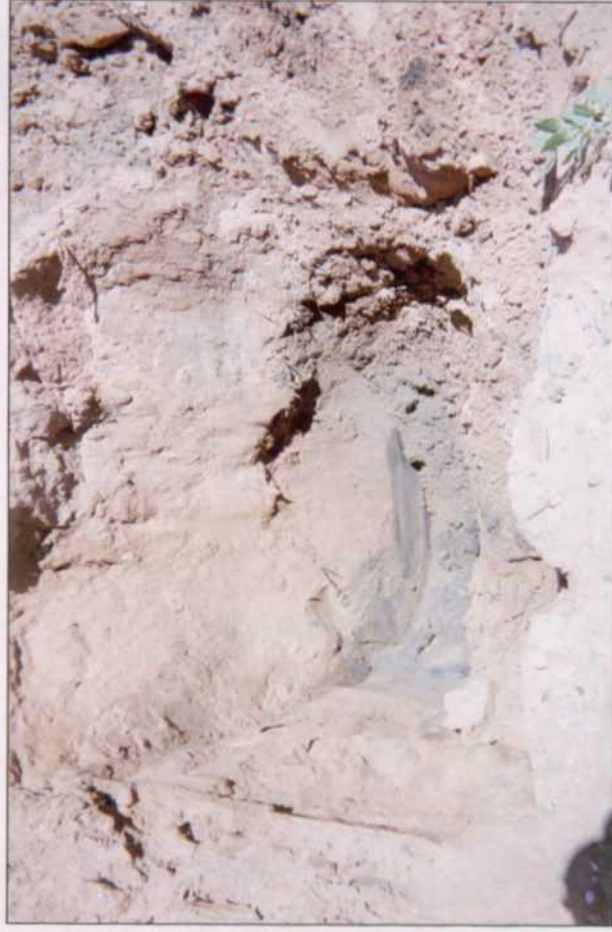
4/27/2005

delineation trench 12 ft deep at former junction site

LOCATION	DEPTH (ft)	ppm
vertical trench at junction box	3	75
	4	68
	5	75
	6	79
	7	75
	8	110
	9	105
	10	84
	11	131
	12	86

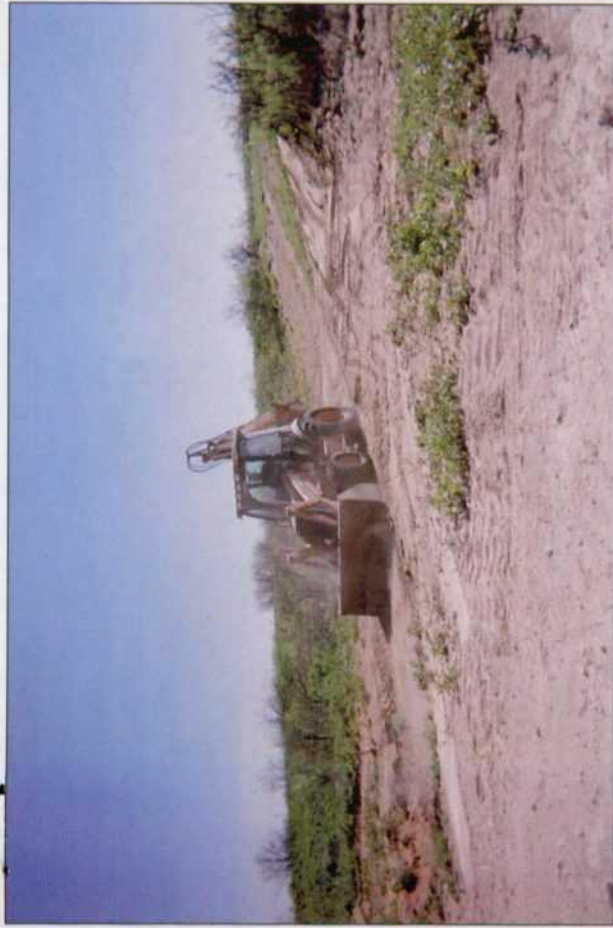
4/28/2005

backfilling trench with imported soil

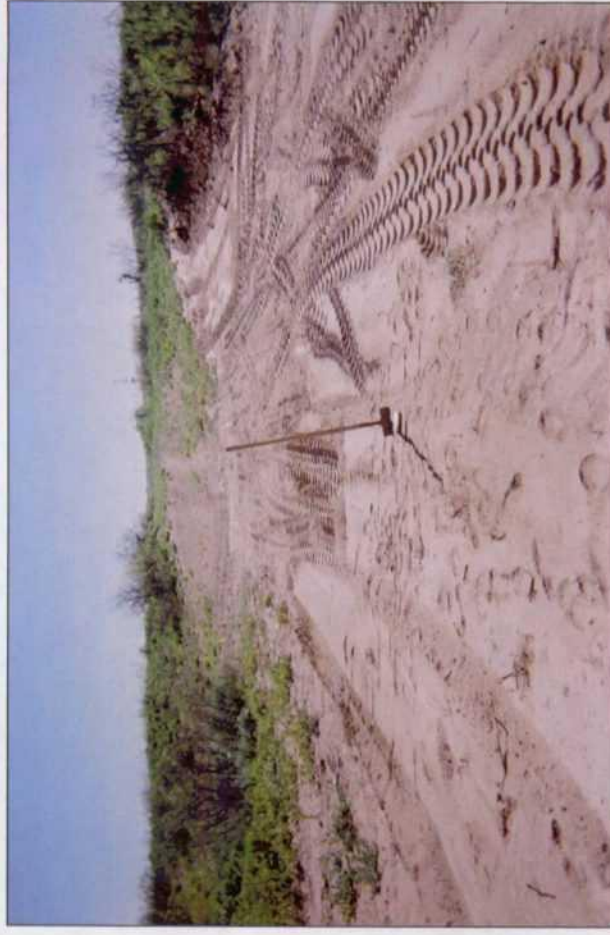
4/28/2005

Backfilled site with ID plate on surface

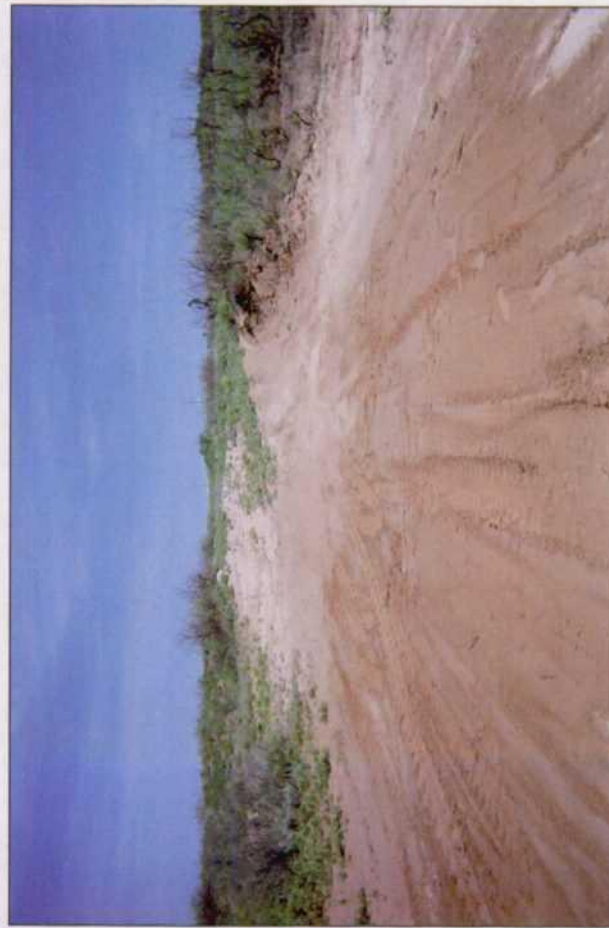
4/28/2005

backfill complete

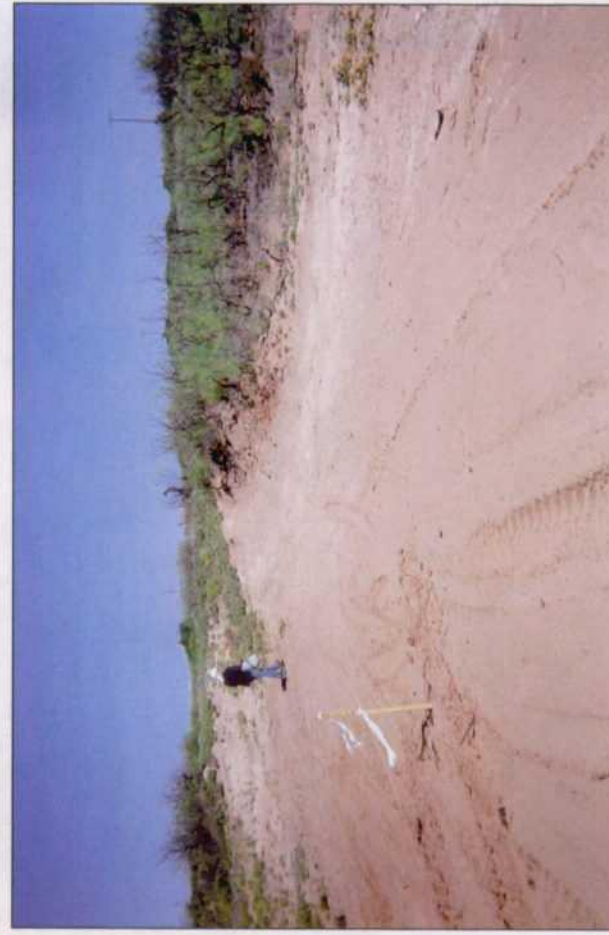
5/9/2005

seeding backfilled site

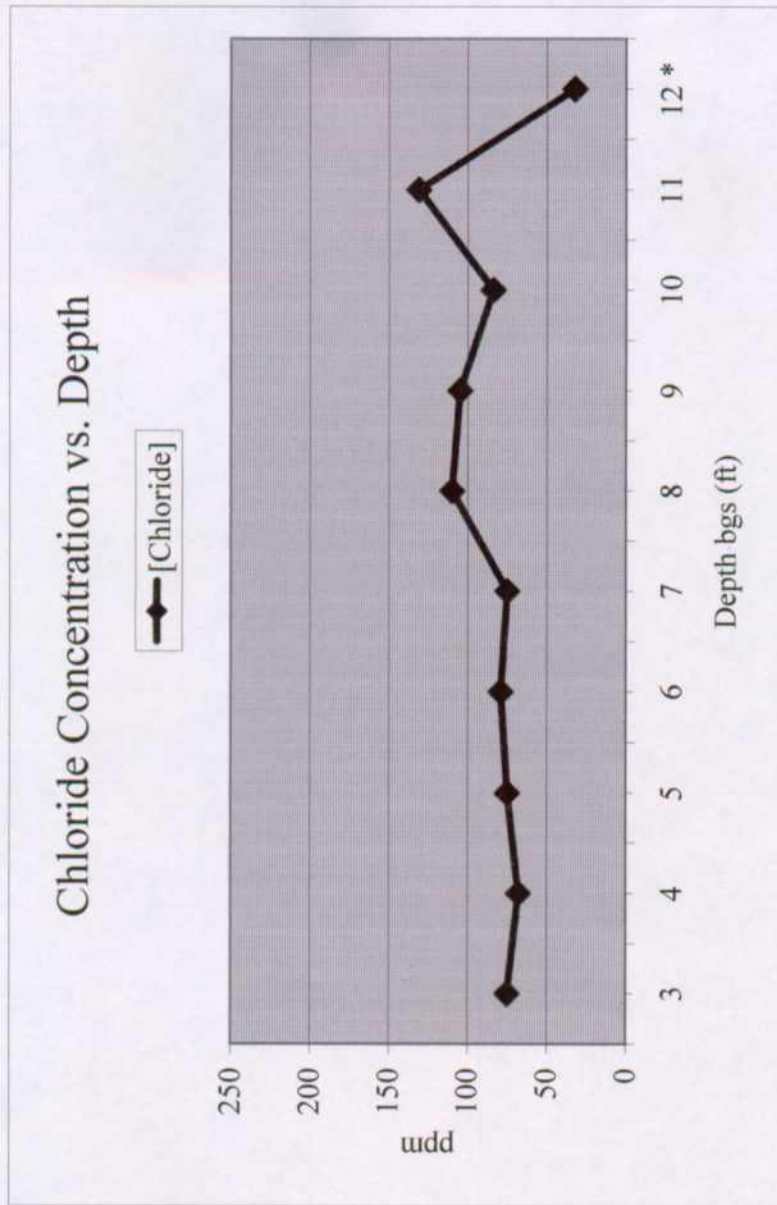
Vertical Delineation at Source

Depth bgs (ft)	[Cl ⁻] ppm
3	75
4	68
5	75
6	79
7	75
8	110
9	105
10	84
11	131
12 *	32.3

Groundwater = 44 ft

* Laboratory analysis
