**RICE OPERATING COMPANY
JUNCTION BOX DISCLOSURE REPORT**

SWD SYSTEM	JUNCTION	UNIT	SECTION	TOWNSHIP	RANGE	COUNTY	BOX DIMENSIONS - FEET		
BD	H-14-1	H	14	22S	37E	Lea	Length	Width	Depth
							10	10	7

BD jct. H-14-1

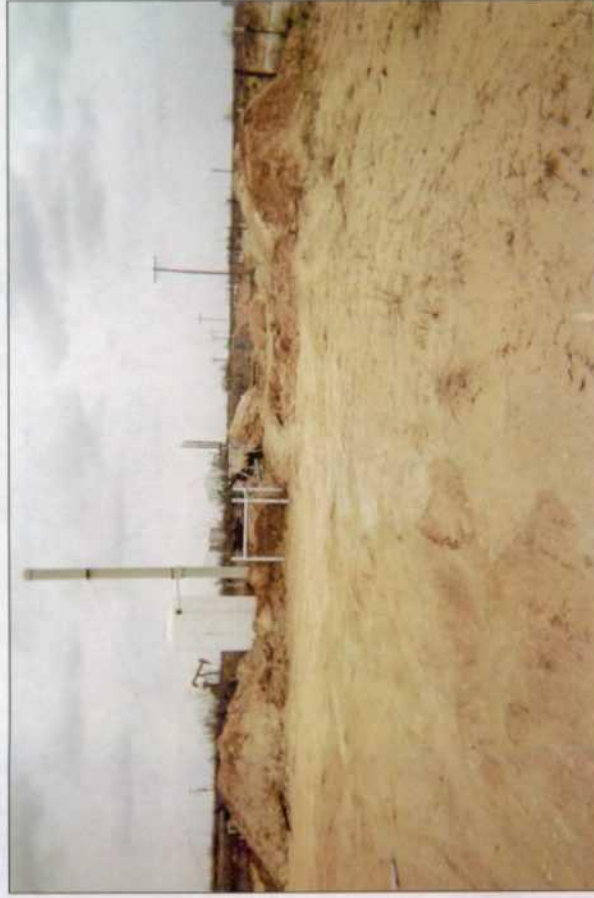
site prior to excavation 2/6/2002

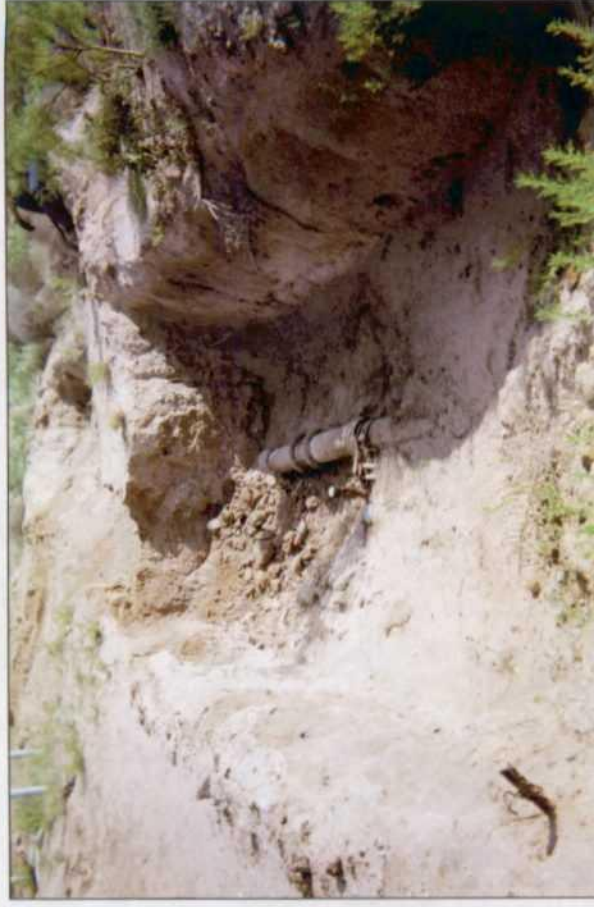
Jct. H-14-1 prior to excavation with old plumbing 8/19/2003

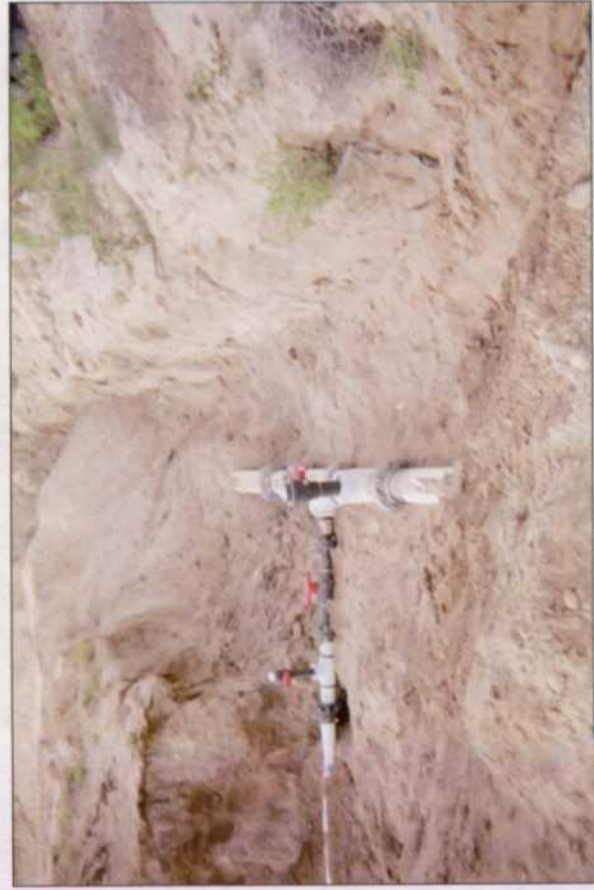
Jct. H-14-1 with new plumbing 8/19/2003

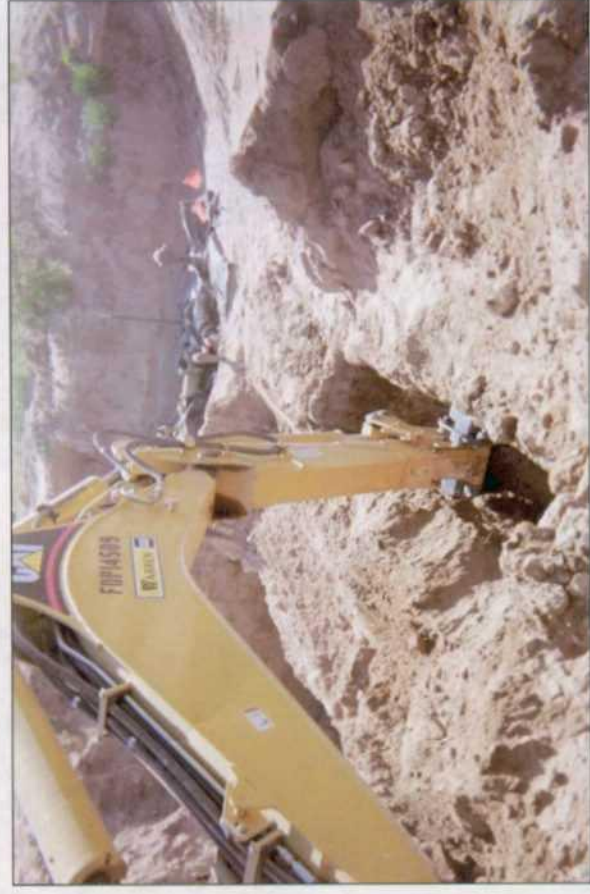
delineation May 2004

General Description of Remedial Action: This junction was the main-line box of a three-box cluster in close proximity. Delineation trenches were made with a backhoe to 12 ft as chloride field tests and PID field screenings were conducted at regular intervals. Chloride concentrations did not exhibit a trend of decline with depth or breadth within the excavation. PID readings were minimal and lab results confirmed TPH concentrations well below NMOCD guidelines. A compacted clay barrier was installed in the 38 x 36 x 6-ft-deep excavation and the excavated soil was blended and backfilled on top of the clay (see diagram). An identification plate was set on the surface to mark the site for future considerations and to identify the clay below. A new watertight junction box has been rebuilt at this location. The disturbed surface has been seeded with a blend of native vegetation and will be monitored for growth.

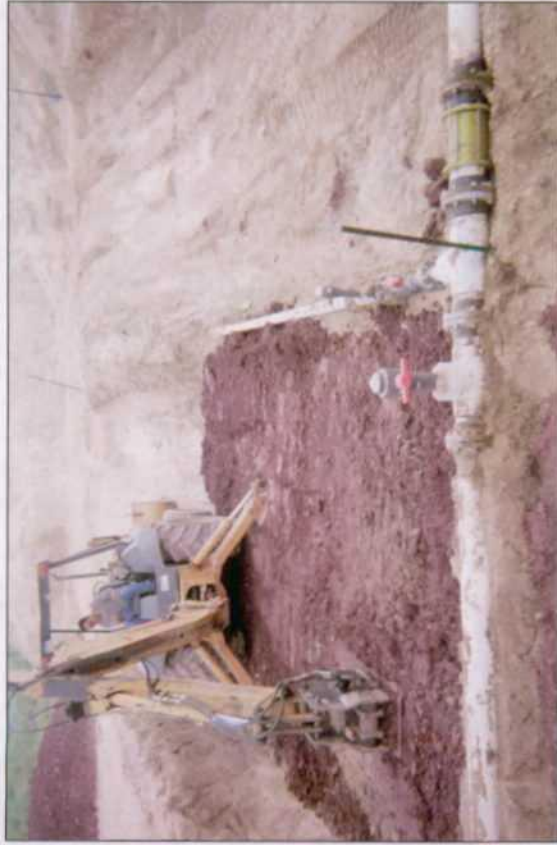
compacting clay

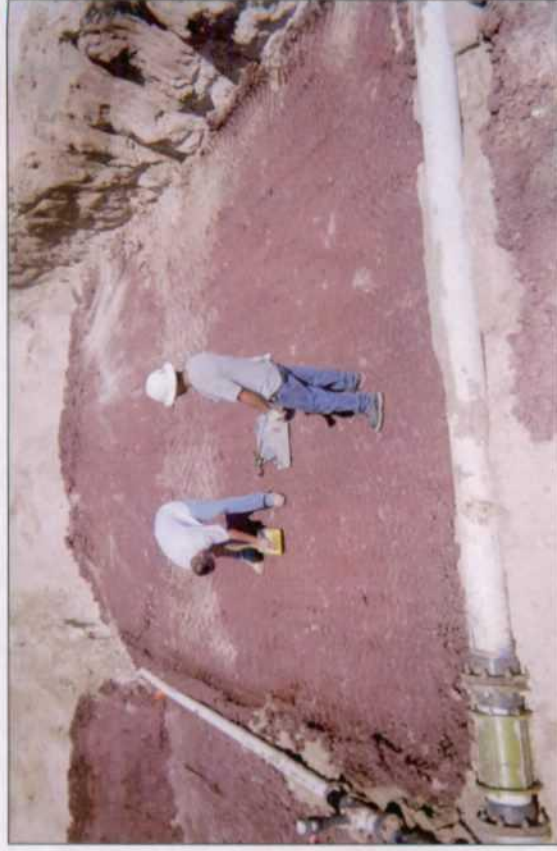
testing clay

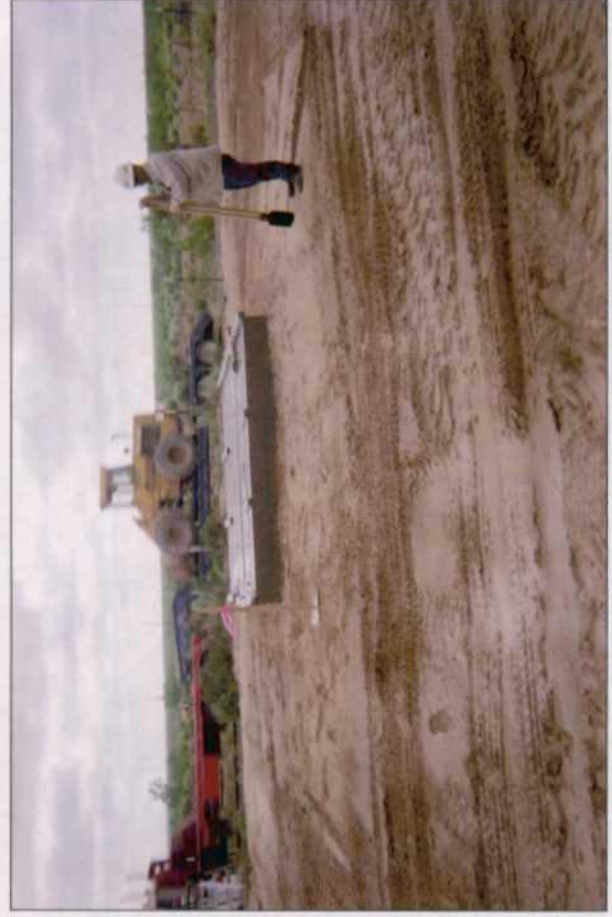
Backfilled site with new jct. box; clay ID plate in foreground

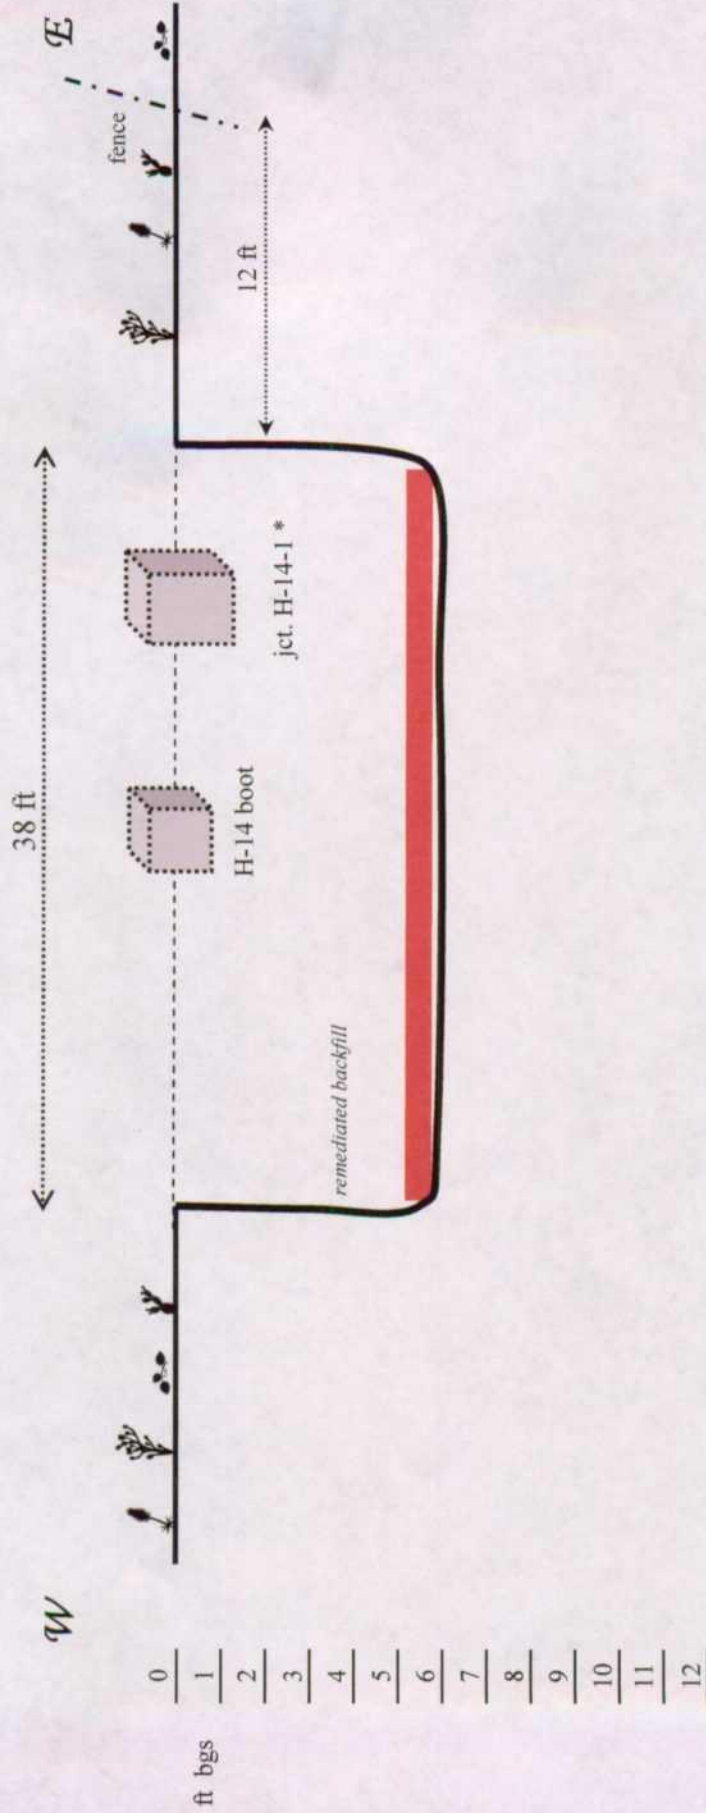
Excavation Cross-Section

38 x 36 x 6-ft-deep

* New water-tight junction box is re-built in this location.

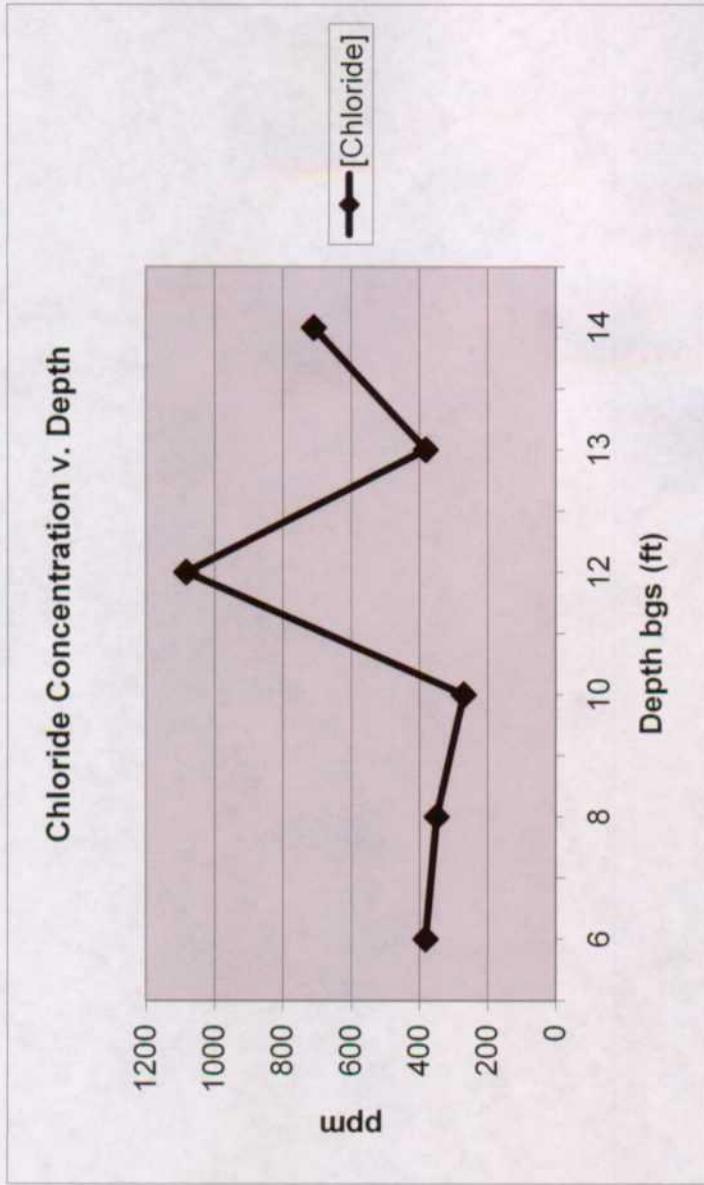
Vertical Delineation at Source

Depth bgs (ft)	[Cl ⁻] ppm
6	382
8	349
10	270
12	1083
13	381
14	710

Groundwater = 65 ft

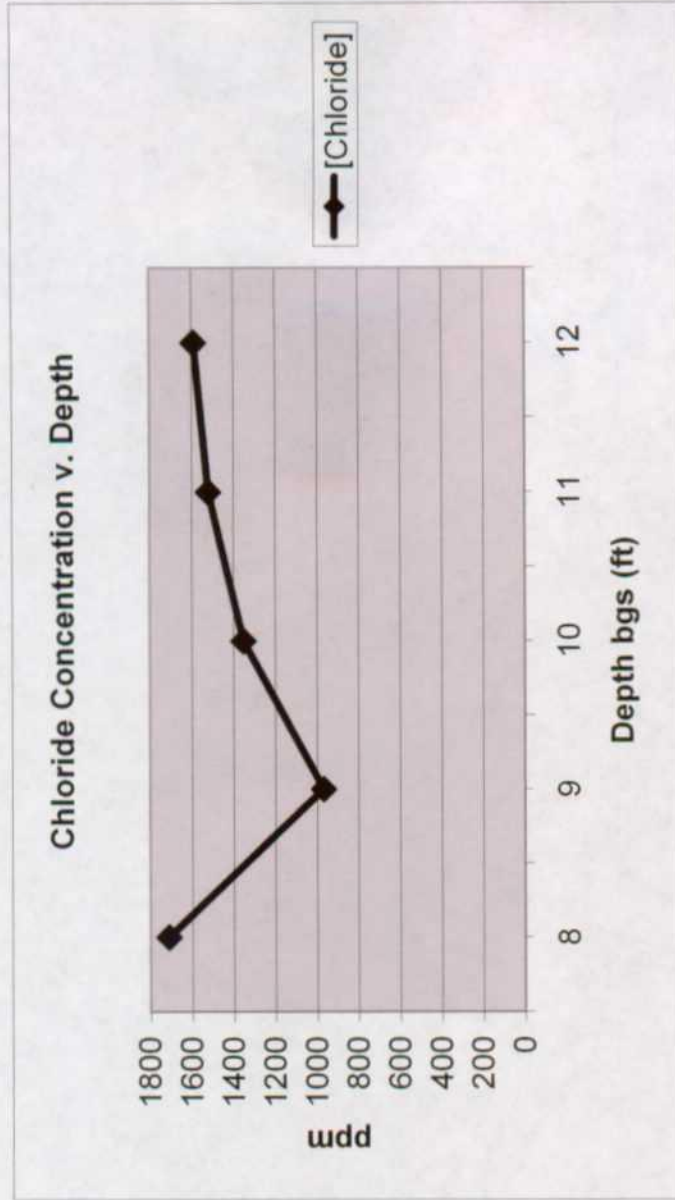
15 ft South of Junction

Depth bgs (ft)	[Cl ⁻] ppm
8	1712
9	969
10	1353
11	1522
12	1590

Groundwater = 65 ft
