BD Jet K-21-1

# Final Report

**RICE OPERATING COMPANY  
JUNCTION BOX FINAL REPORT**

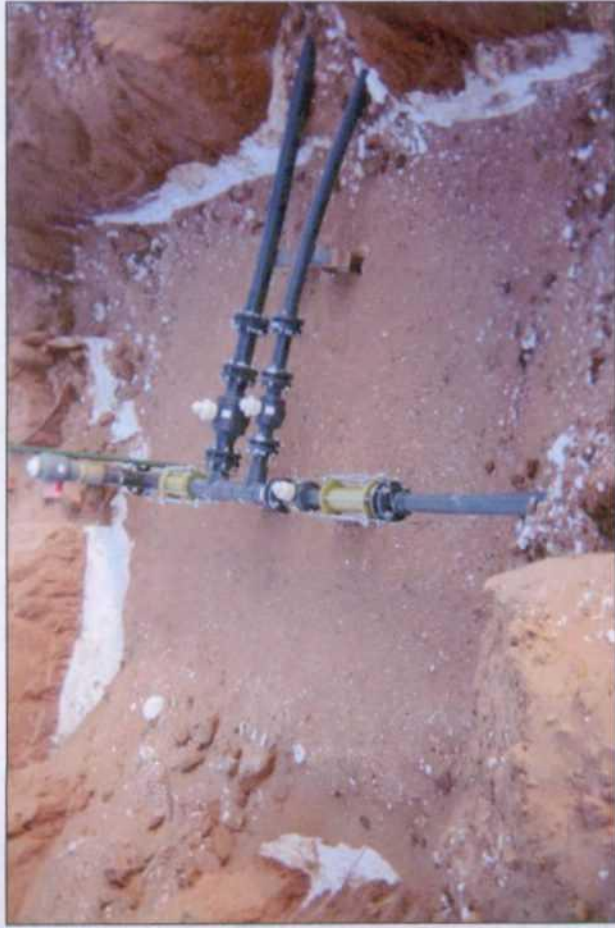
12/9/2003

floor of new jct. box 23 ft south of former

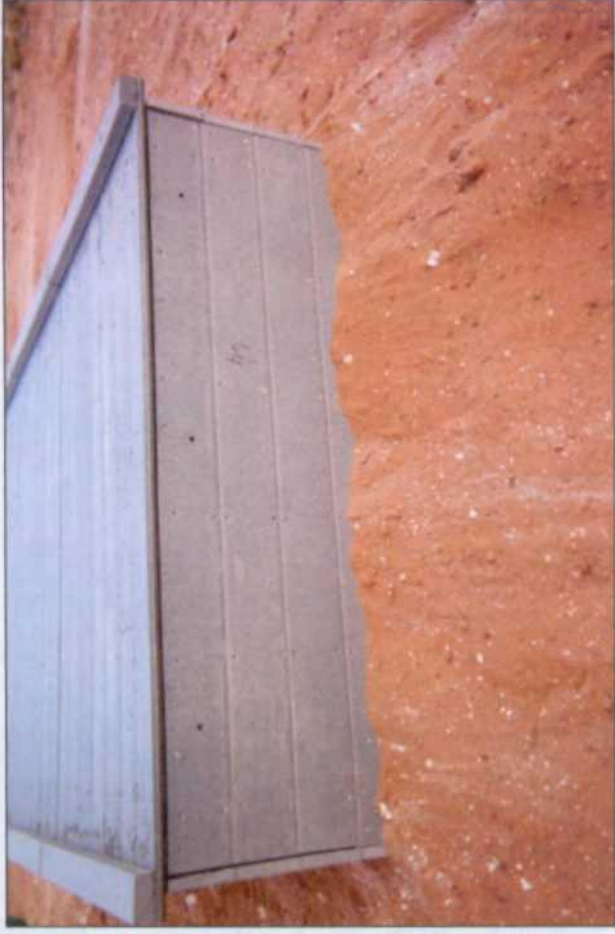
12/12/2003

new box complete 23 ft south of former location

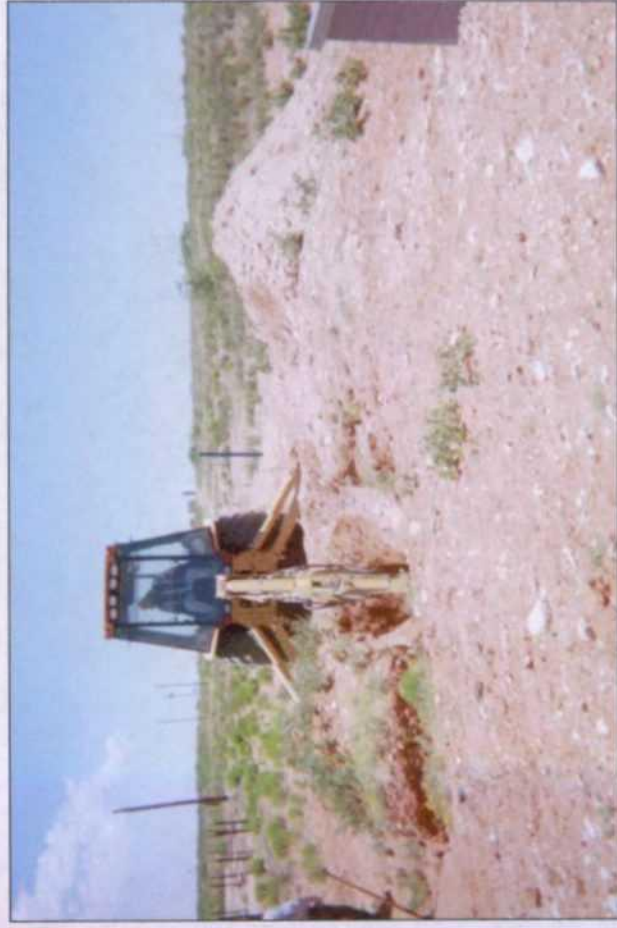
6/11/2004

vertical delineation at former junction box

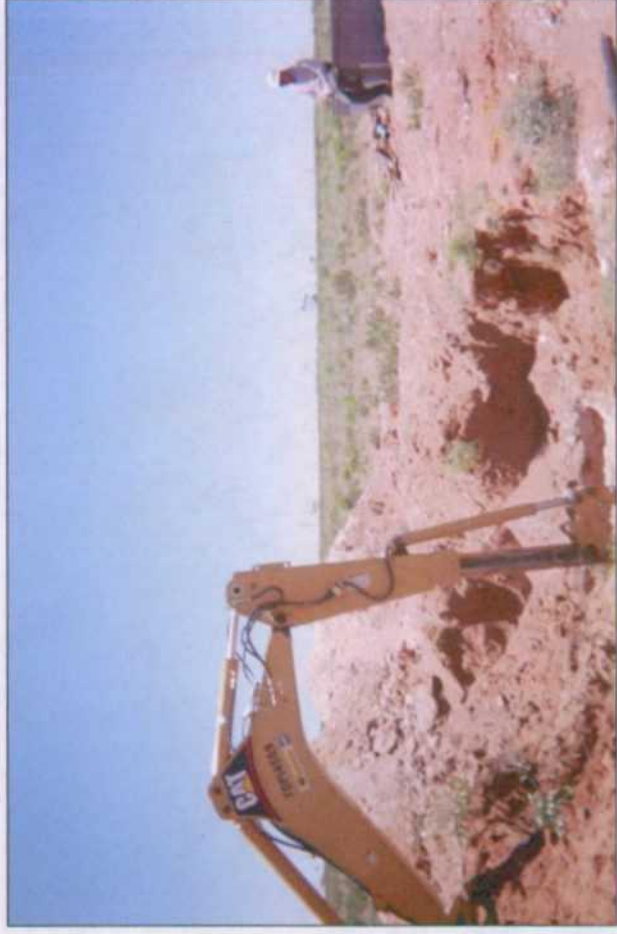
6/11/2004

delineation trench 5 ft east of junction
