Final Report

RICE OPERATING COMPANY JUNCTION BOX FINAL REPORT

BD jct. L-33

Unit 'L', Sec. 33, T21S, R37E

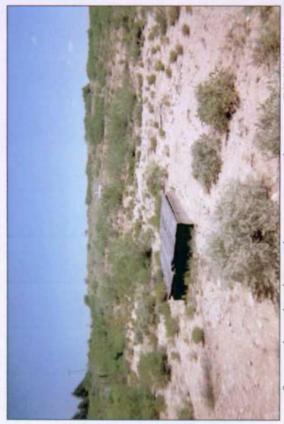
junction box delineation and excavation

7/28/2003 former junction box prior to excavation

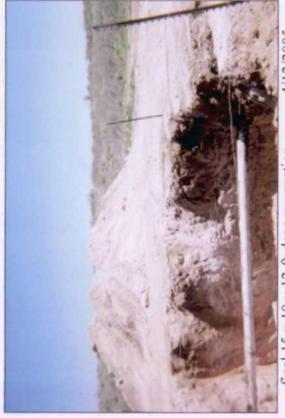
4/12/2005

final 15 x 10 x 12-ft-deep excavation

low throughout the 10 x 15 x 12 ft deep excavation, although field indications suggested hydrocarbon impact. The excavated soils were blended on site for about 2 months to degrade hydrocarbon in the soils before backfilling. On 7/11/05 the spoils were backfilled into the excavation An identification plate has been placed on the surface of this site to mark the location of the former box and to aid in identifying this site for further environmental considerations. NMOCD was notified of potential groundwater impact at this location but further excavation and soil remediation

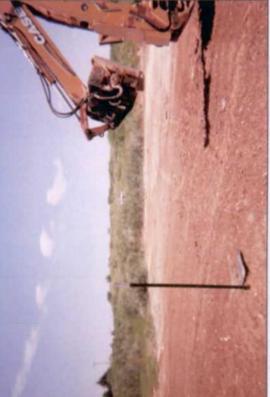
backfilled excavation with ID plate at site of former box

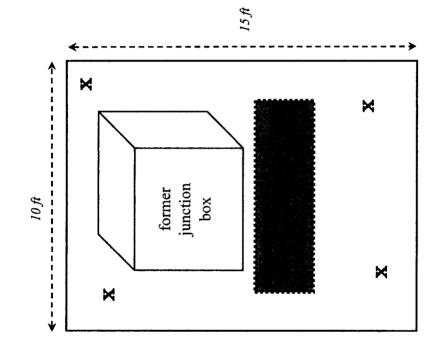
15 x 10 x 12 ft Excavation Plan View
