**RICE OPERATING COMPANY
JUNCTION BOX DISCLOSURE* REPORT**

SWD SYSTEM	JUNCTION	UNIT	SECTION	TOWNSHIP	RANGE	COUNTY	BOX DIMENSIONS - FEET		
BD	P-26-2	P	26	21S	37E	Lea	Length	Width	Depth
							moved 67 ft north

BD jct. P-26-2

unit 'P', sec. 26, T21S, R37E

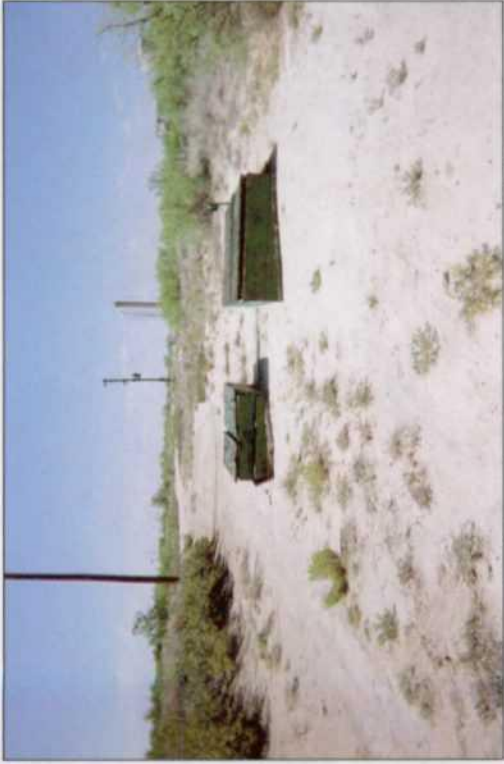
7/22/2003

undisturbed junction boxes

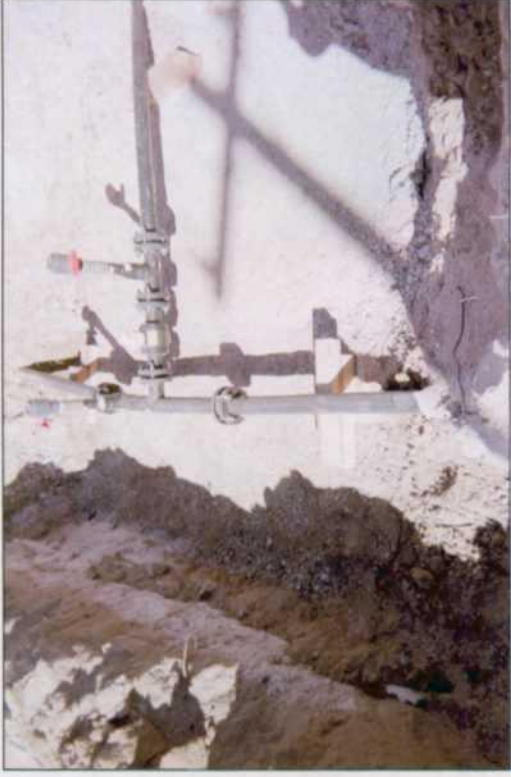
8/20/2003

new plumbing at new junction box site

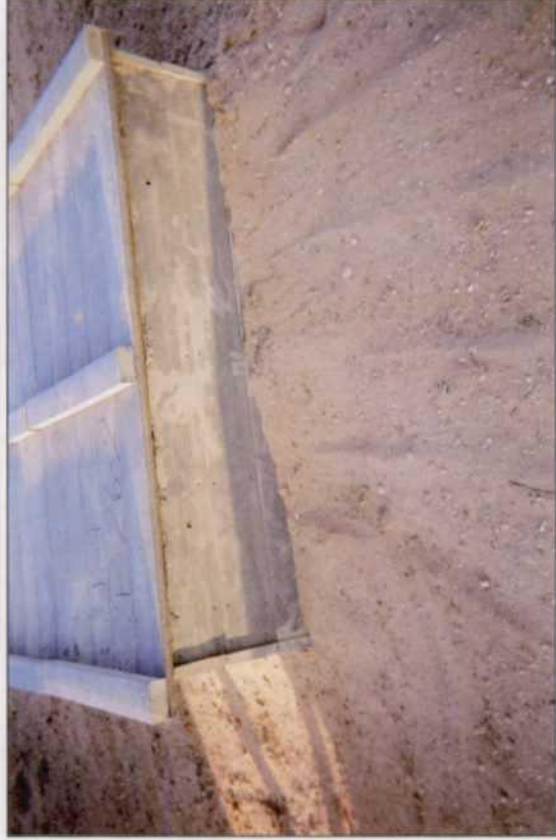
11/05/2003

completed new junction box 67 ft north of old site

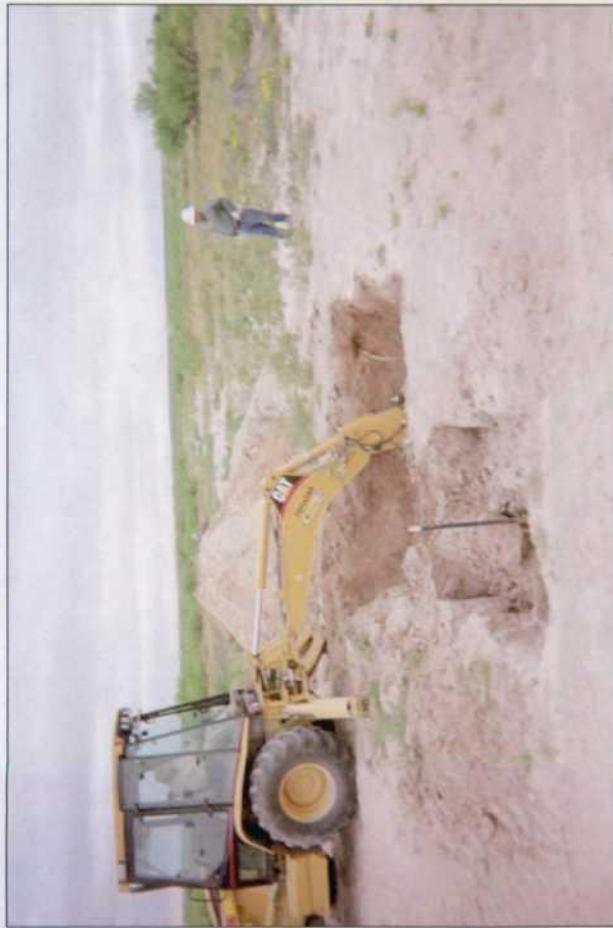
6/2/2004

beginning delineation & excavation

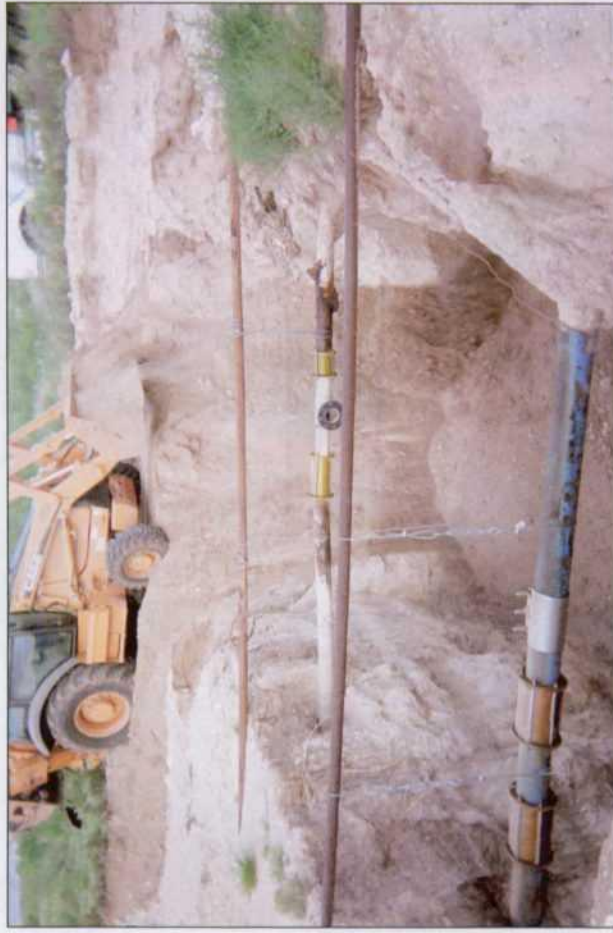
7/7/2004

backfilling 10 x 12 x 12-ft-deep excavation

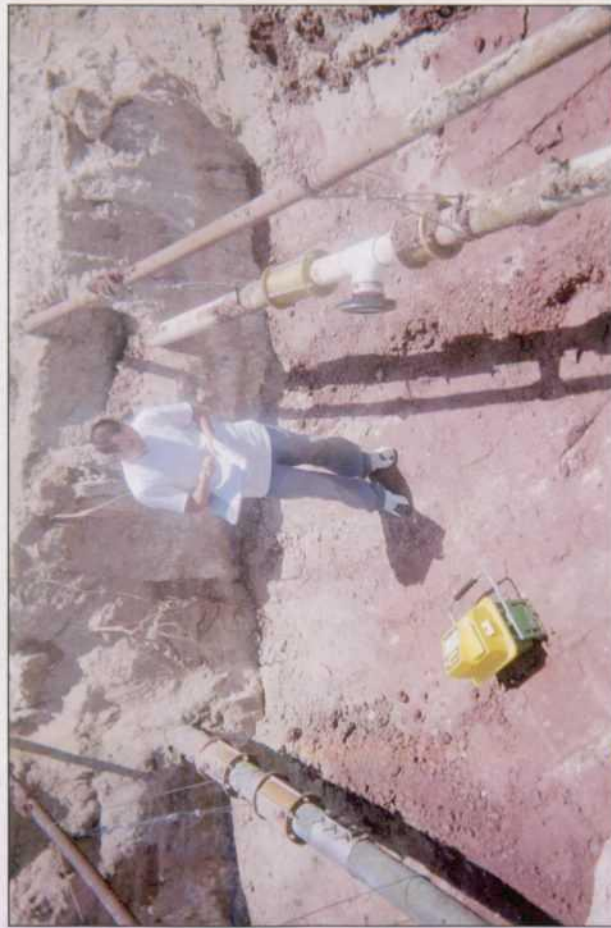
7/7/2004

testing clay barrier installed at 6 ft BGS

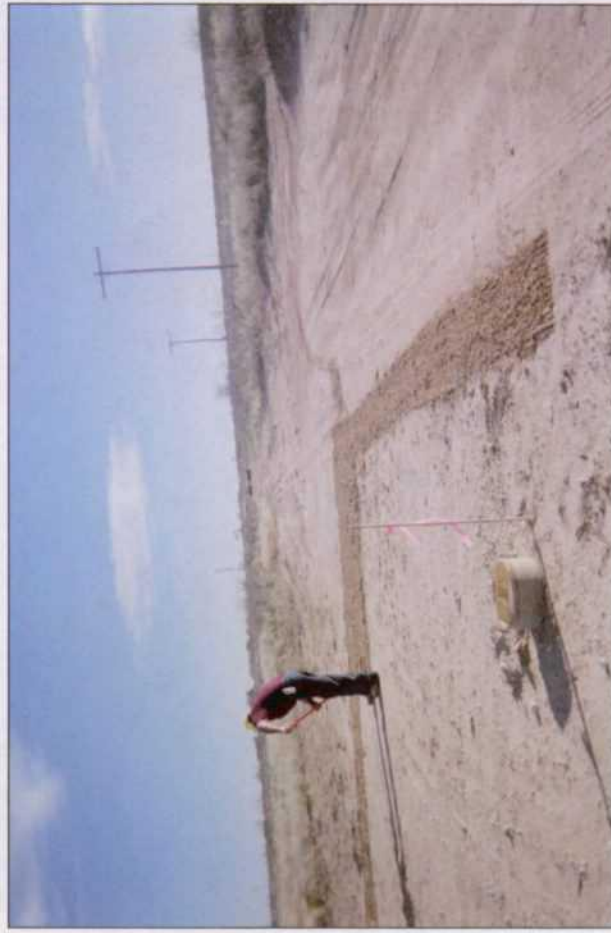
1/7/2005

seeding disturbed surface at backfilled site; ID plate in foreground

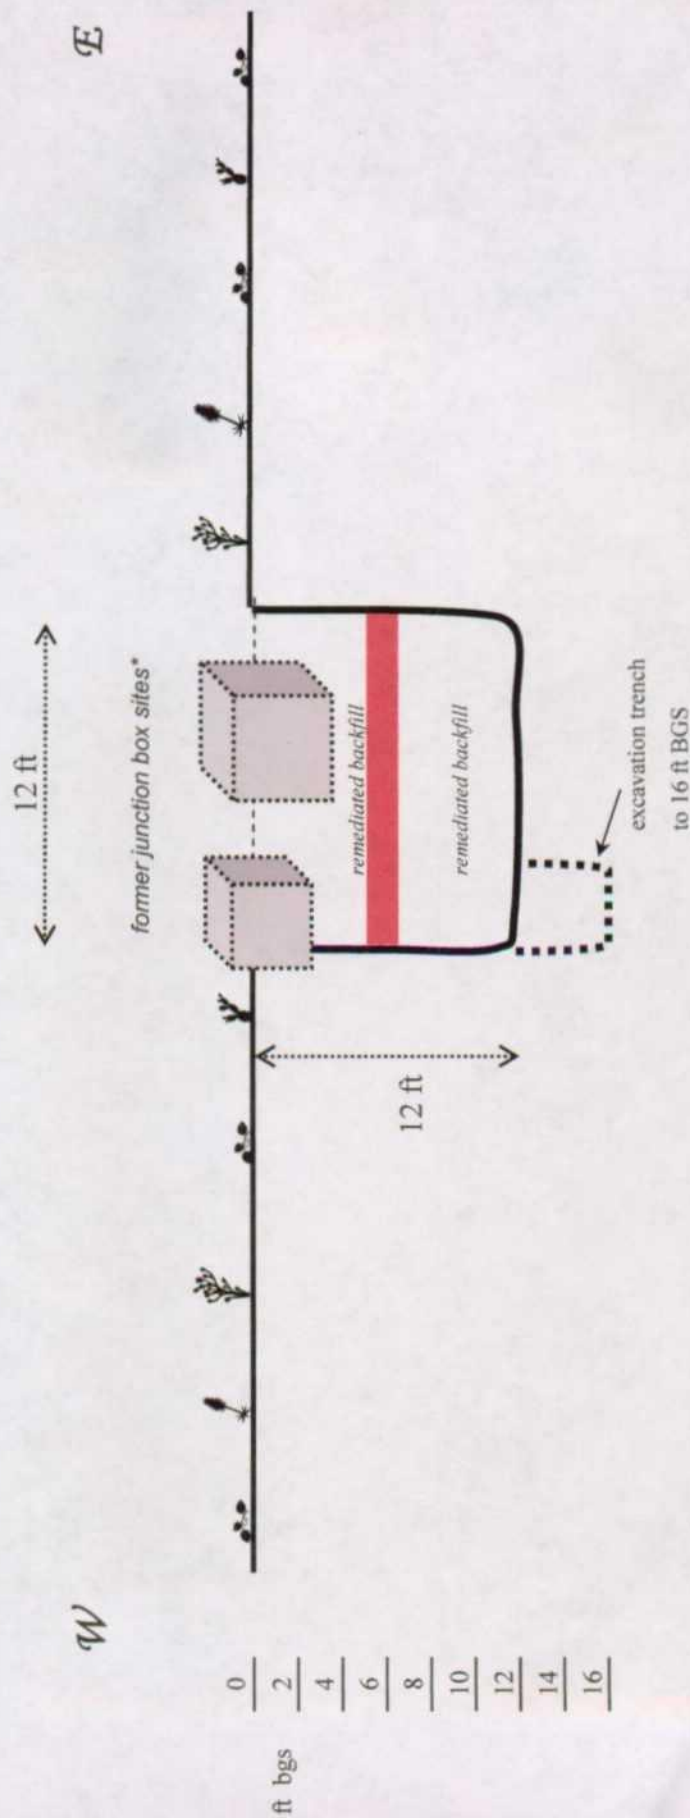
Excavation Cross-Section

10 x 12 x 12-ft-deep

* A new watertight junction box has been built to replace these 67 ft North of this location.

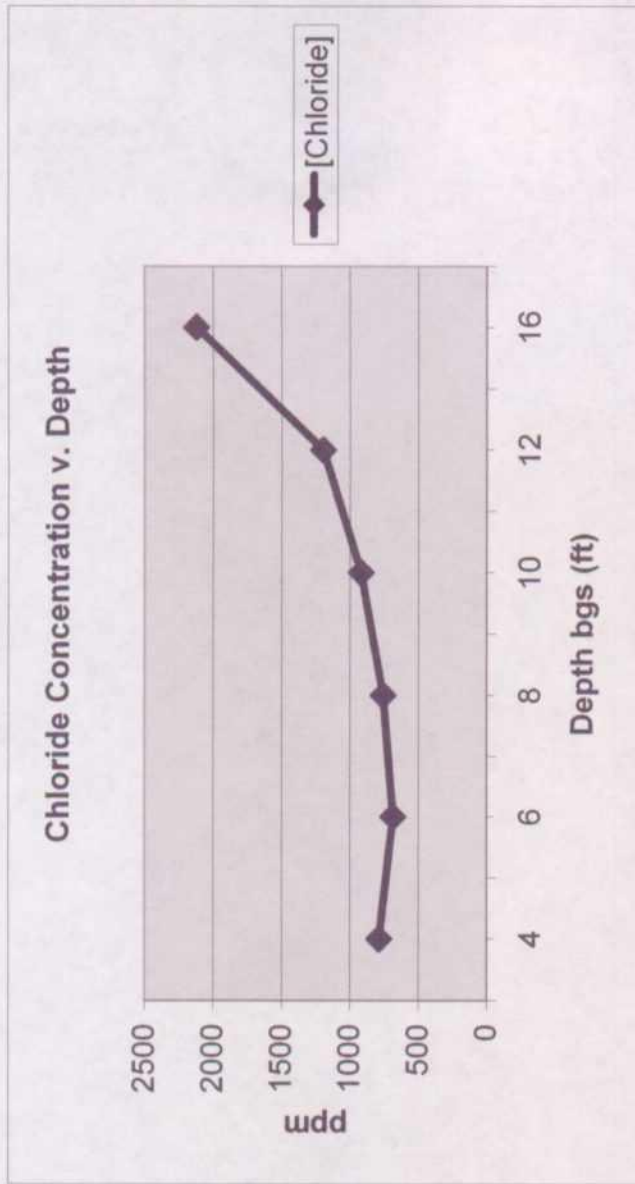
7 ft West of Junction Box

Depth bgs (ft)	[Cl] ppm
4	789
6	685
8	758
10	920
12	1196
16	2122

Groundwater = 45 ft

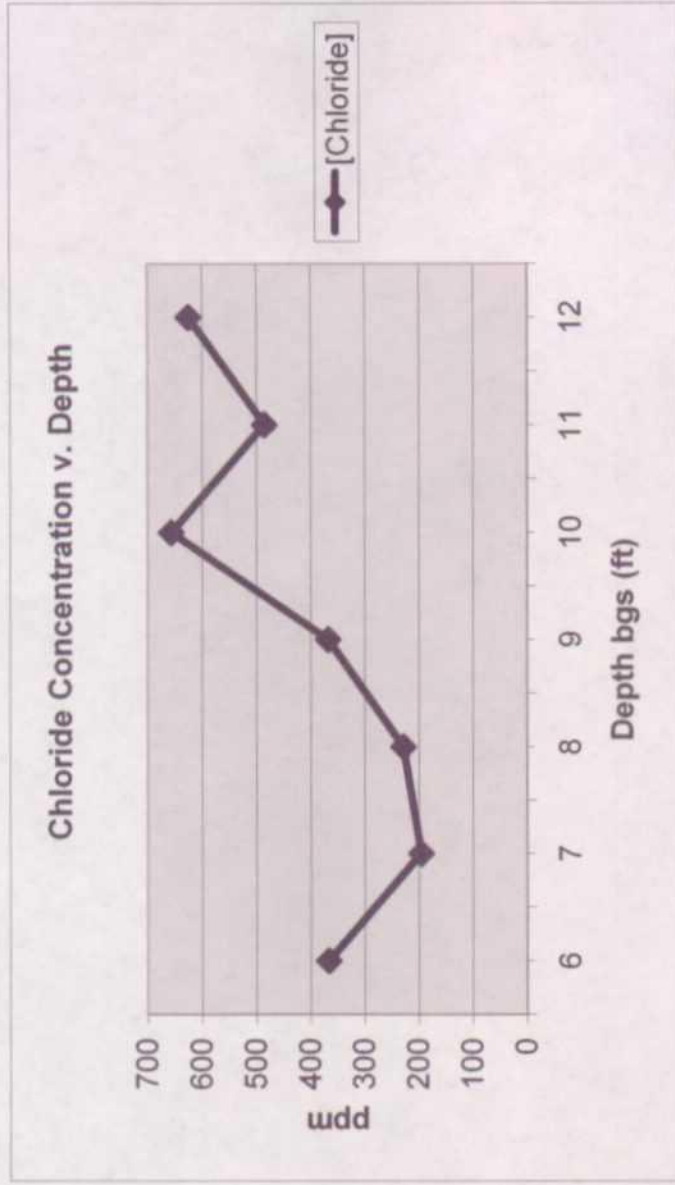
Vertical at junction

Depth bgs (ft)	[Cl ⁻] ppm
6	367
7	196
8	229
9	368
10	657
11	485
12	625

Groundwater = 45 ft
