EME State R' EOL

FINAL REPORT

**RICE OPERATING COMPANY
JUNCTION BOX FINAL REPORT**

EME State 'A' EOL

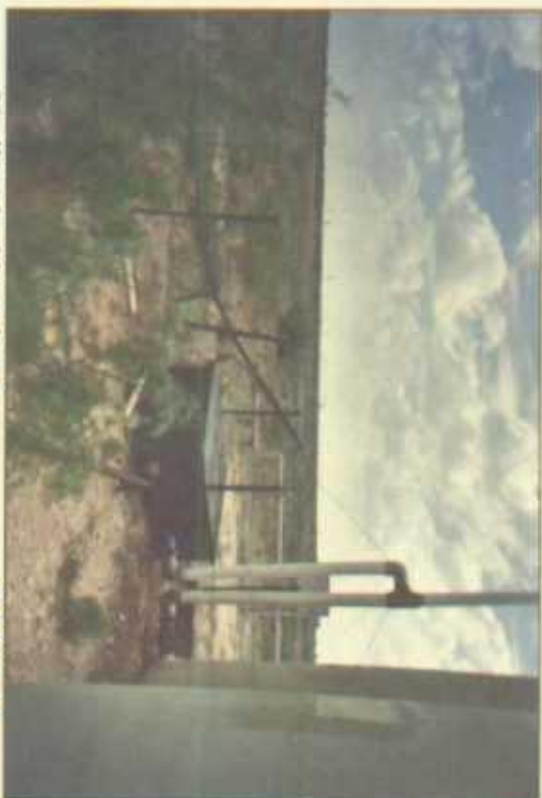
8/13/2003

Undisturbed junction box

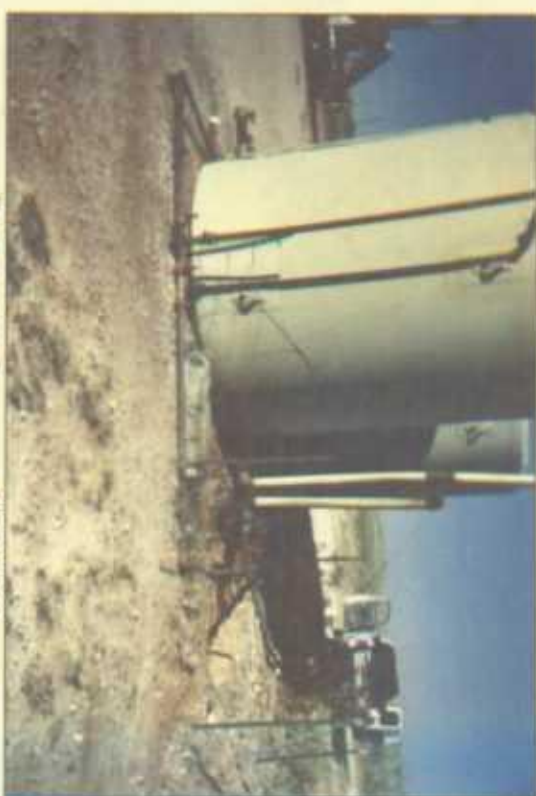
8/20/2003

Box removed

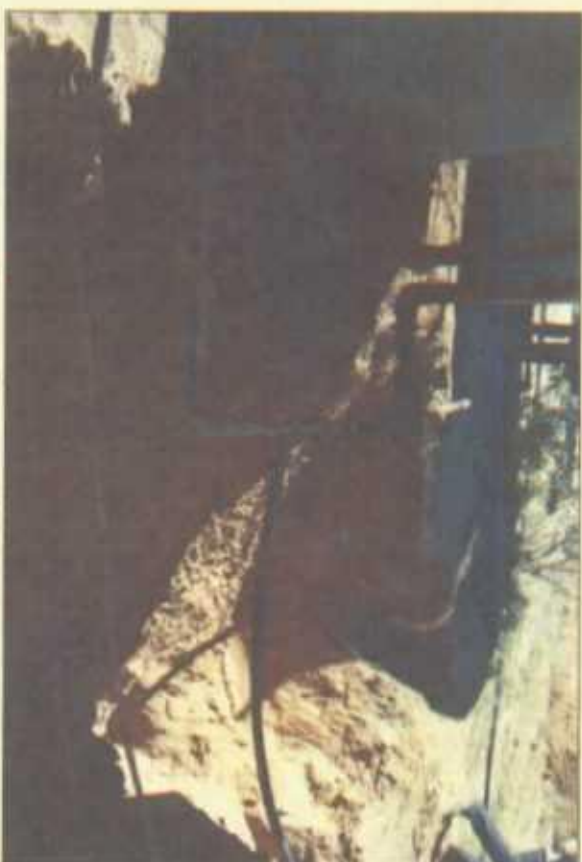
Excavation 10/29/2003

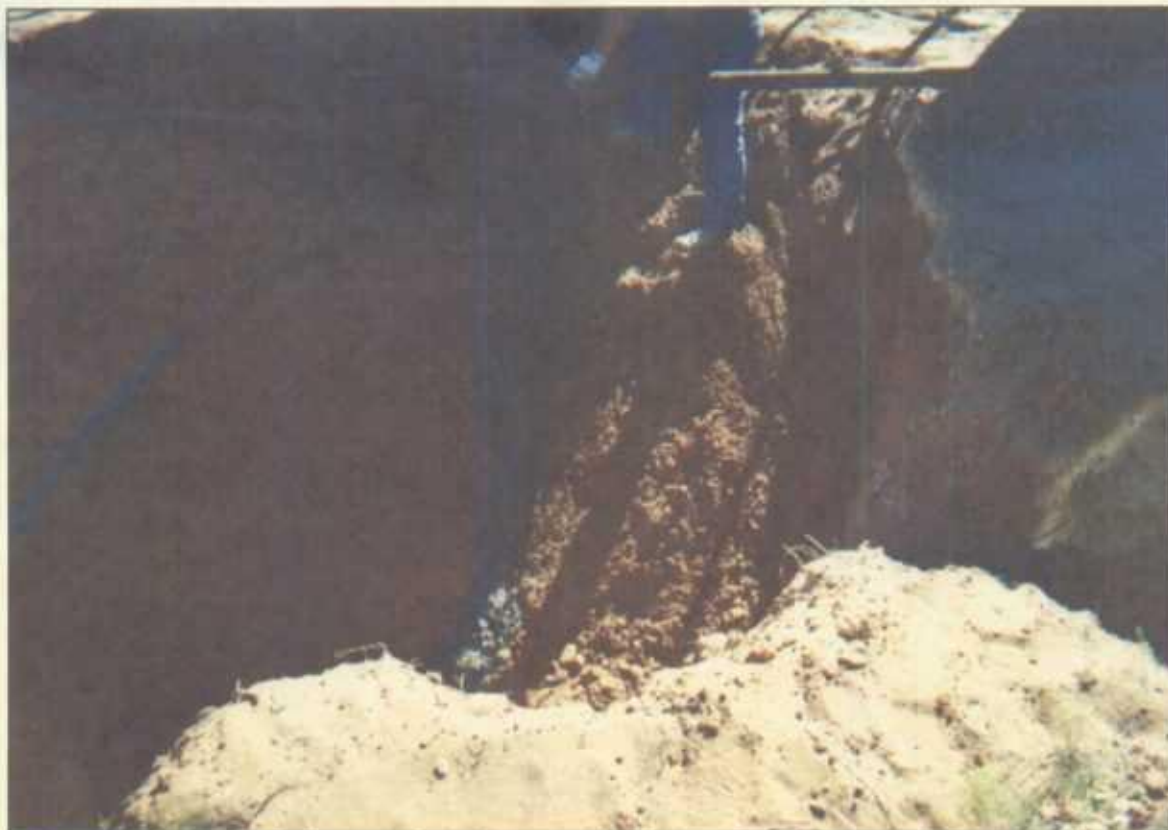
10/29/2003

Repairing battery leak as crude and water spill into excavation

inside the yard of an active production battery. Before the site was to be delineated, a leak occurred at the battery on the weekend of Oct. 25-26 which puddled in the EOL box. The site was excavated on 10/28/03 with a backhoe while chloride tests and PID readings were performed regularly. A conclusive trend of decline was observed vertically (see graph) and laterally. PID readings were all minimal and lab TPH results confirmed concentrations well below NMOCD guidelines. On 10/29/2003, personnel arrived at the battery to repair the leak. As the leak was repaired, crude oil and water spilled into the junction box excavation down the south wall (see photo). During the repair, the south wall of the excavation collapsed so samples from the south wall were not included in the final wall composite. The 15 x 14 x 12-ft-deep excavation was backfilled and capped with a caliche pad. Any further surface remediation of impact contributed from the facility will be conducted when the facility is abandoned in cooperation with the producer.

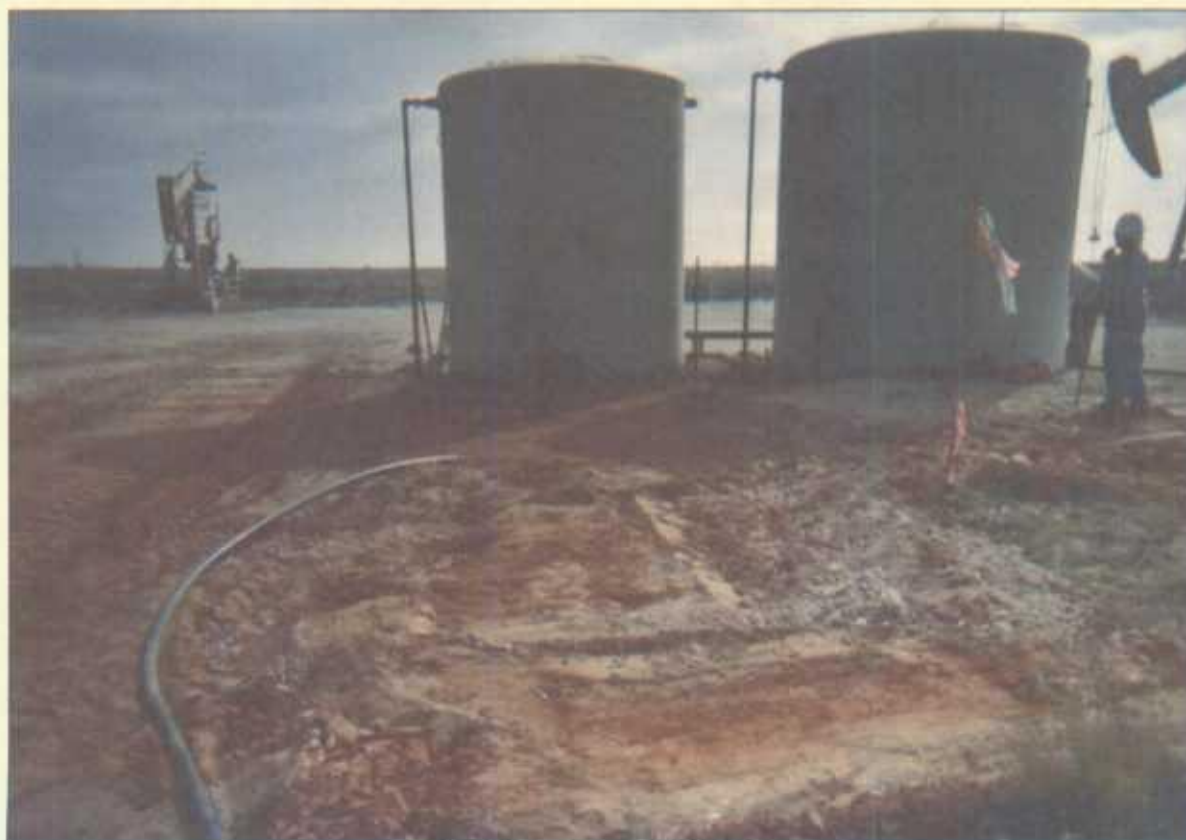
11/5/2003

Backfilled
