# FINAL REPORT

# RICE OPERATING COMPANY JUNCTION BOX FINAL REPORT

# EME L.H. B-31 EOL

unit 'J', sec. 31, T21S, R36E

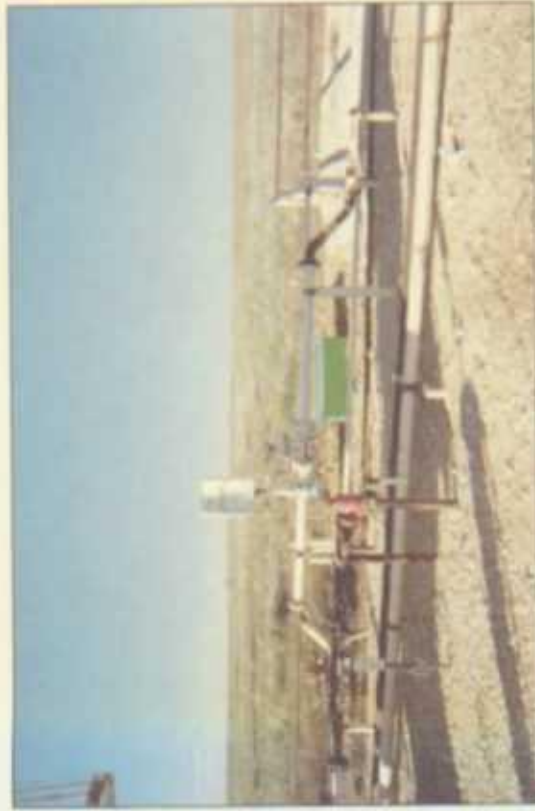
11/17/2003

undisturbed junction box

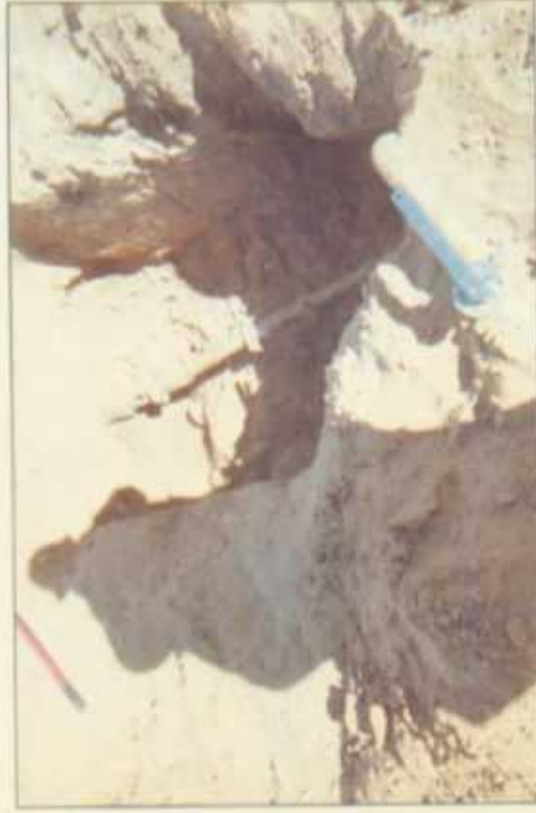
12/2/2003

old box site after lumber removed

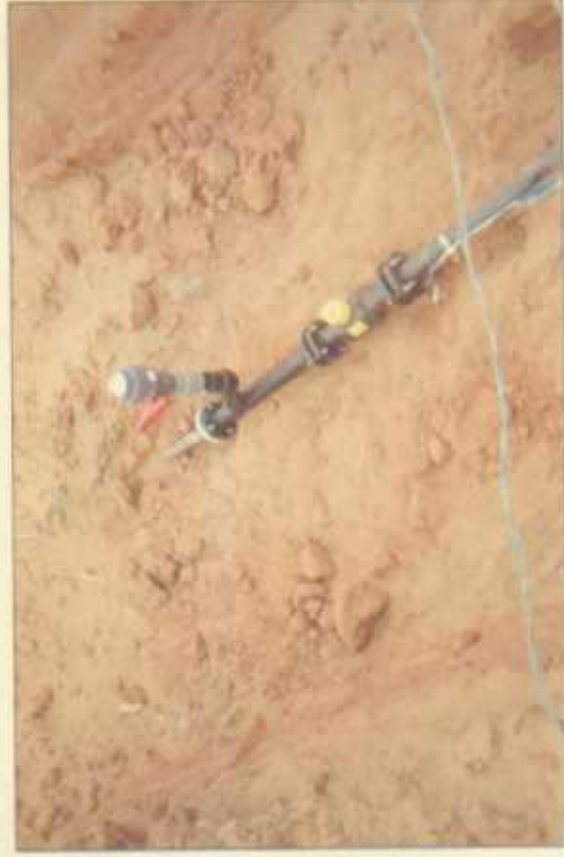
12/2/2003

new plumbing for new box 32 ft North of old box

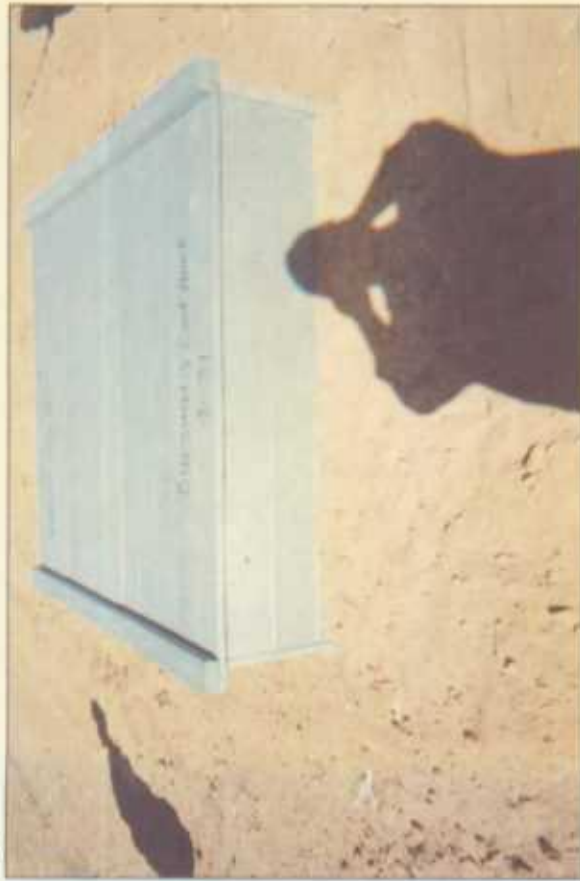
12/8/2003

completed new box 32 ft North

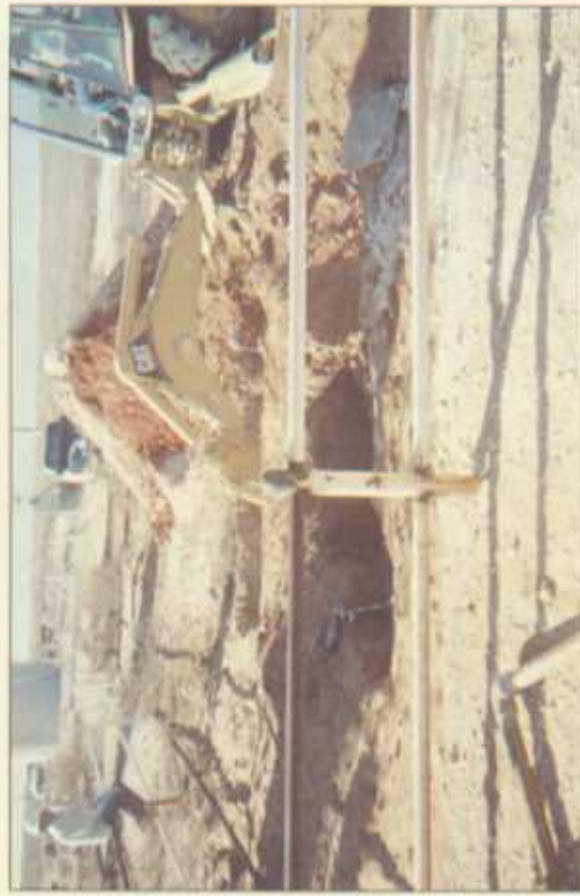
12/12/2003

delineation & excavation

General Description of Remedial Action: This end-of-line (EOL) box was located on the north side of an active production facility. The box was moved 35 ft north with a new pipeline. The old box site was delineated using a backhoe while PID screenings and chloride field tests were conducted at regular intervals, producing a 10 x 10 x 10-ft-deep excavation. Further excavation was not possible due to the proximity of active facilities at the battery. All PID readings were 0.0 ppm and lab results revealed non-detect TPH concentrations that meet NMOCD guidelines. A 4-point decline in field chloride concentrations was observed with depth within the excavation. The excavation was backfilled with soils that were blended on-site. In July, the soils settled and the excavation area was capped with about 1 ft of clean, imported soils. The disturbed surface is expected to return to productive capacity at a normal rate.

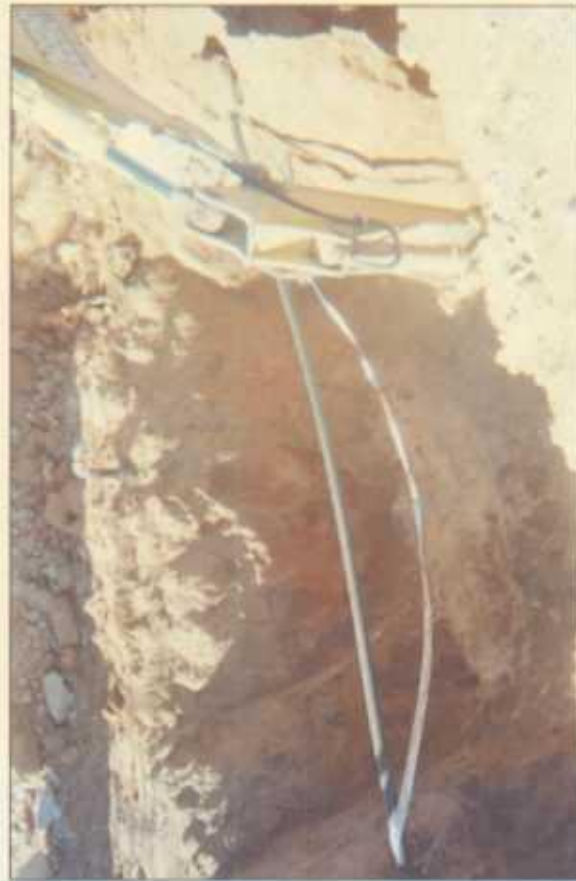
12/17/2003

delineation & excavation

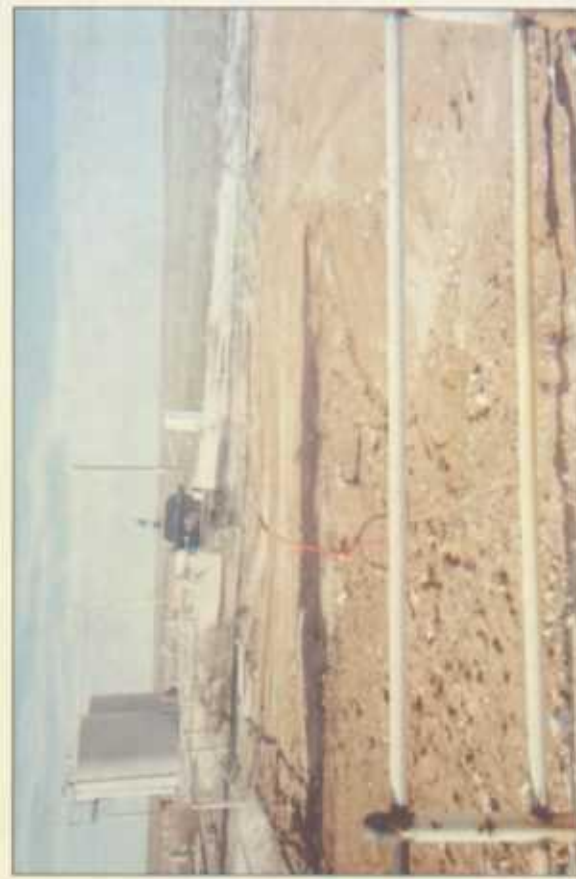
12/30/2003

backfilled excavation
