# FINAL REPORT

**RICE OPERATING COMPANY  
JUNCTION BOX CLOSURE REPORT**

## EME T. Closson EOL

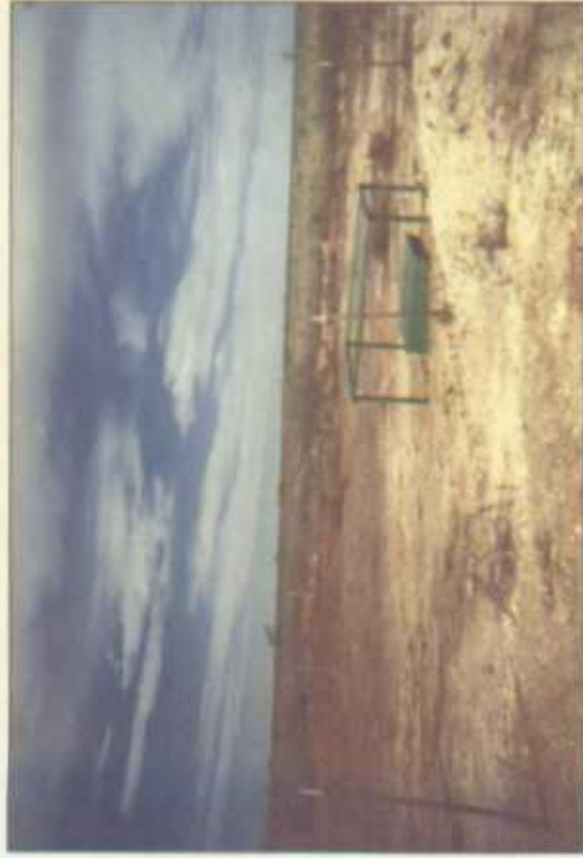
Undisturbed EOL box (north side of battery) 11/17/2003

**General Description of Remedial Action:** This End-Of-Line box was located just outside the fence of an active production battery. The surface surrounding the box is visibly impacted by TPH and has hydrocarbon staining (see photos). The box was removed and the site was delineated with a backhoe while PID readings and chloride tests were regularly performed. Chloride concentrations west of the junction warranted further delineation. NMOCD TPH guidelines were met, but elevated PID readings were observed. On 3/18/2004, a soil bore was conducted and advanced to a depth of 60 ft. Based on the depth to groundwater and the declination trend of chloride concentrations with depth, groundwater is not threatened by this junction box. Soil bore PID readings were low and the 60 ft sample showed NMOCD TPH guidelines were met. A new junction box will not be re-built here and has been eliminated.

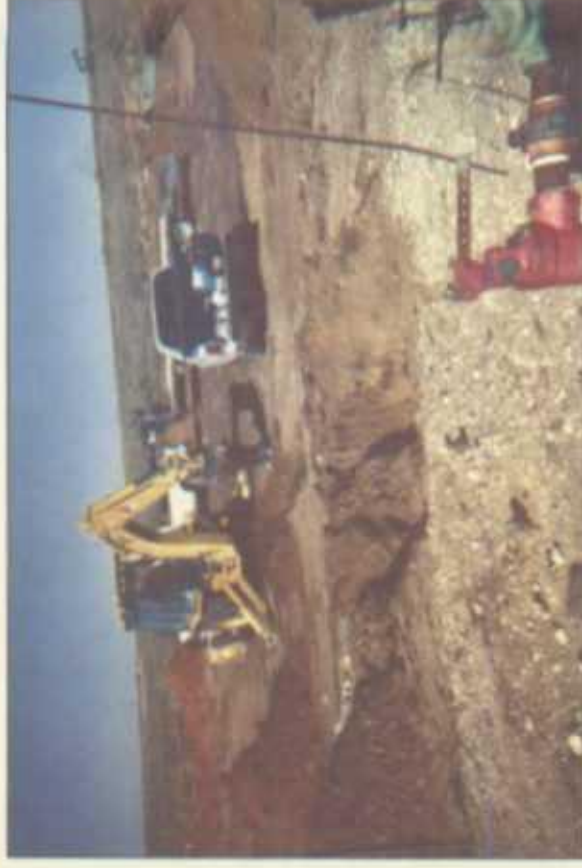
Delineation & excavation 12/9/2003

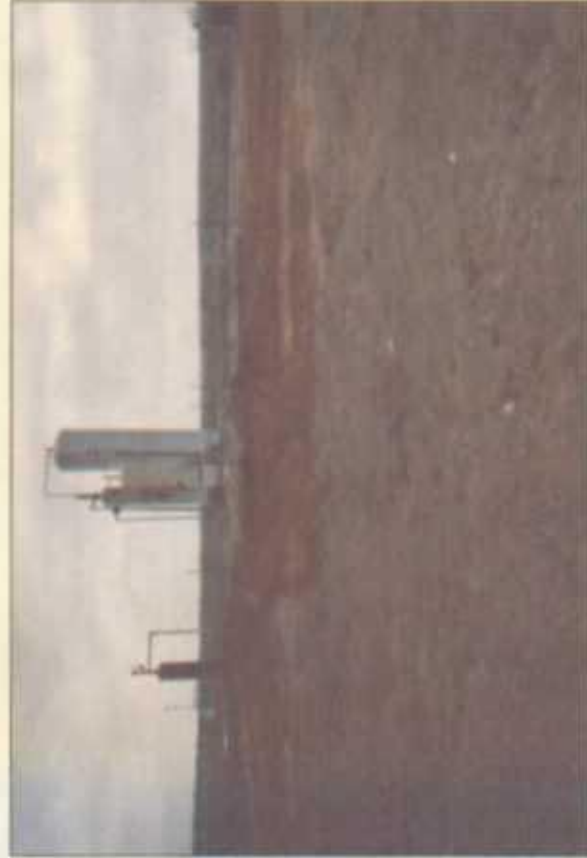
Excavation prior to backfilling (looking south) 12/12/2003

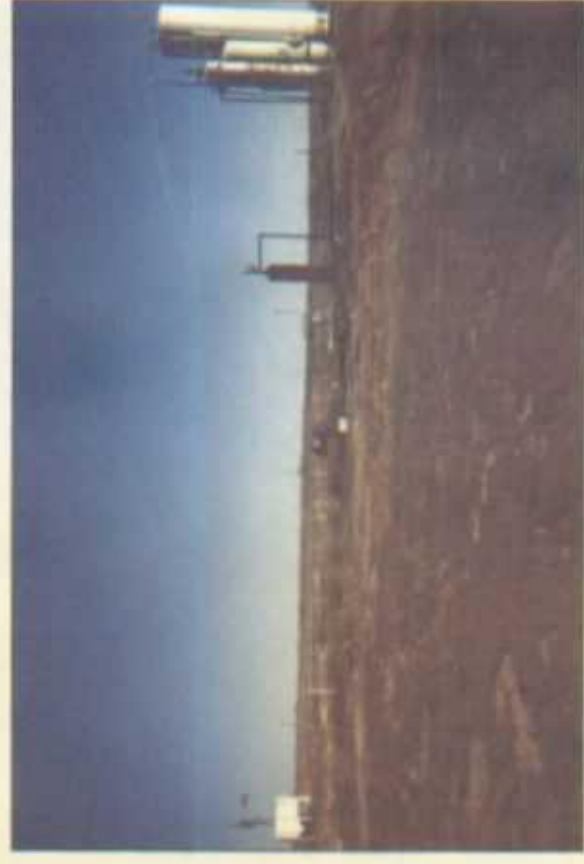
Backfilled site surrounded by asphaltine surface near battery 12/18/2003

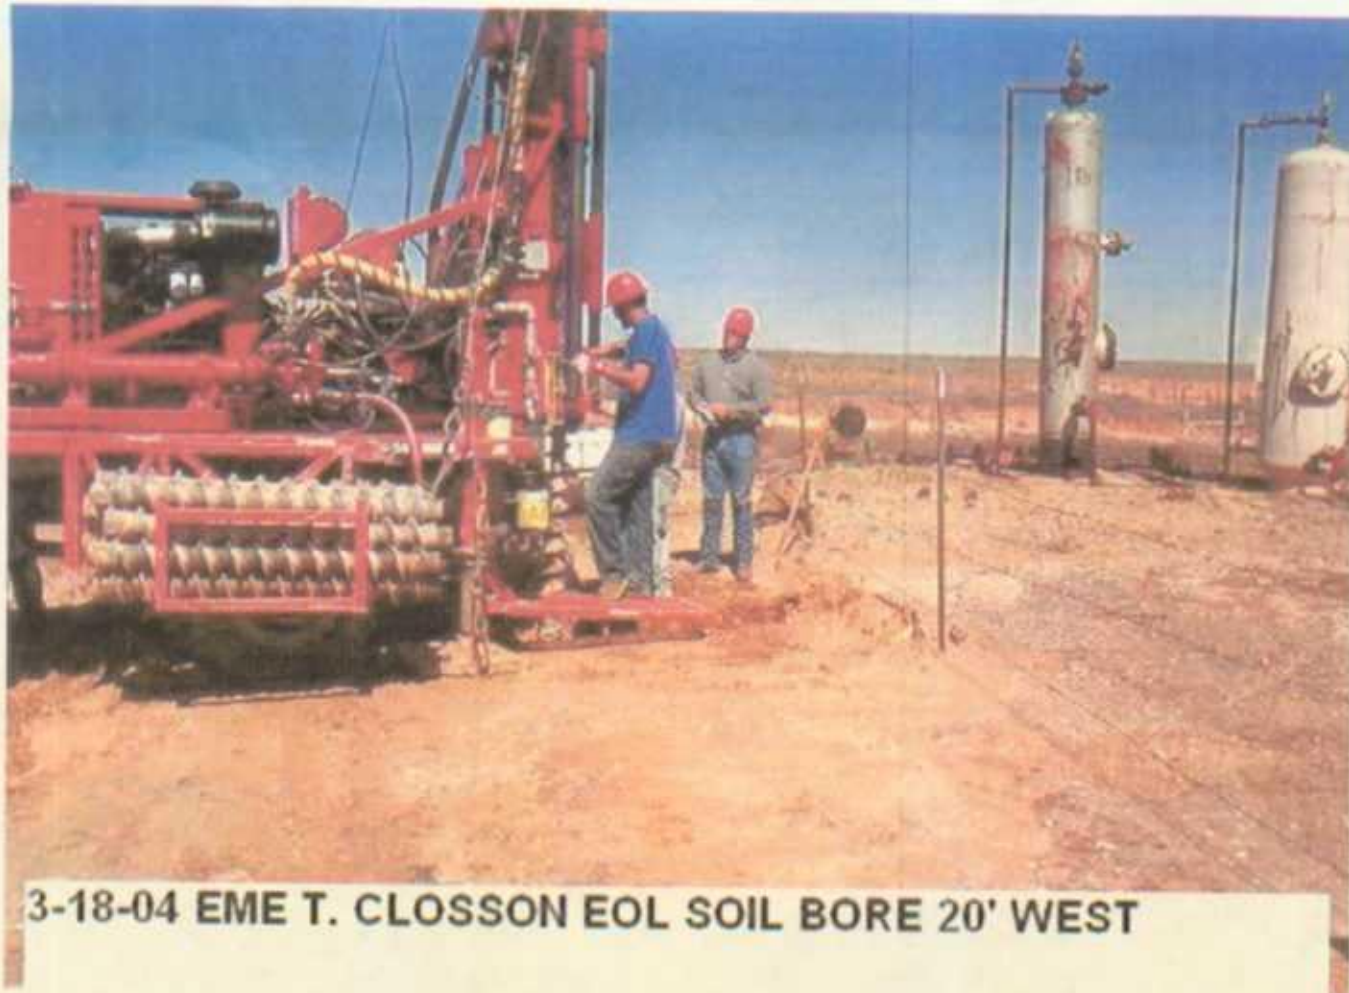
3-18-04 EME T. CLOSSON EOL SOIL BORE 20' WEST

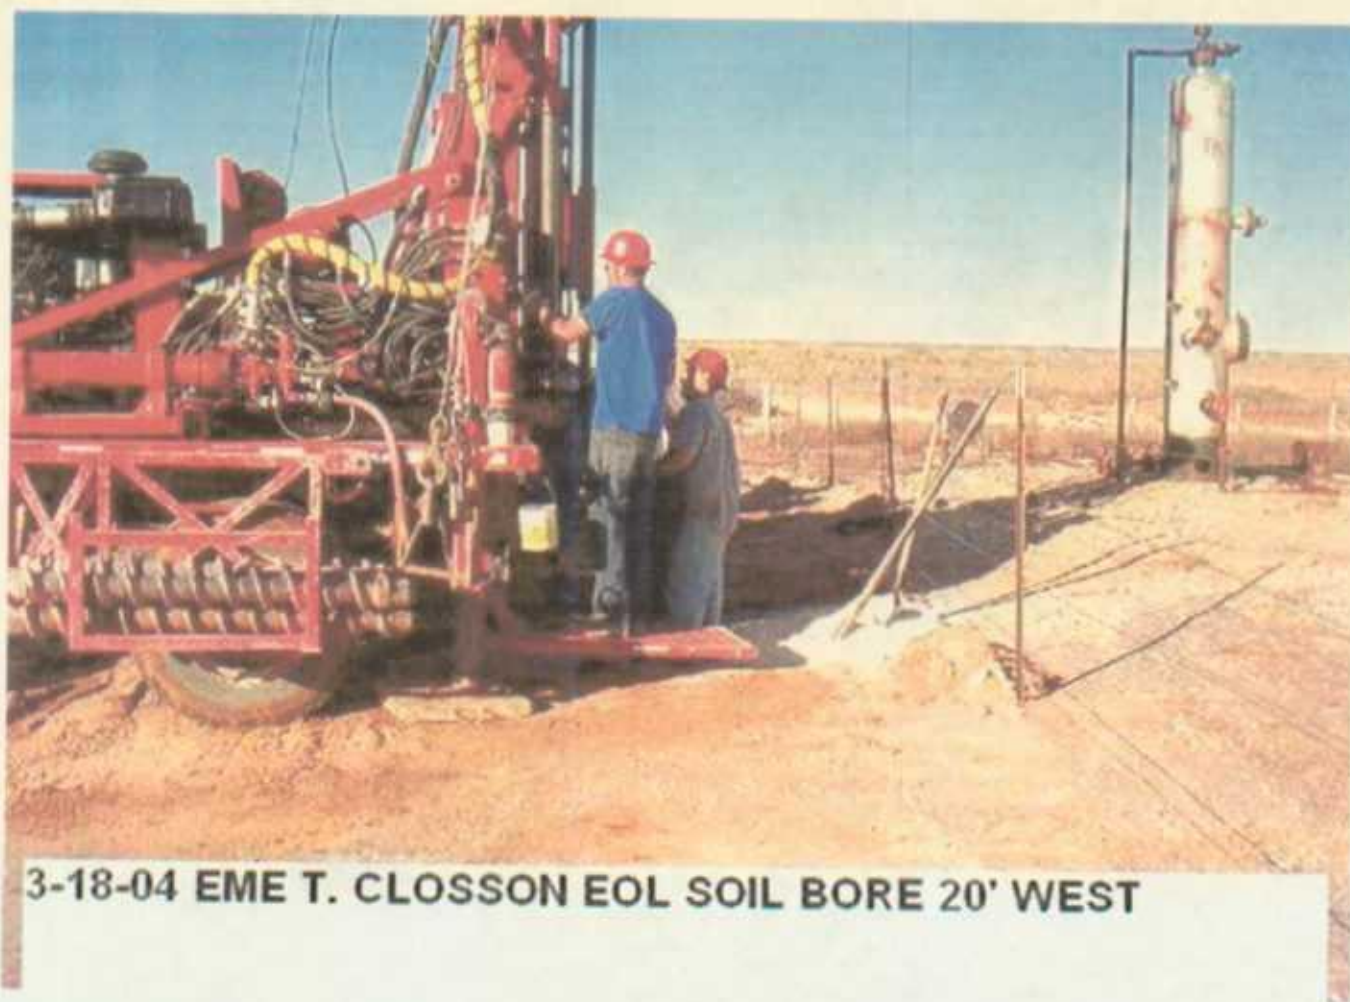
3-18-04 EME T. CLOSSON EOL SOIL BORE 20' WEST

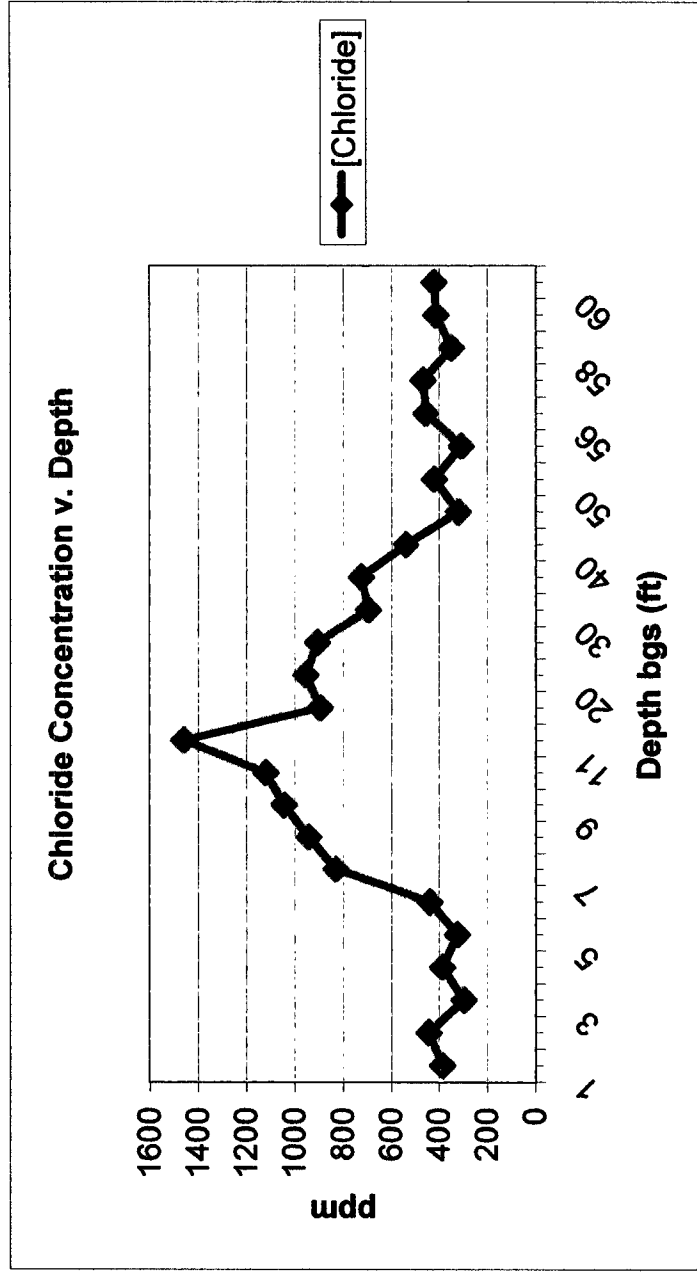
# EME T. Closson EOL

20 ft west of junction

Depth bgs (ft)	[Cl <sup>-</sup> ] ppm
1	386
2	442
3	297
4	387
5	324
6	438
7	831
8	944
9	1046
10	1121
11	1461
15	896
20	956
25	907
30	696
35	725
40	539
45	320
50	419
55	308
56	454
57	466
58	350
59	413
60	421

Groundwater = 180 ft
