EME State 'B' EA

RICE OPERATING COMPANY JUNCTION BOX FINAL REPORT

EME State 'B' EOL

Unit 'B', Sec. 29, T21S, R36E

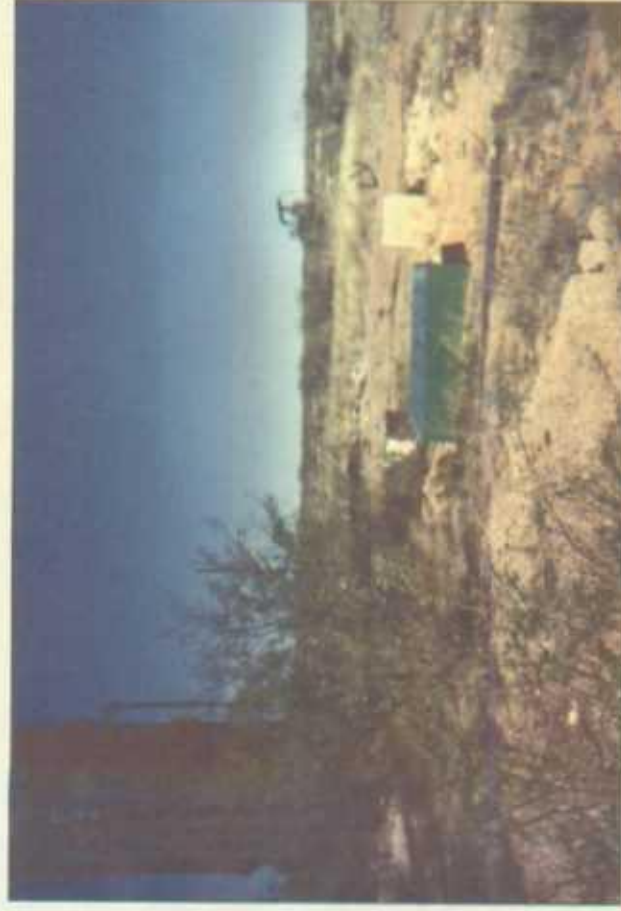
11/19/2003

Undisturbed Junction Box

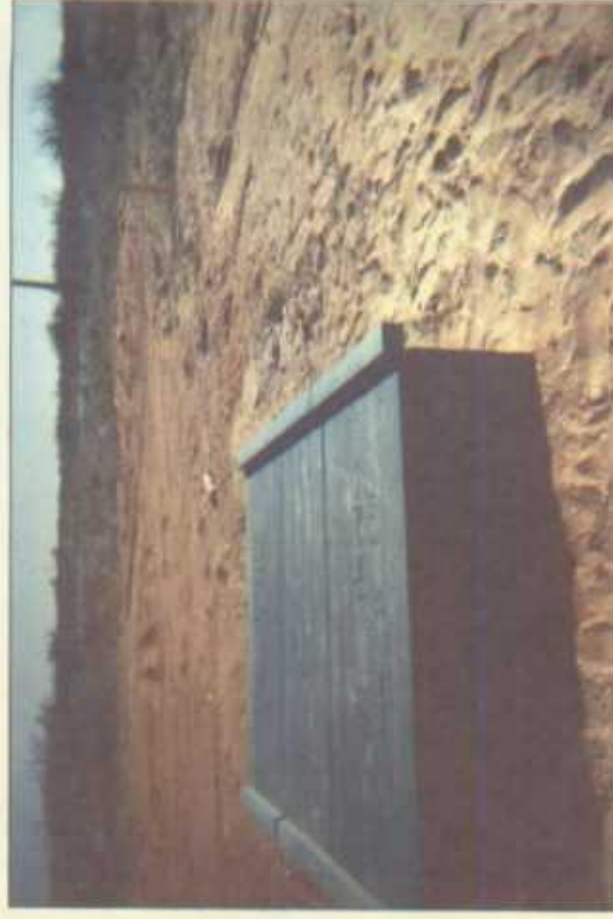
2/6/2004

New junction box 33 ft southeast

General Description of Remedial Action: This End-Of-Line box was located near an active production facility and surrounded by healthy vegetation. Vertical delineation to 11 ft was conducted using a backhoe while samples were field-tested for VOC's and chloride at regular intervals. All PID readings were 0.0 and lab tests confirmed TPH concentrations were well below NMOCD guidelines. Chloride concentrations were all minimal and there was no physical indications of chloride or hydrocarbon impact at this site. The delineation trench was backfilled with excavated soil that was blended on-site. The 8 x 8 ft of disturbed surface will be re-seeded with a blend of native vegetation and is expected to return to productive capacity at a normal rate. A new water-tight junction box has been built 33 ft southeast of this site.

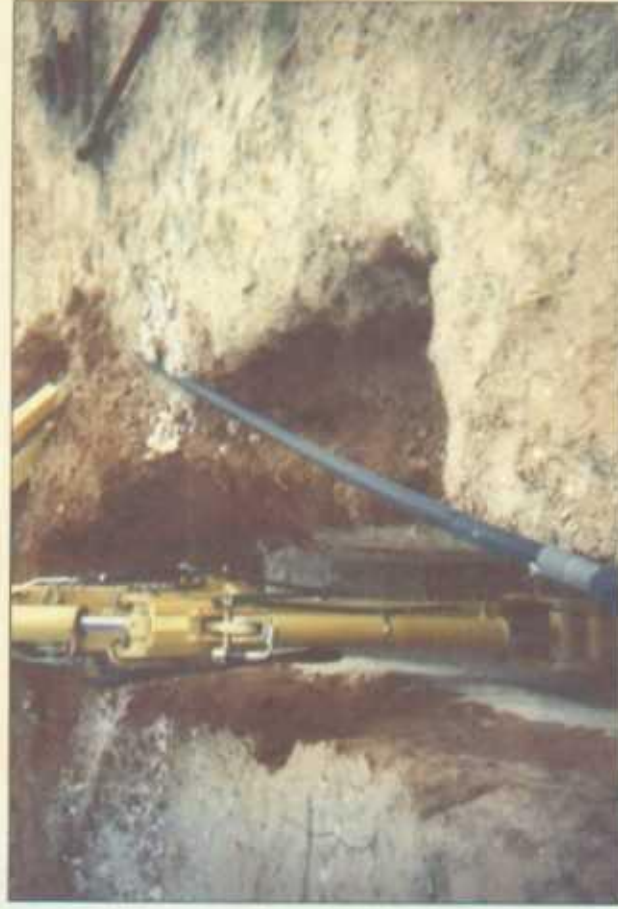
3/5/2004

Vertical delineation with backhoe (looking east)

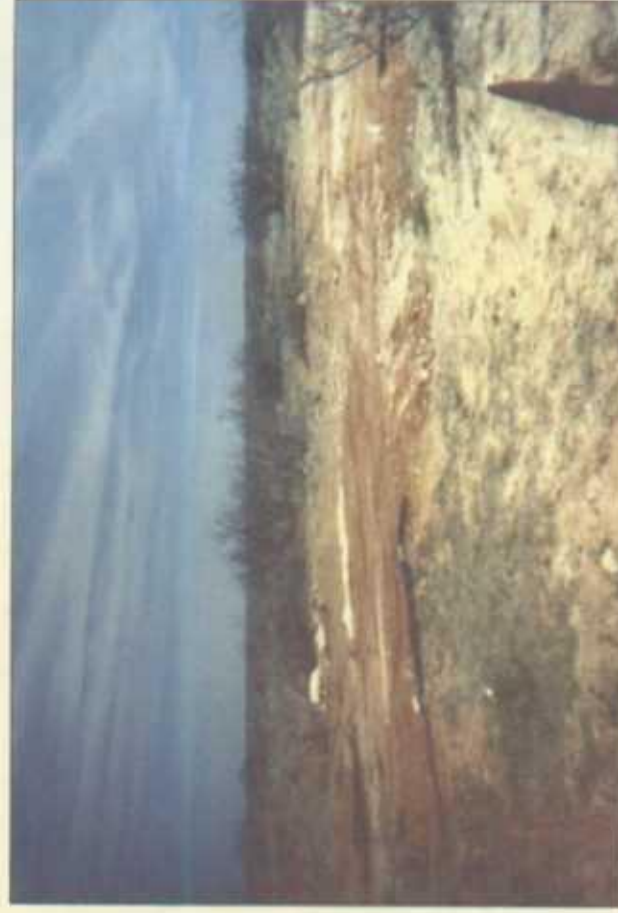
3/19/2004

Backfilled Excavation (looking east)
