EME 0-35 North

# **FINAL REPORT**

**RICE OPERATING COMPANY  
JUNCTION BOX FINAL REPORT**

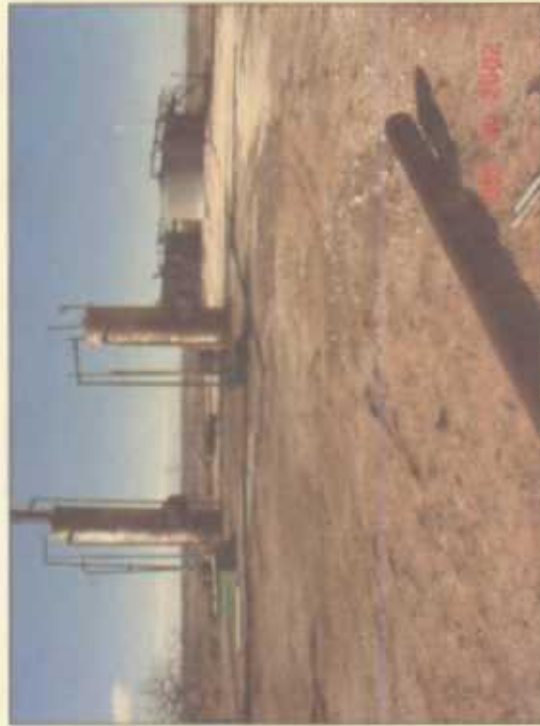
Boxes inside battery (looking SW); North box on right. 12/30/02

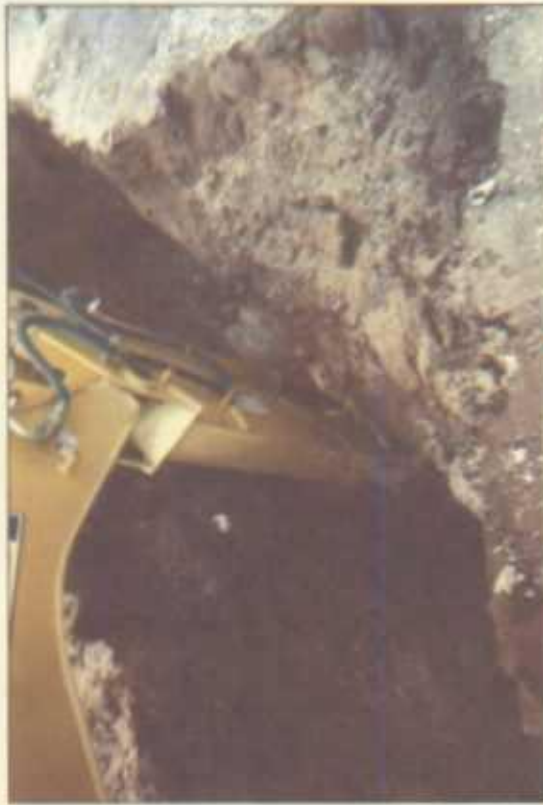
Vertical delineation with backhoe 3/22/04

General Description of Remedial Action: This was the North box of 2 that were located inside an active production facility. Vertical delineation was conducted with a backhoe while chloride field tests were performed every foot. Chloride concentrations exhibited a conclusive decline in concentrations (see graph), indicative of non-saturated vadose conditions and not threatening to groundwater at 122 ft BGS. PID field screening results were minimal and lab analysis confirmed TPH concentrations well below NMOCD guidelines. The excavation trench was backfilled and contoured to the surrounding surface. A new watertight junction box has been built outside the battery approximately 200 ft Northeast of this box.

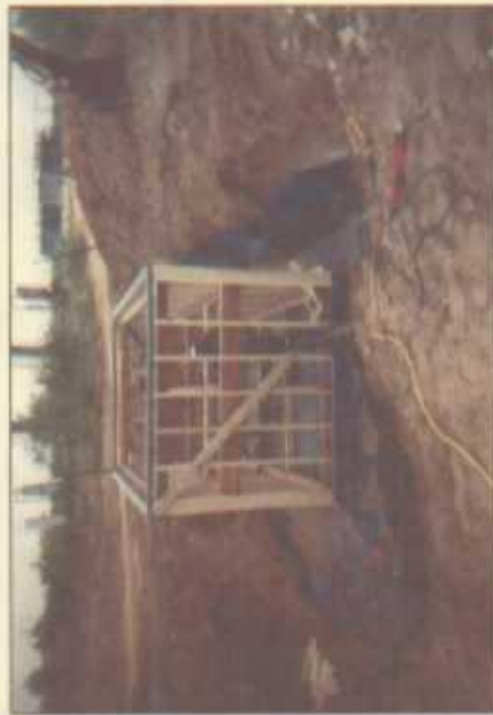
Construction of new junction box 200 ft NE 9/26/03
