FINAL REPORT

**RICE OPERATING COMPANY
JUNCTION BOX FINAL REPORT**

EME F-1 EOL

unit 'U', Sec. 1, T21S, R36E

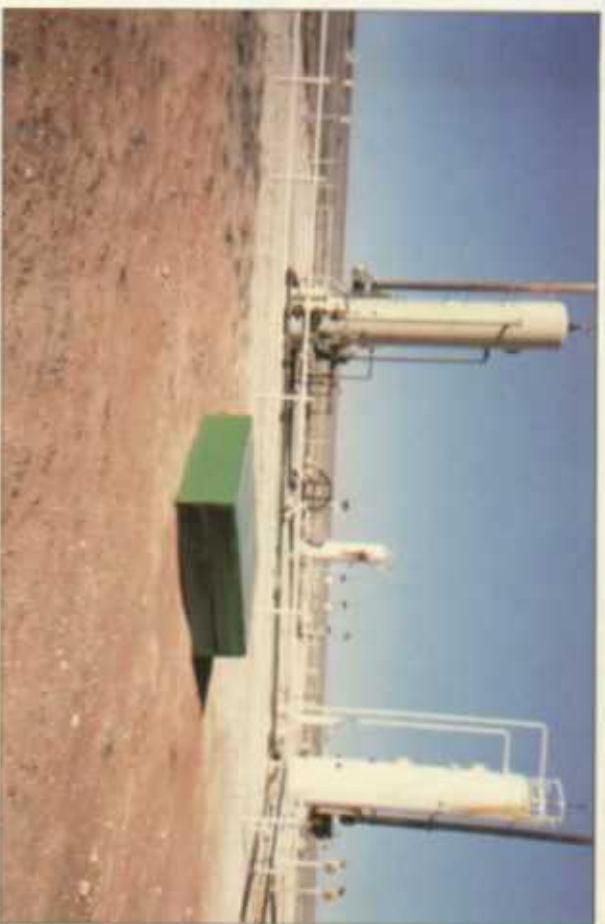
11/19/2003

Undisturbed junction box prior to excavation

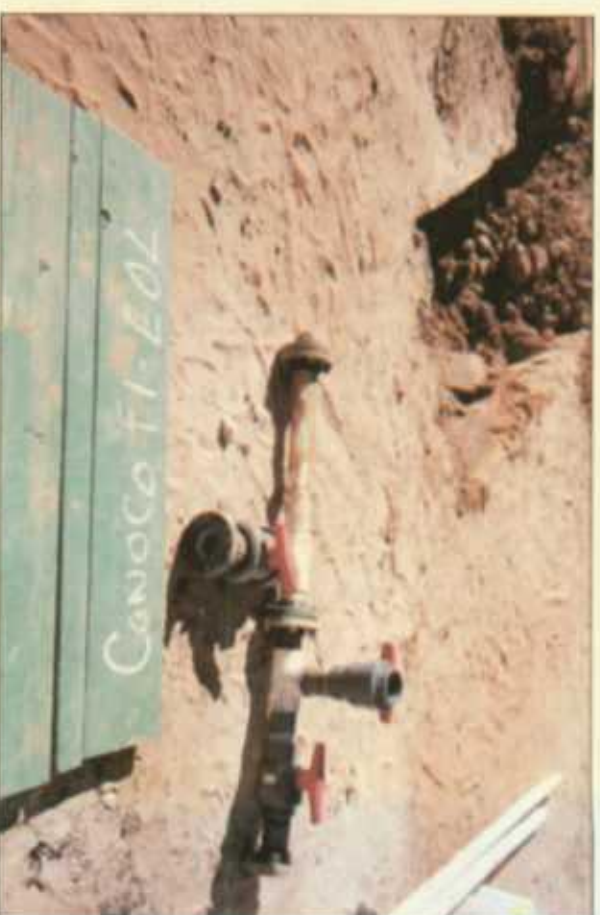
1/9/2004

Old box site with old plumbing: lid in foreground

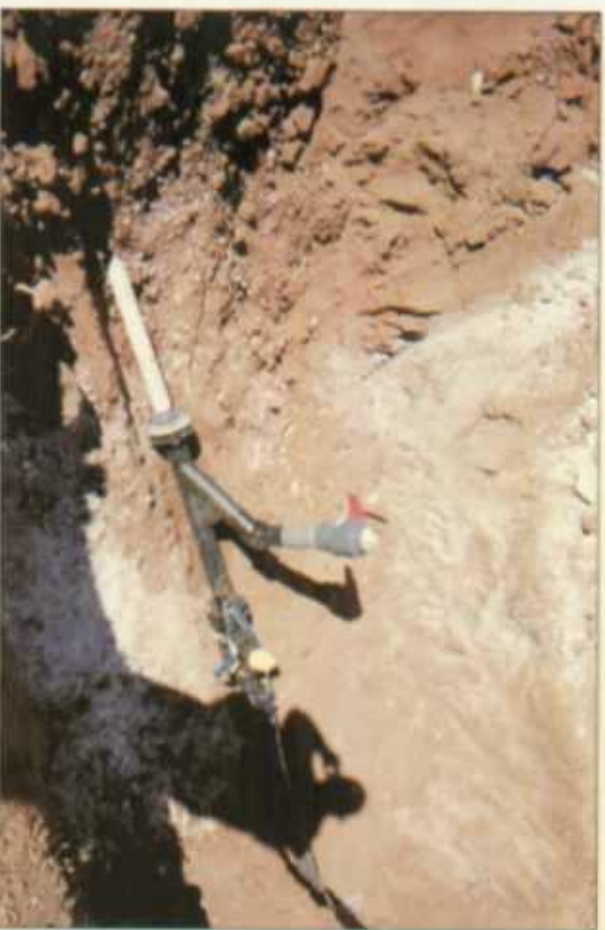
1/9/2004

New plumbing at new box site 45 ft southwest

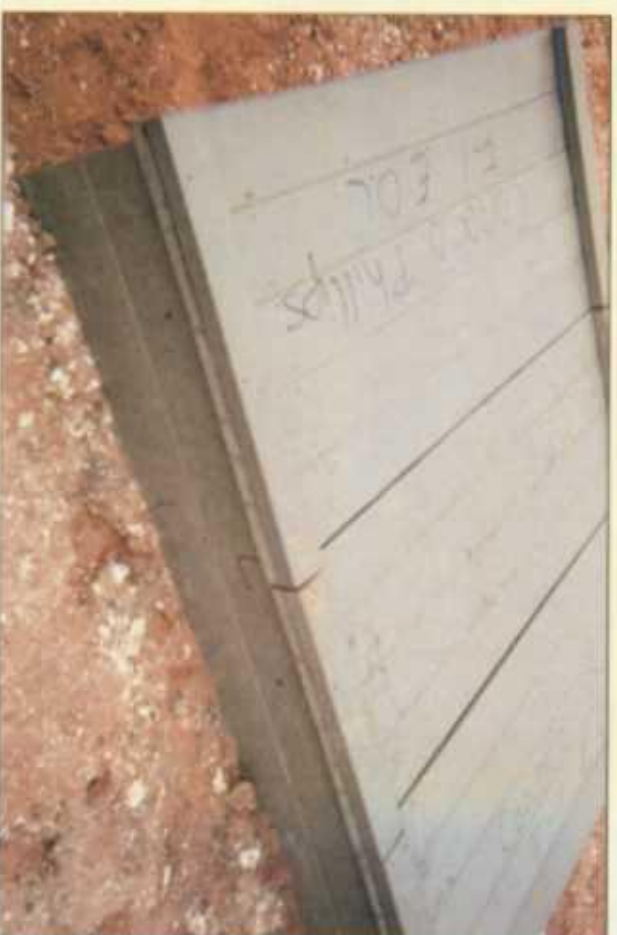
1/16/2004

Completed new junction box 45 ft southwest of old one

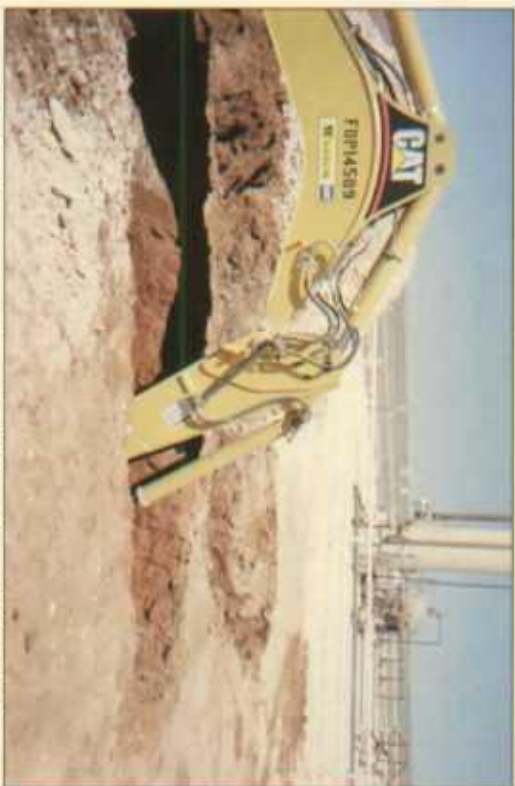
Beginning excavation & delineation 3/17/2004

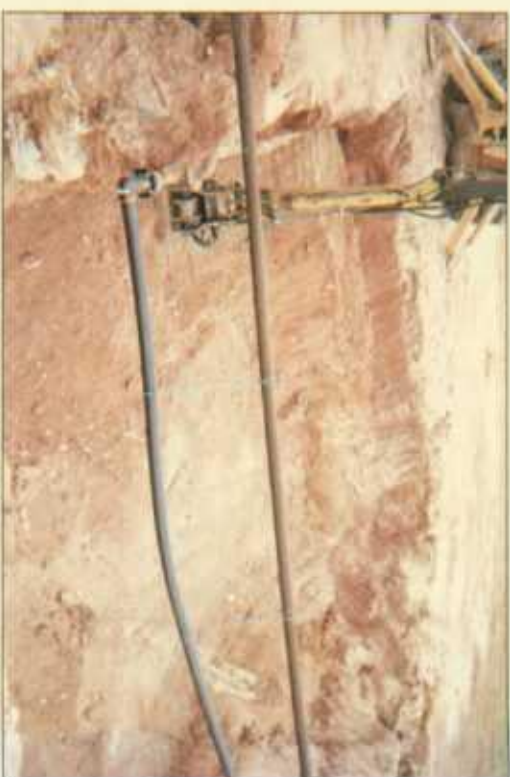
Final excavation: 23 x 20 x 12-ft-deep 3/17/2004

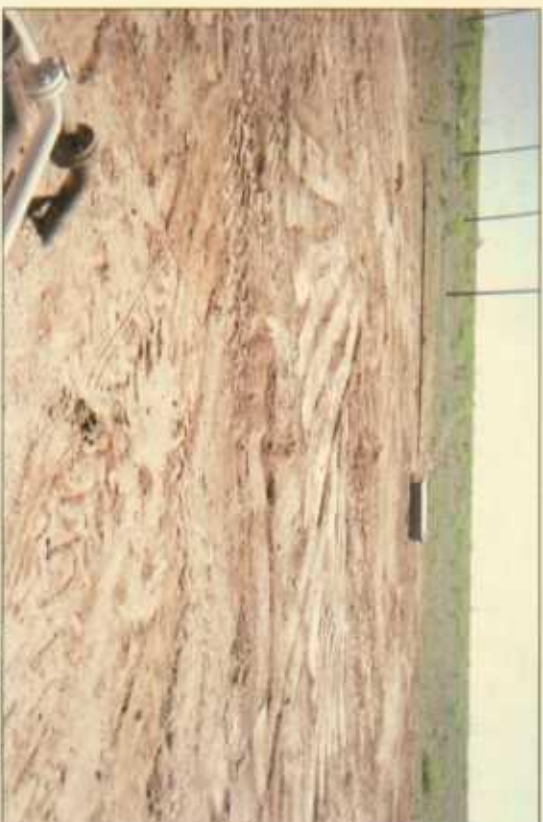
Backfilled site with new box in foreground 5/6/2004
