**RICE OPERATING COMPANY
JUNCTION BOX FINAL REPORT**

SWD SYSTEM	JUNCTION	UNIT	SECTION	TOWNSHIP	RANGE	COUNTY	BOX DIMENSIONS - FEET		
EME	J-32	J	32	19S	37E	Lea	Length	Width	Depth
							6	5	5

EME jct. J-32

unit 'J', Sec. 32, T19S, R37E

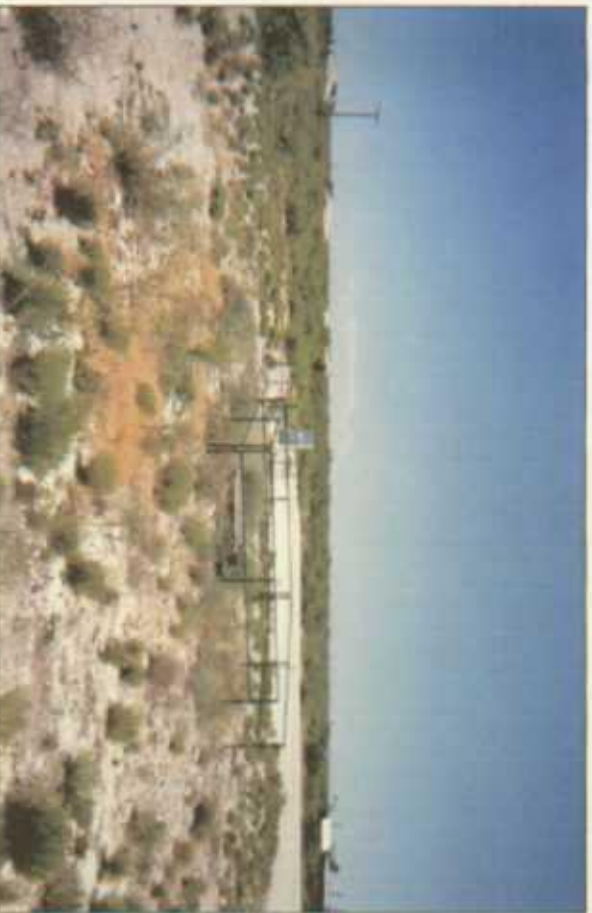
7/26/2004

undisturbed junction box

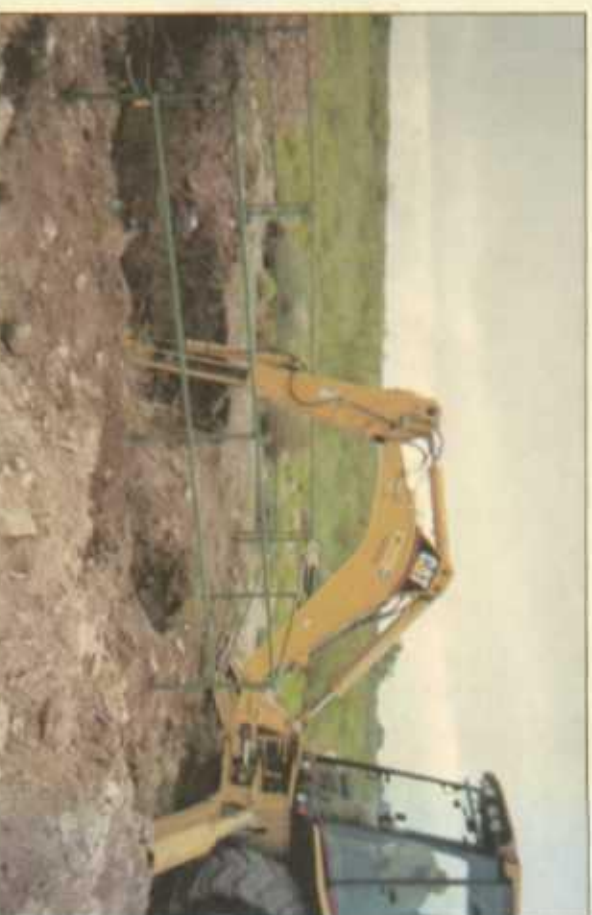
7/26/2004

delineation & excavation

General Description of Remedial Action: Initial assessment of this junction box included no physical evidence of hydrocarbon or chloride impact. The lumber was removed and excavation and delineation was performed with a backhoe while field screenings were conducted for chloride and VOC's. Field tests yielded low chloride concentrations, similar to background levels. All PID readings were 0.0 except one at 6 ft, which was 1.1 ppm. TPH guidelines were met within the 10 x 10 x 6-ft-deep excavation, as concentrations were non-detect in laboratory samples. The excavated soil was blended on site and then backfilled into the hole. A new watertight junction box has been built over this location.

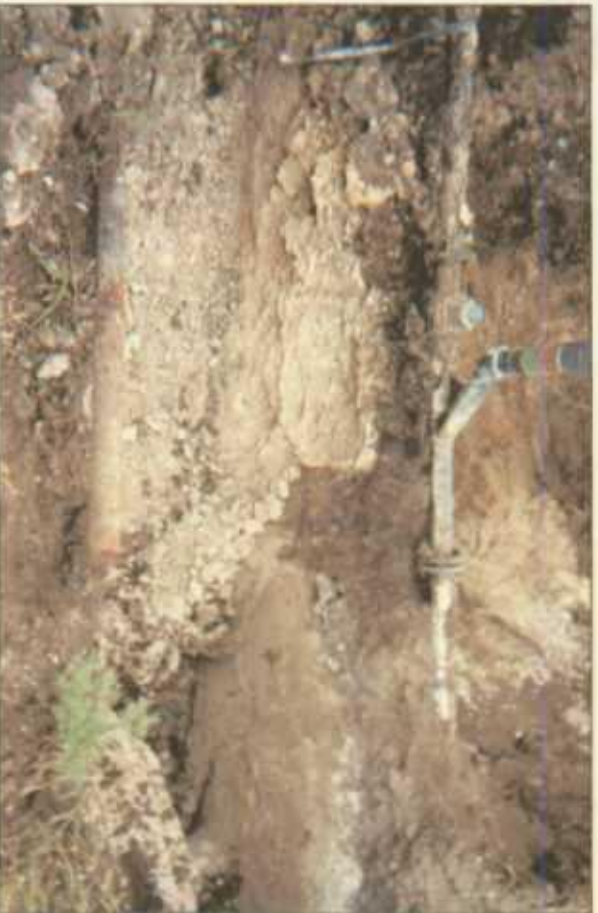
7/26/2004

delineation & excavation

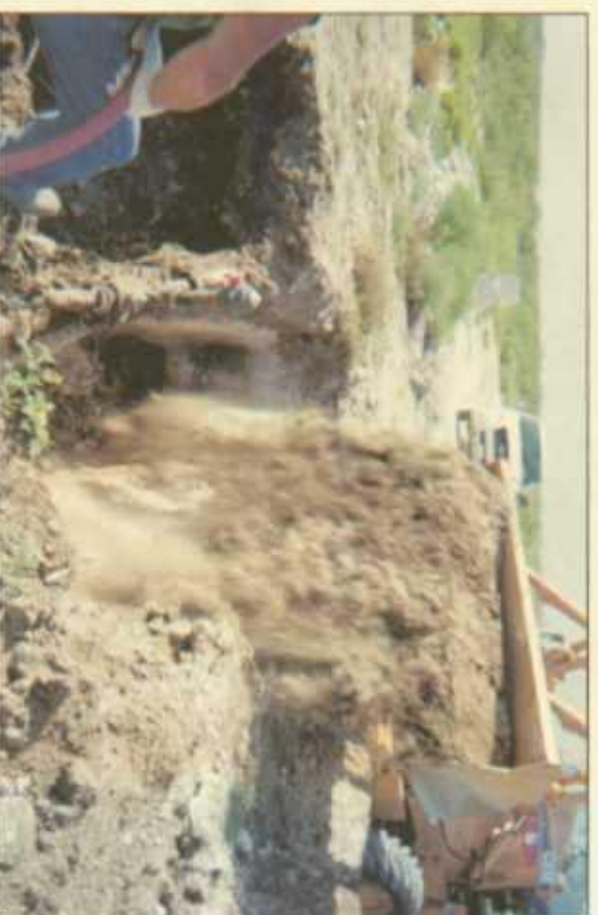
8/10/2004

backfilling

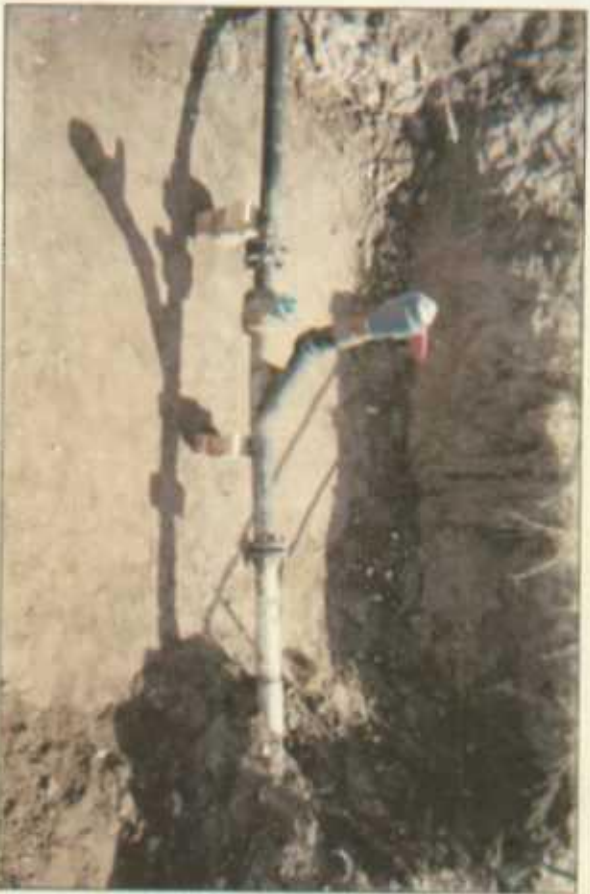
8/31/2004

compacted floor ready for box

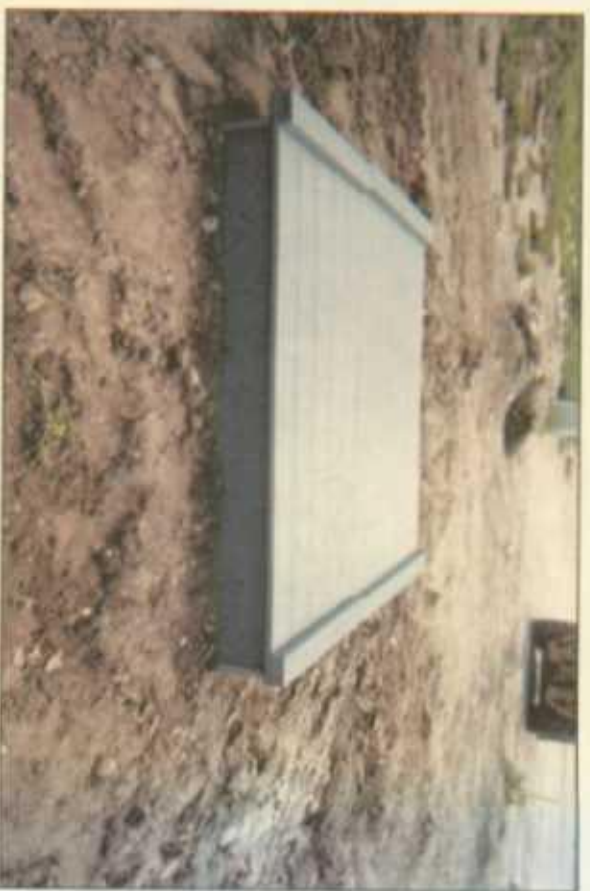
9/1/2004

completed watertight junction box

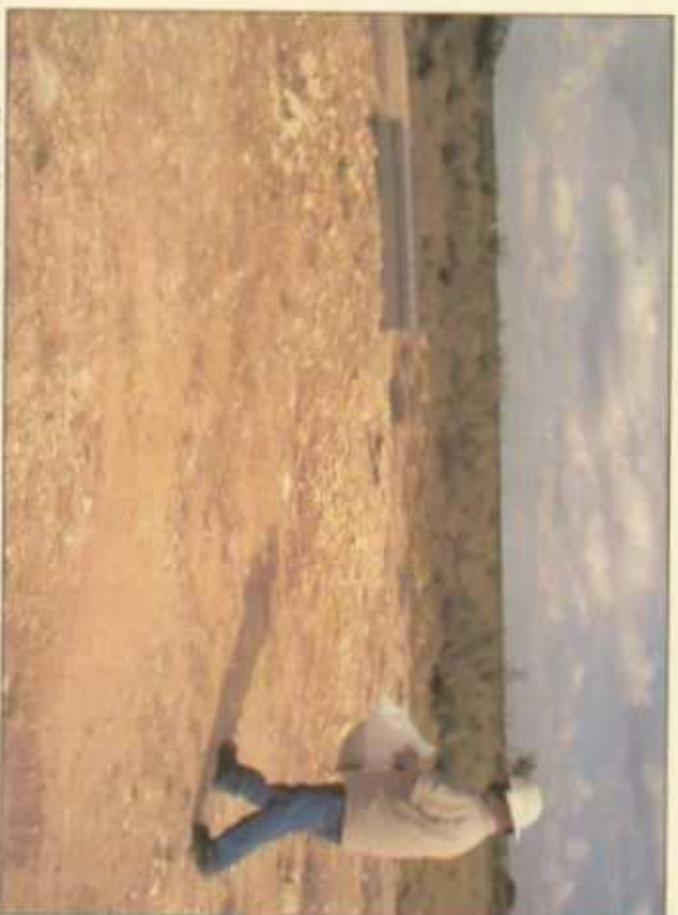
10/4/2004

seeding disturbed surface
