FINAL REPORT

**RICE OPERATING COMPANY
JUNCTION BOX FINAL REPORT**

EME Citation Devonian vent G-20

unit 'G', Sec. 20, T21S, R36E

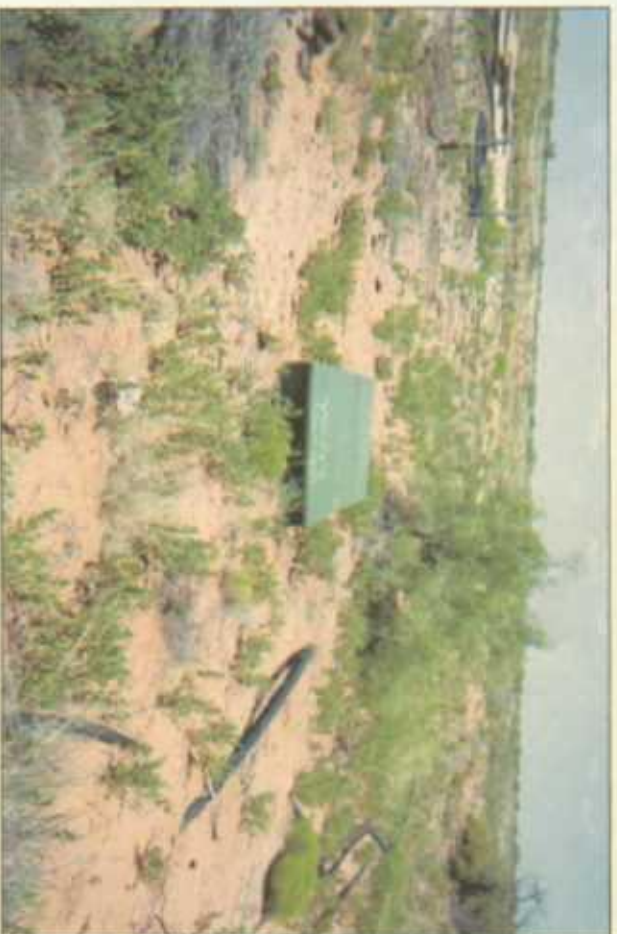
7/23/2003

undisturbed junction box

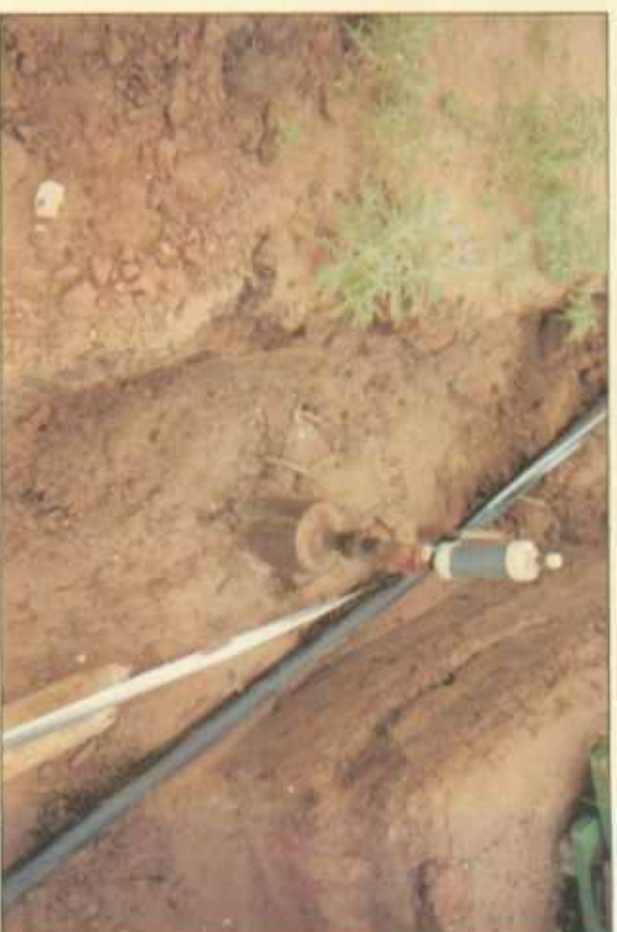
7/23/2003

old junction site; lumber removed

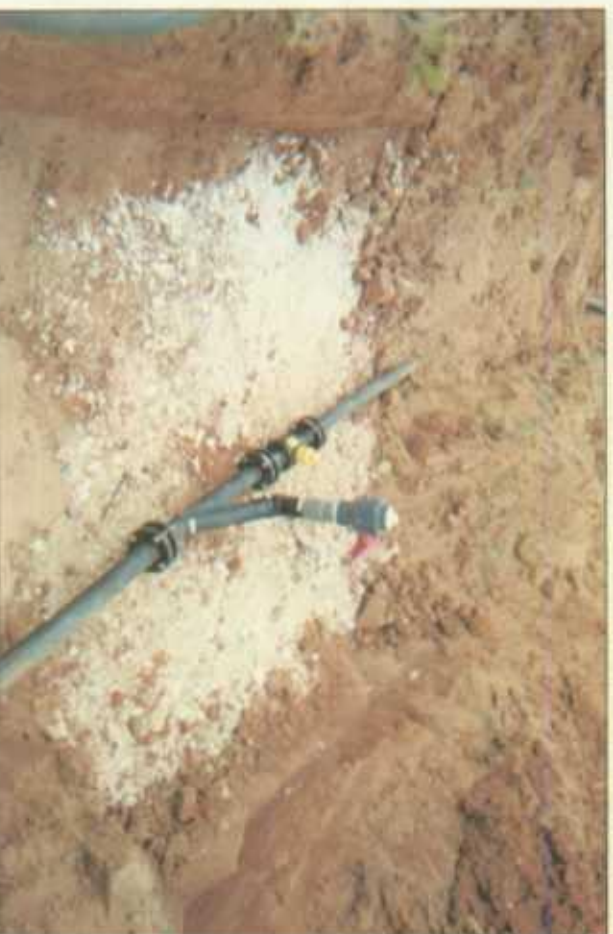
6/23/2004

new plumbing in new box location 167 ft north

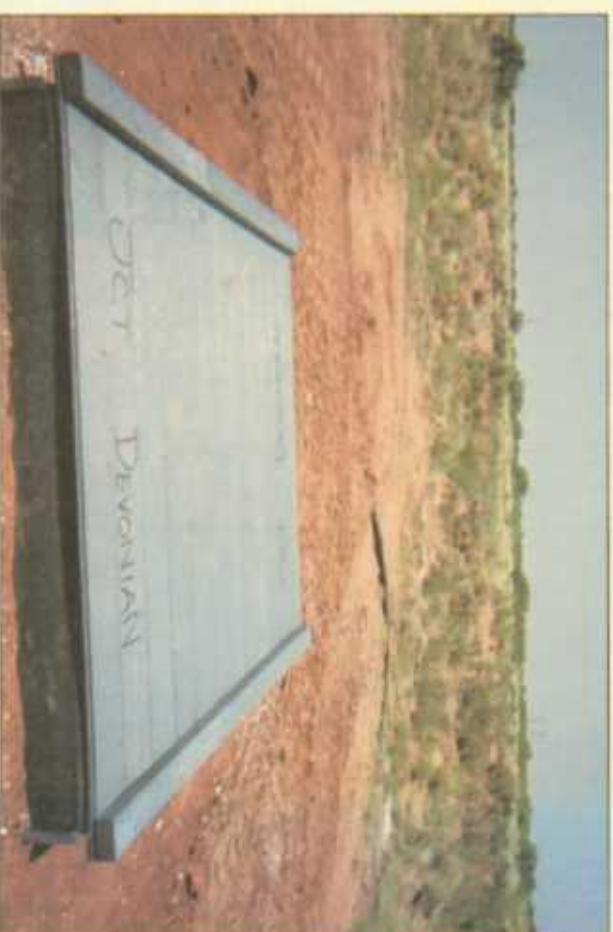
7/9/2004

completed new watertight junction box 167 ft north

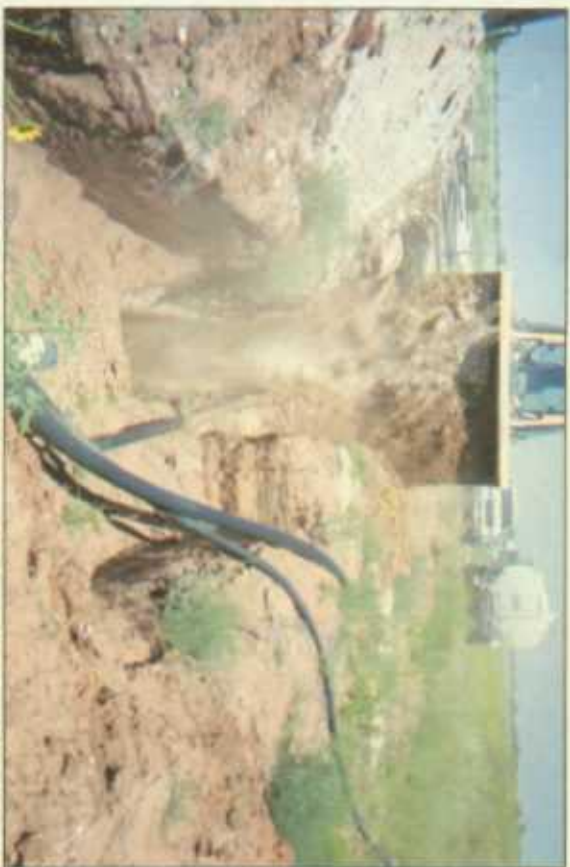
backfilling delineation excavation at old box site 8/12/2004

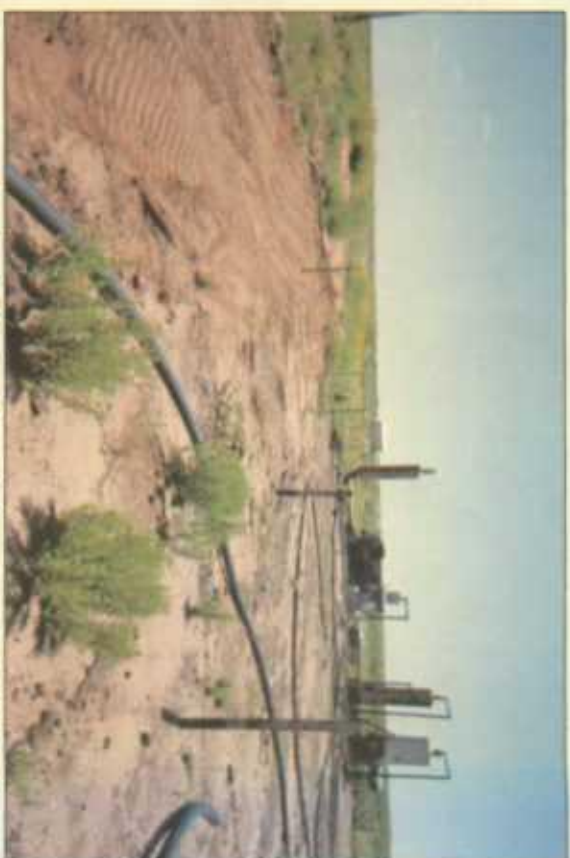
excavation backfilled and graded 8/12/2004

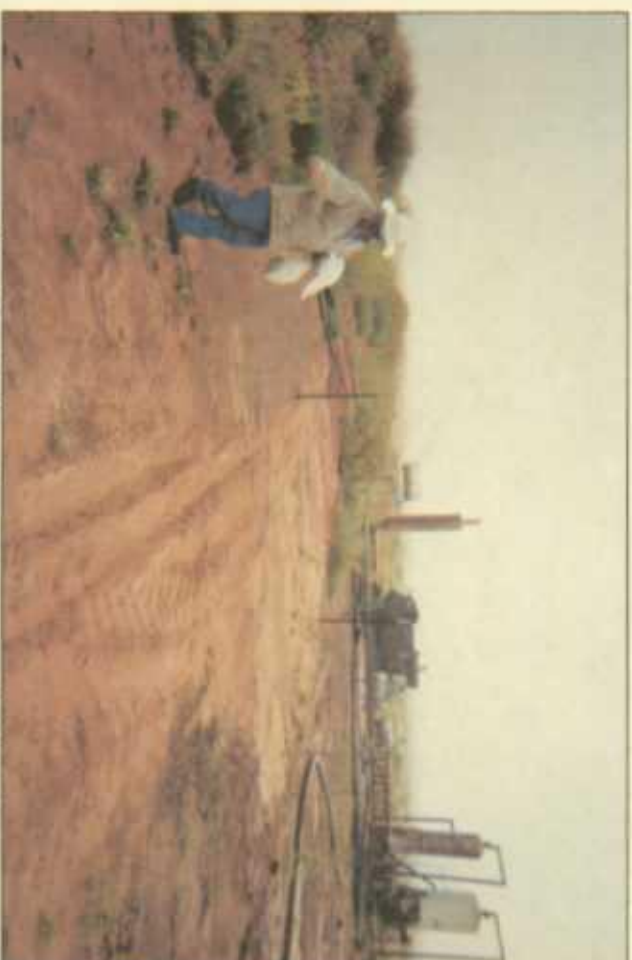
seeding disturbed surface 9/24/2004

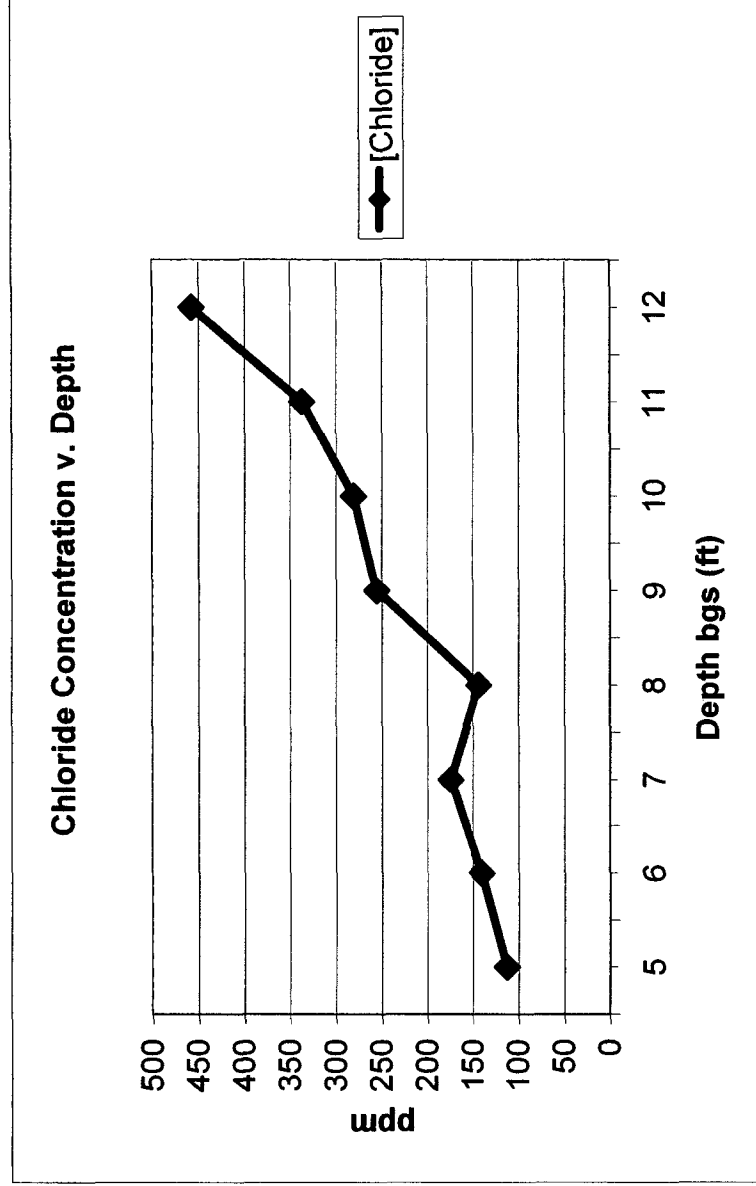
Vertical Delineation at Source

Depth bgs (ft)	[Cl ⁻] ppm
5	113
6	141
7	175
8	144
9	256
10	281
11	337
12	458

Groundwater = 174 ft
