FINAL REPORT

**RICE OPERATING COMPANY
JUNCTION BOX FINAL REPORT**

SWD SYSTEM	JUNCTION	UNIT	SECTION	TOWNSHIP	RANGE	COUNTY	BOX DIMENSIONS - FEET		
EME	O-24-1	O	24	20S	36E	Lea	Length	Width	Depth
							eliminated--no box

EME jct. O-24-1

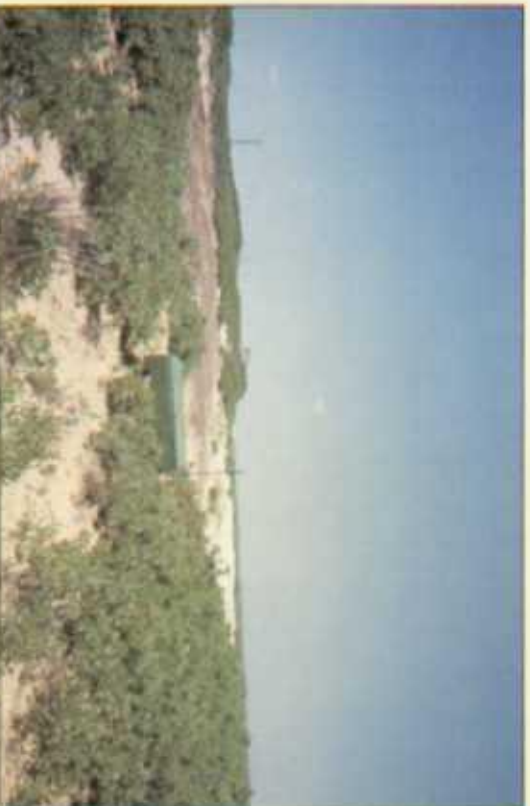
5/7/2004

Undisturbed junction box

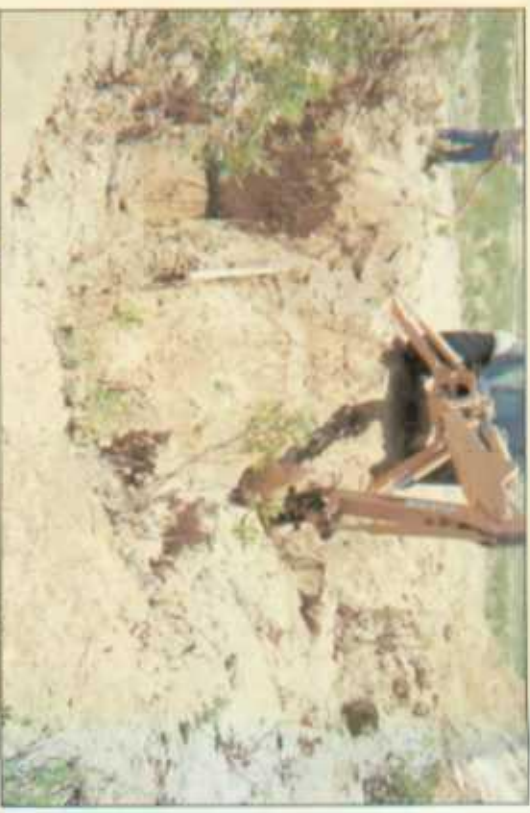
5/19/2004

backhoe delineation

General Description of Remedial Action: Delineation and excavation were performed at this junction box site with a backhoe as chloride field tests and PID field screenings were conducted at regular intervals. Vertical delineation at the box yielded an overall trend of chloride decline and low concentrations. A spike was observed at around 9 ft indicating a mass of historical chloride that has been flushed through the loose sand by recent rains (see graph). The graph indicates non-saturated vadose conditions that are not threatening to groundwater. All PID readings were 0.0 ppm and laboratory results confirmed TPH concentrations well below NMOCD guidelines. Soils from the 10 x 10 x 12-ft deep excavation were blended before they were backfilled into the hole. The surface has been contoured and will be seeded with a blend of native vegetation. This junction has been eliminated with a new pipeline re-plumbed straight through.

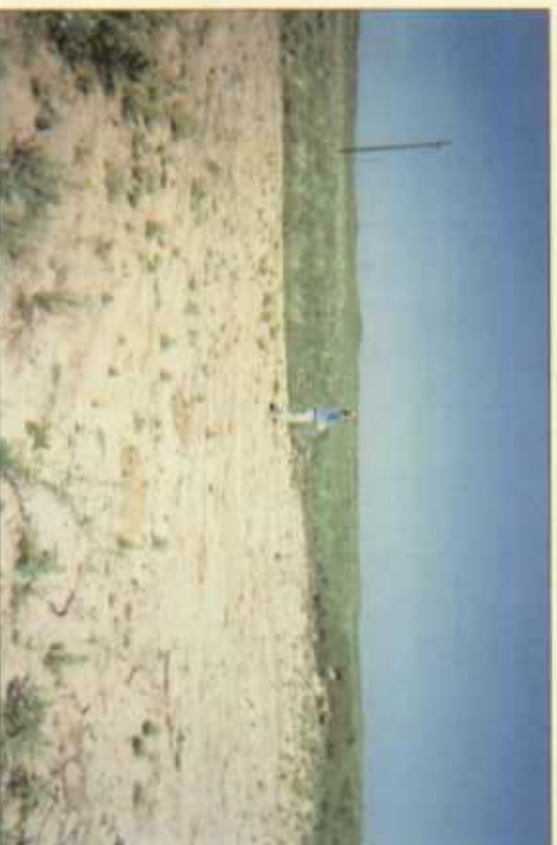
8/4/2004

seeding disturbed surface

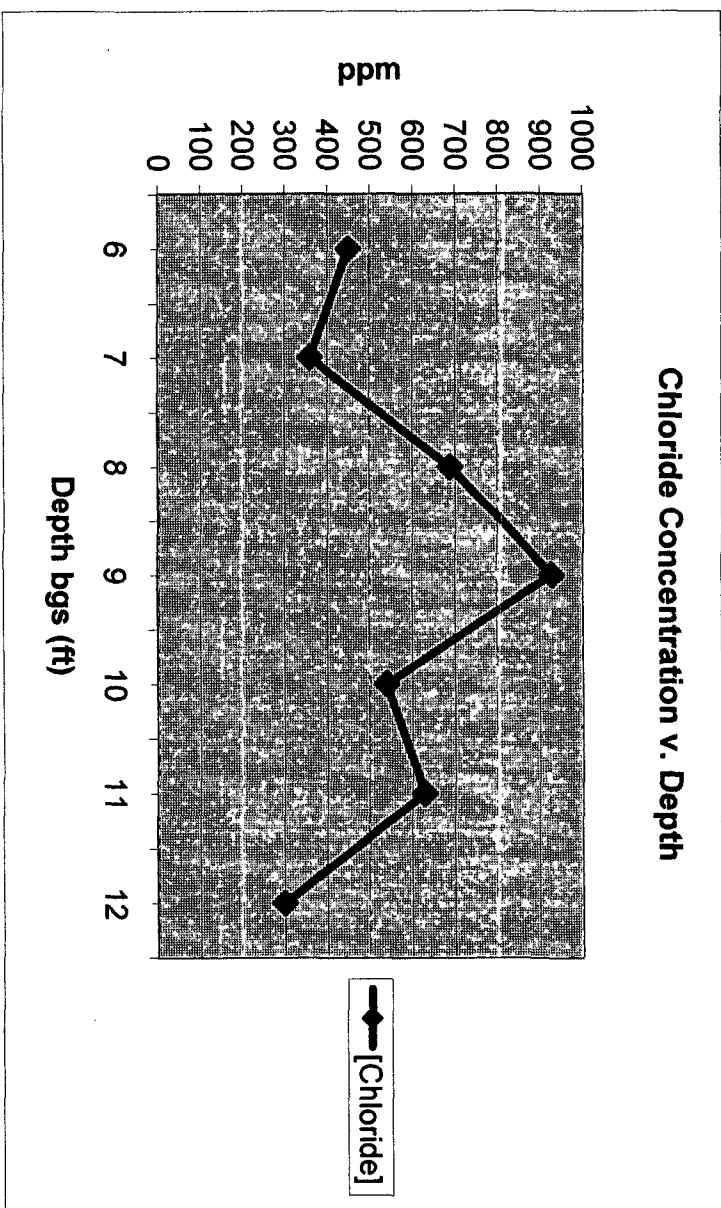
Vertical Delineation at Source

Depth bgs (ft)	Cl ⁻ (ppm)
6	449
7	359
8	689
9	929
10	539
11	629
12	299

Groundwater = 36-117 ft

LOCATION	DEPTH (ft)	ppm
Vertical	6	449
at source	7	359
	8	689
	9	929
	10	539
	11	629
	12	299
5 ft West	6	149
	8	179
	10	179
	12	149
5 ft East	6	119
	8	209
	10	179
	12	89
