EME JCH. E-26

**RICE OPERATING COMPANY
JUNCTION BOX FINAL REPORT**

SWD SYSTEM	JUNCTION	UNIT	SECTION	TOWNSHIP	RANGE	COUNTY	BOX DIMENSIONS - FEET		
EME	E-26	E	26	19S	36E	Lea	Length	Width	Depth
							no box--eliminated

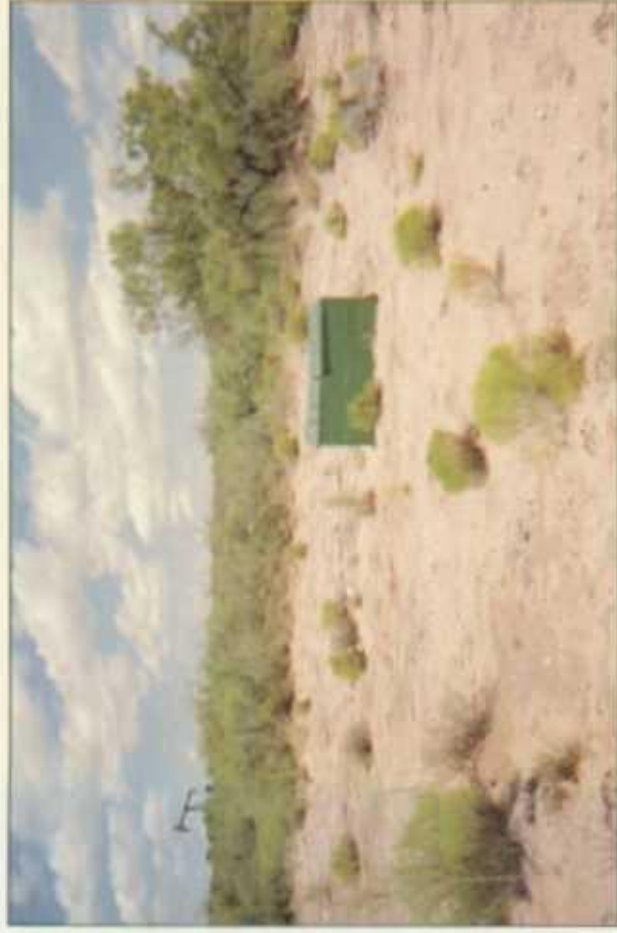
undisturbed junction box

8/20/2004

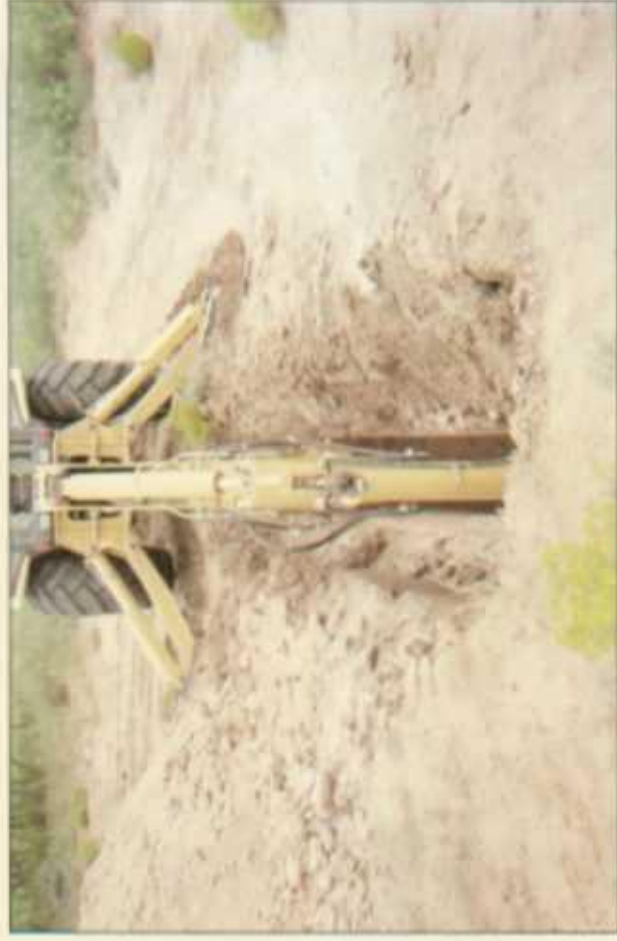
vertical delineation & excavation at junction

9/1/2004

General Description of Remedial Action: This junction box was located on a PVC pipeline that has been isolated. The junction was removed and the lines were capped. When the lumber was removed, the box site was delineated using a backhoe while chloride field tests and PID screenings were conducted every foot. All PID readings were 0.1 ppm and chloride concentrations exhibited a significant trend of decline vertically (see graph) and laterally throughout the 30 x 30 x 12-ft-deep excavation. Lab results confirmed TPH concentrations well below NMOCD guidelines. The excavated soils were blended on site and then backfilled into the excavation and contoured to the surrounding surface. The disturbed surface was seeded with a blend of native vegetation on 9/21/2004 and is expected to return to productive capacity at a normal rate. Since the junction has been eliminated, a new box is not required at this site.

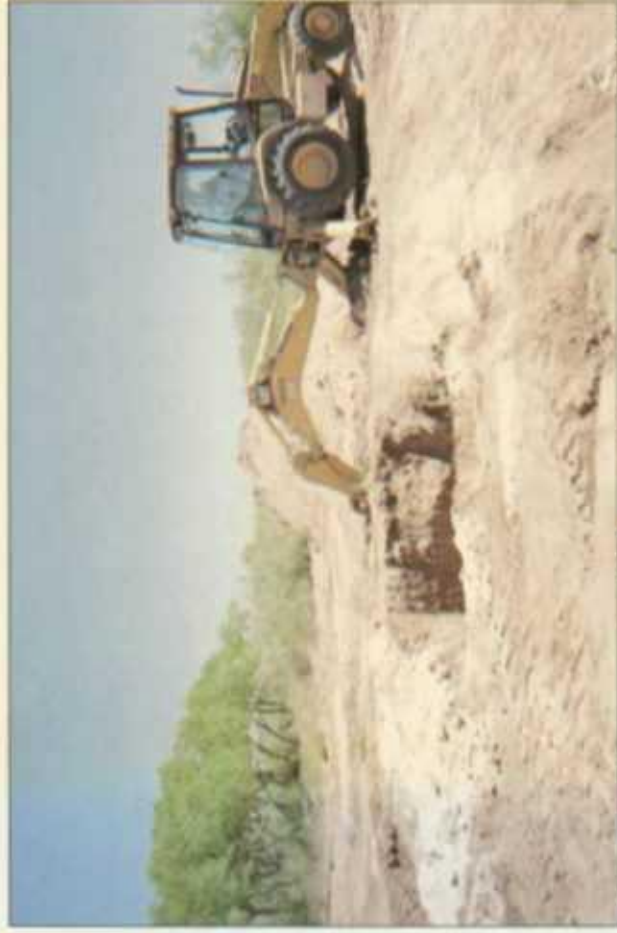
delineation & excavation 15 ft east of junction

9/2/2004

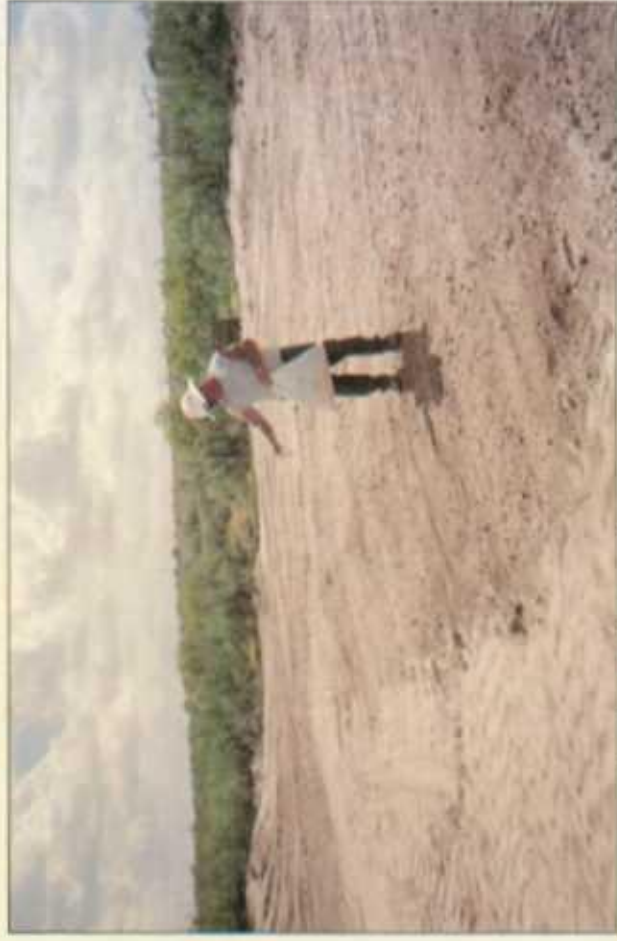
seeding backfilled surface

9/21/2004

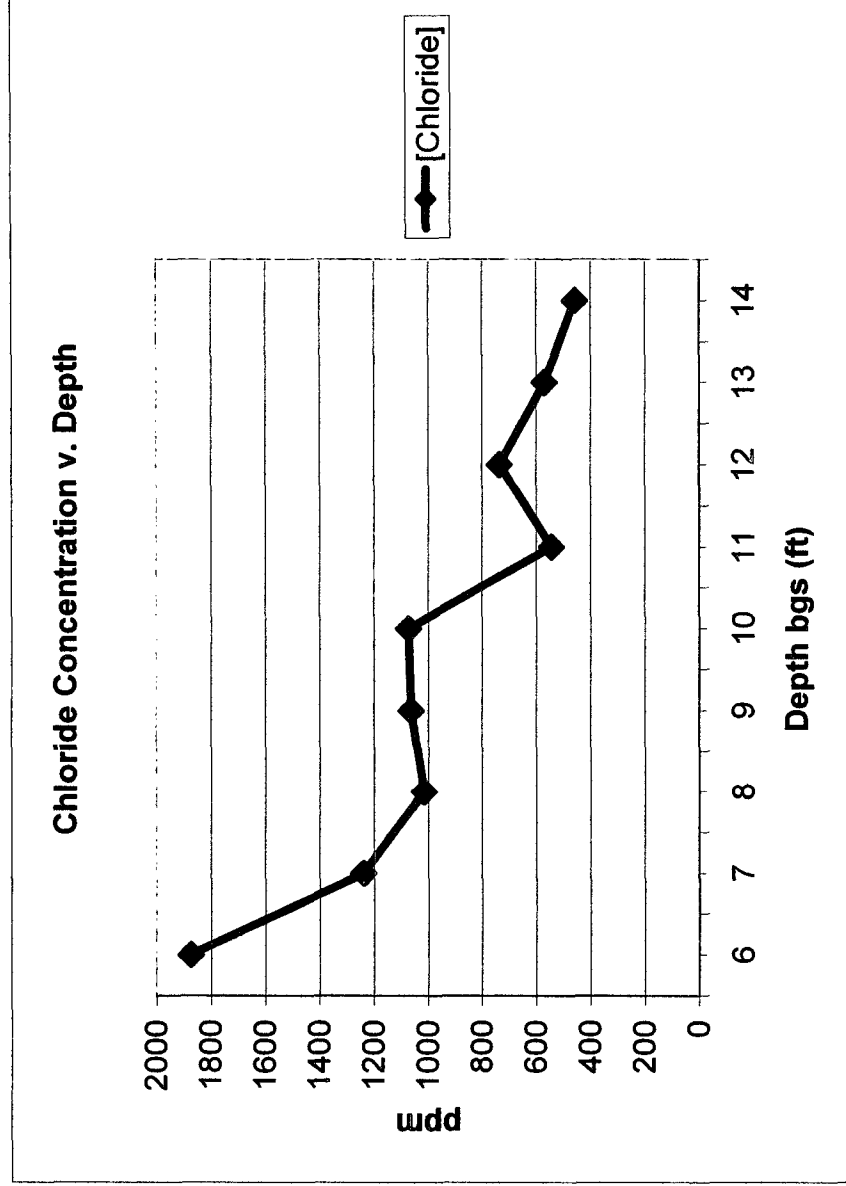
Vertical Delineation at Source

Depth bgs (ft)	[Cl ⁻] ppm
6	1875
7	1239
8	1016
9	1064
10	1074
11	543
12	735
13	571
14	458

Groundwater = 59 ft

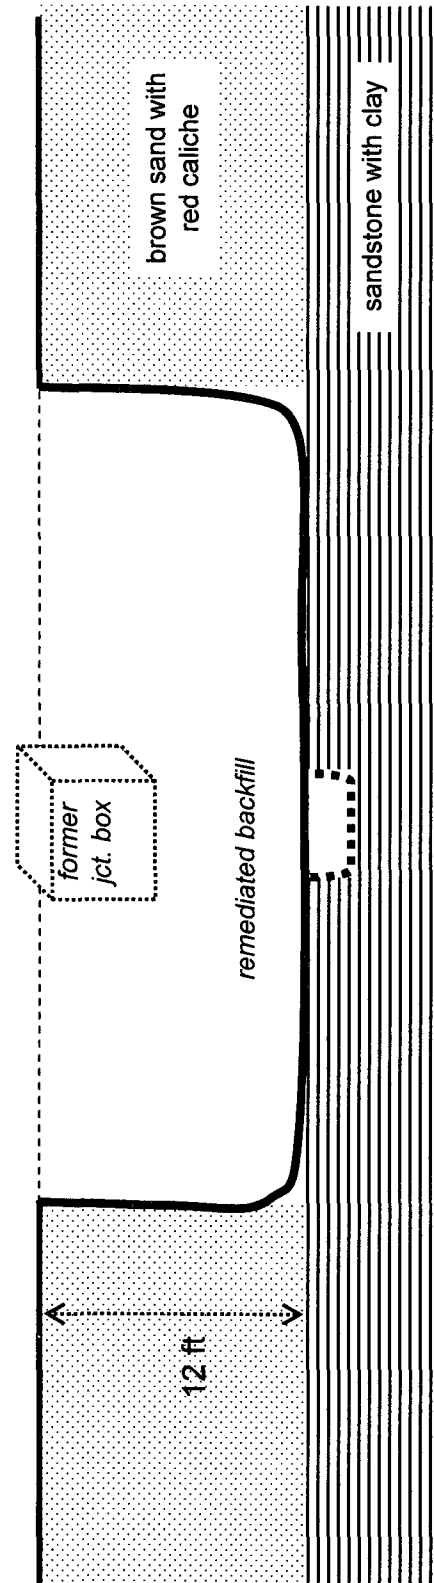
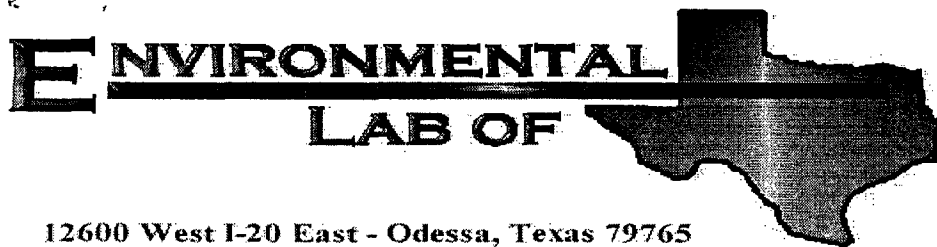
Excavation Cross-Section

30 x 30 x 12 ft

30 ft

ft BGS
