EME Jct J-1

1R0427-170

**RICE OPERATING COMPANY
JUNCTION BOX DISCLOSURE* REPORT**

unit 'J', Sec. 1, T20S, R36E

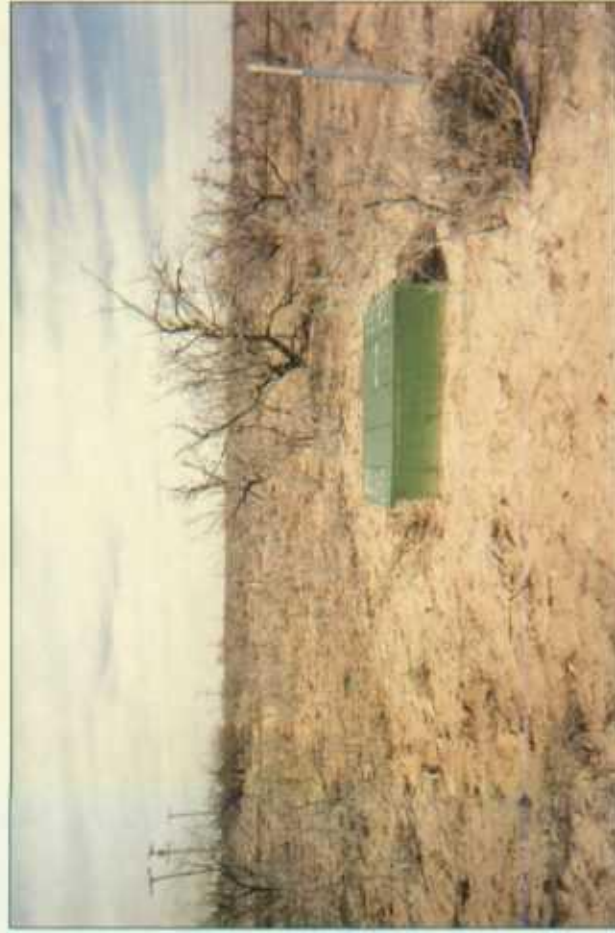
12/30/2003

undisturbed junction box

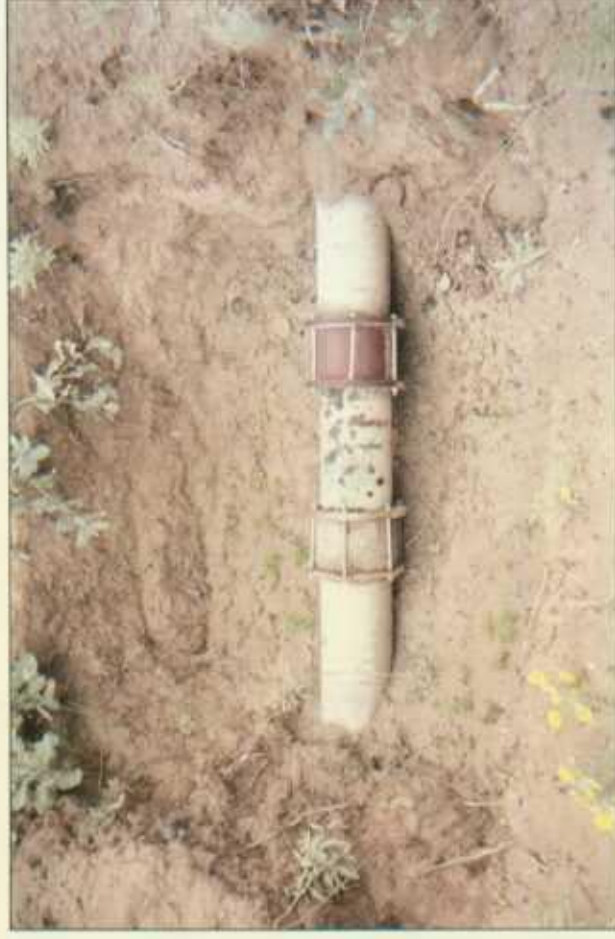
7/28/2004

box lumber removed

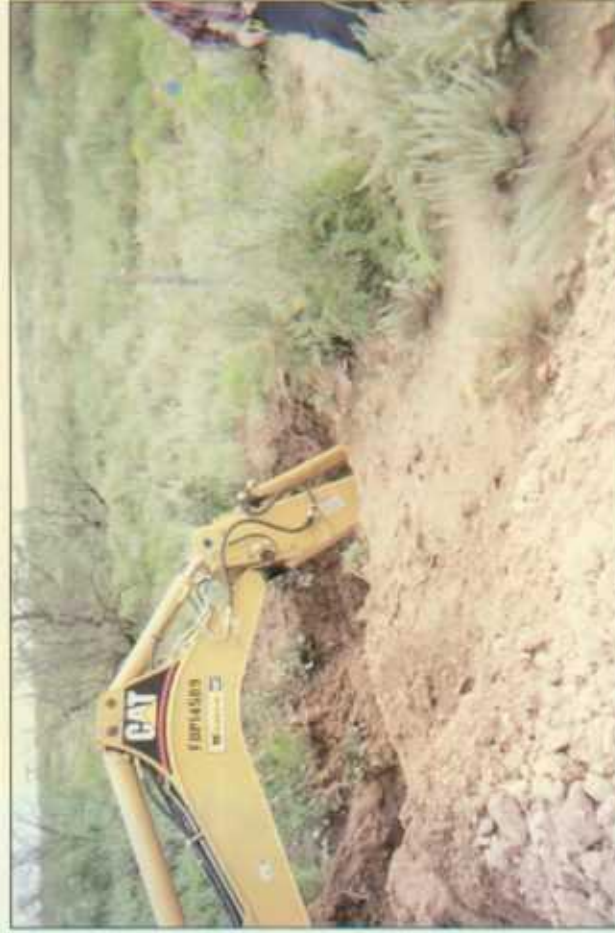
8/16/2004

beginning excavation

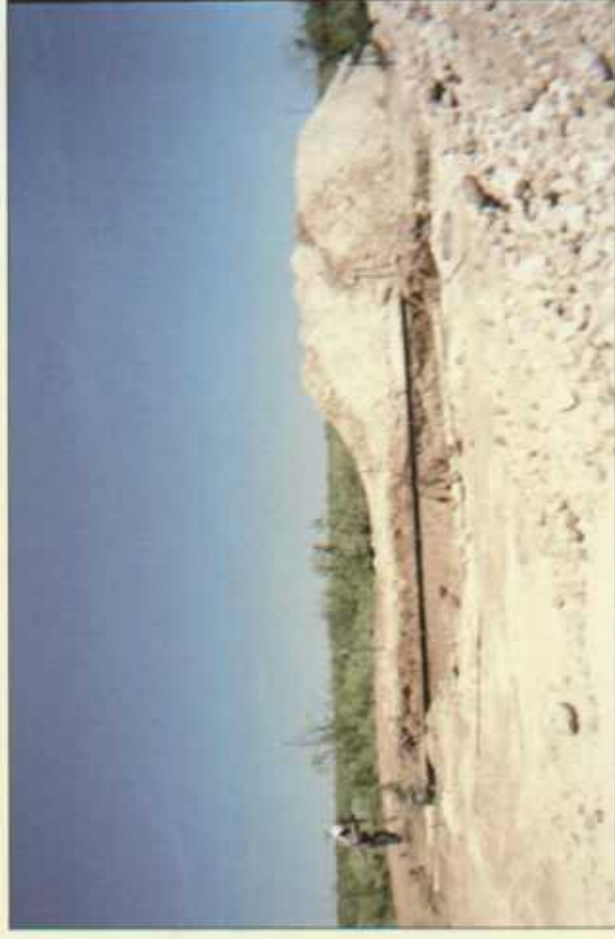
8/23/2004

final excavation

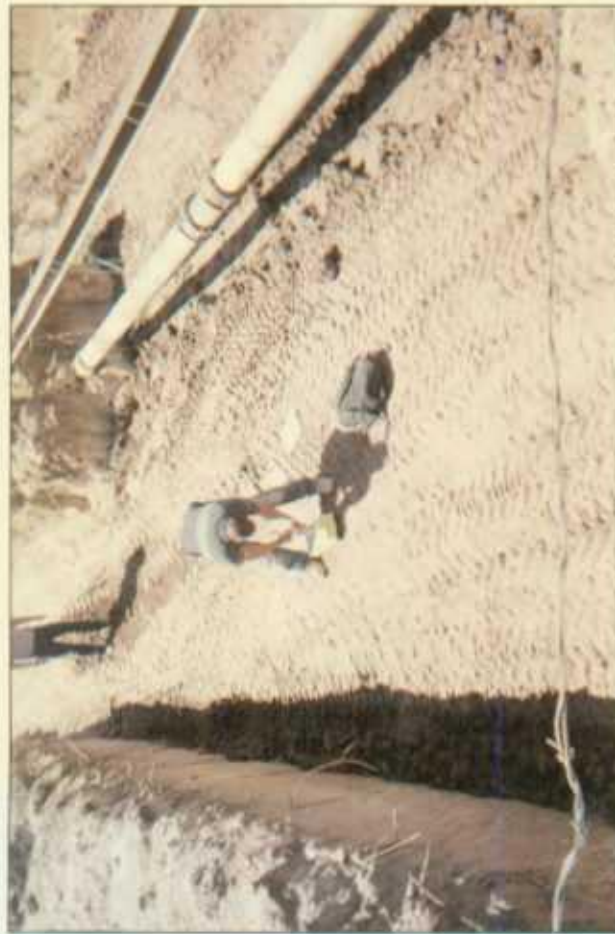
9/2/2004

testing clay

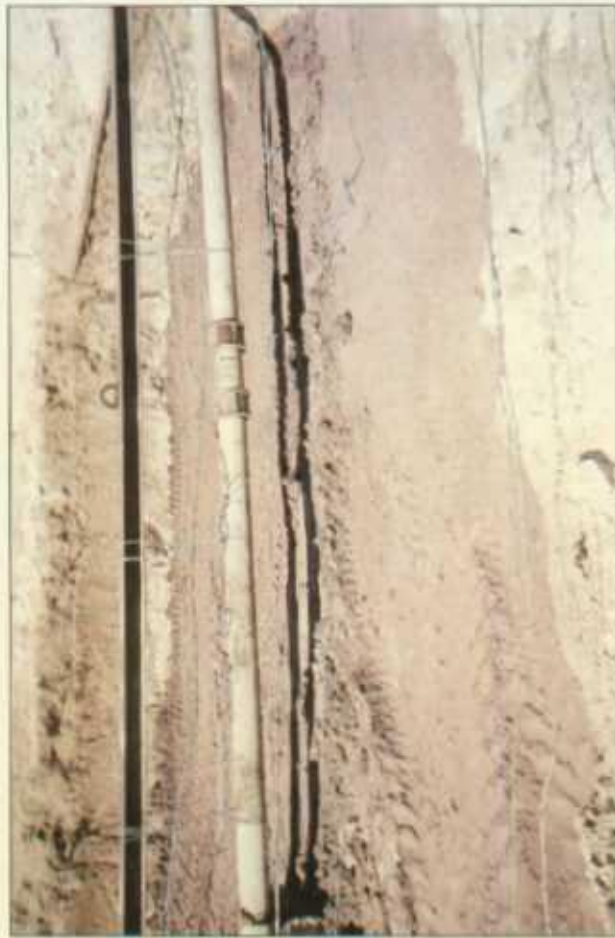
9/2/2004

compacted clay at 6 ft BGS

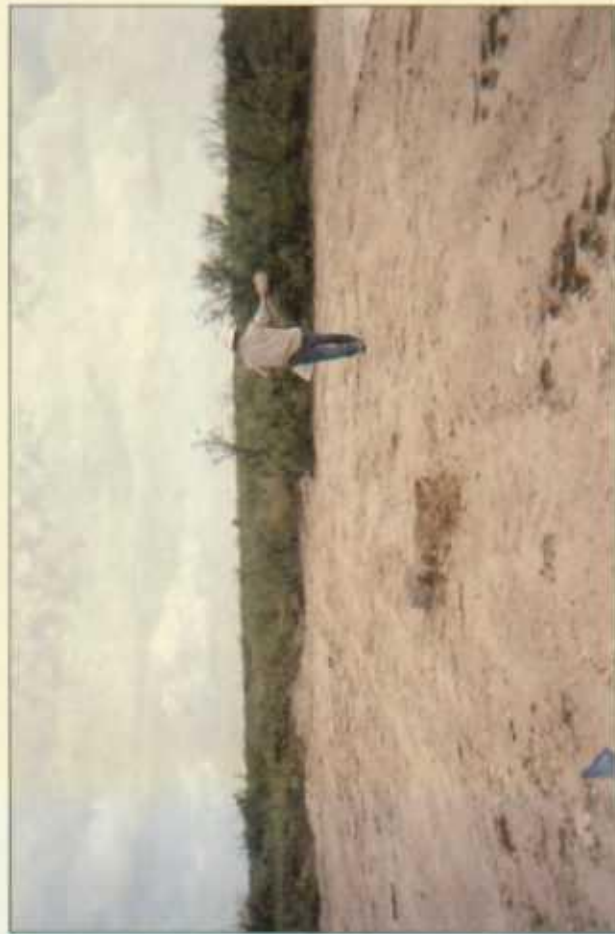
10/4/2004

seeding disturbed surface; ID plate in foreground

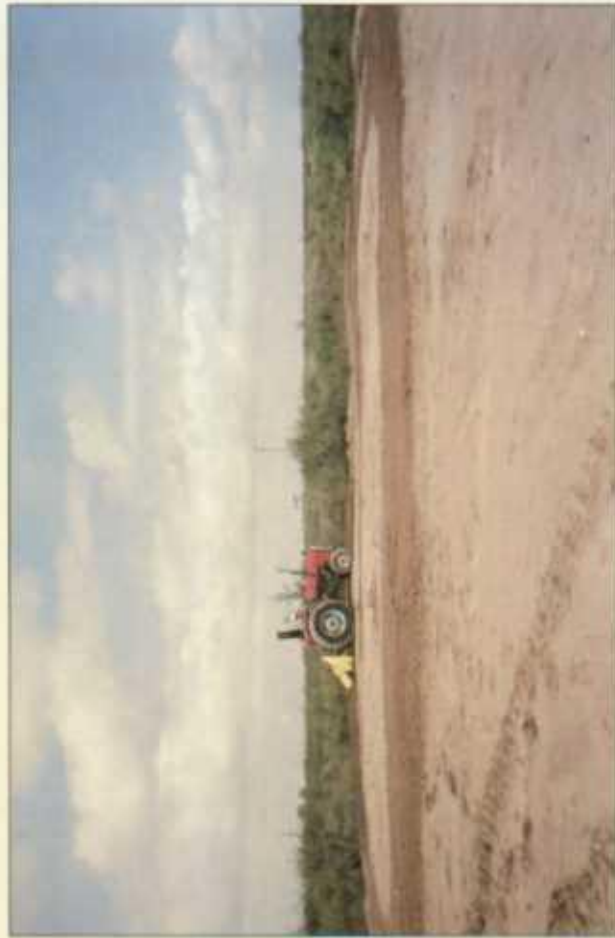
10/4/2004

tilling seed into soil

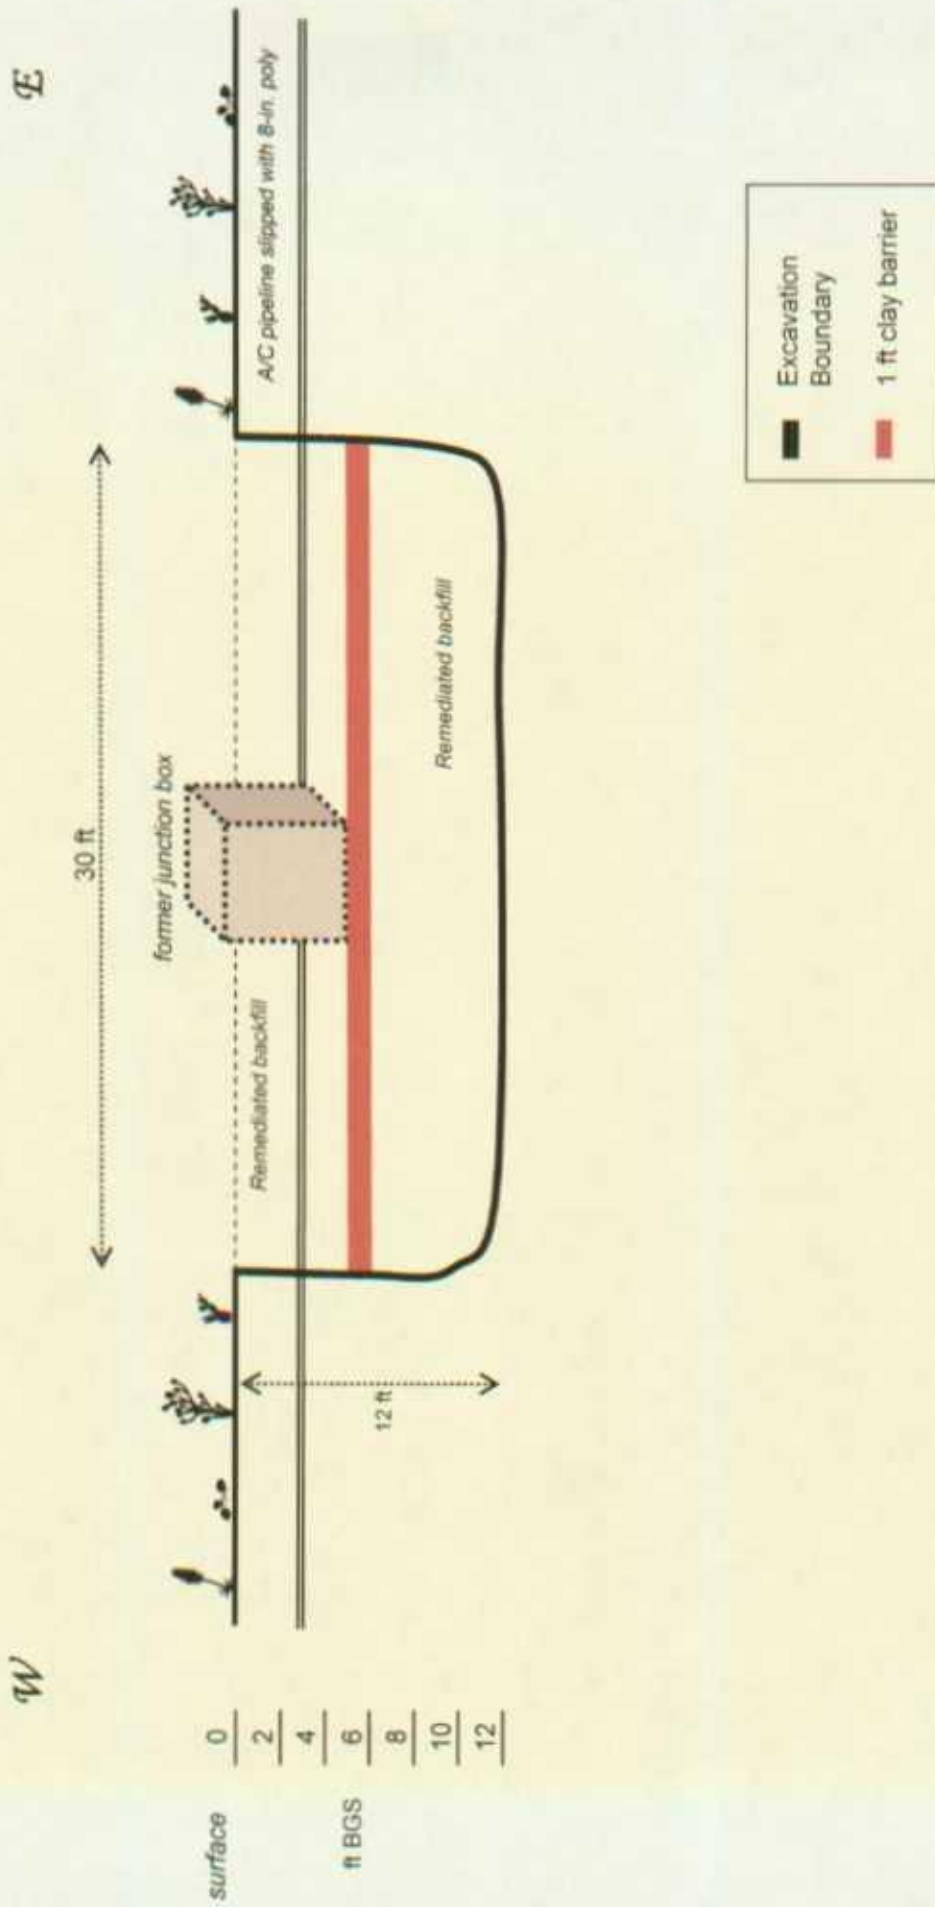
Excavation Cross-Section

30 x 30 x 12 ft

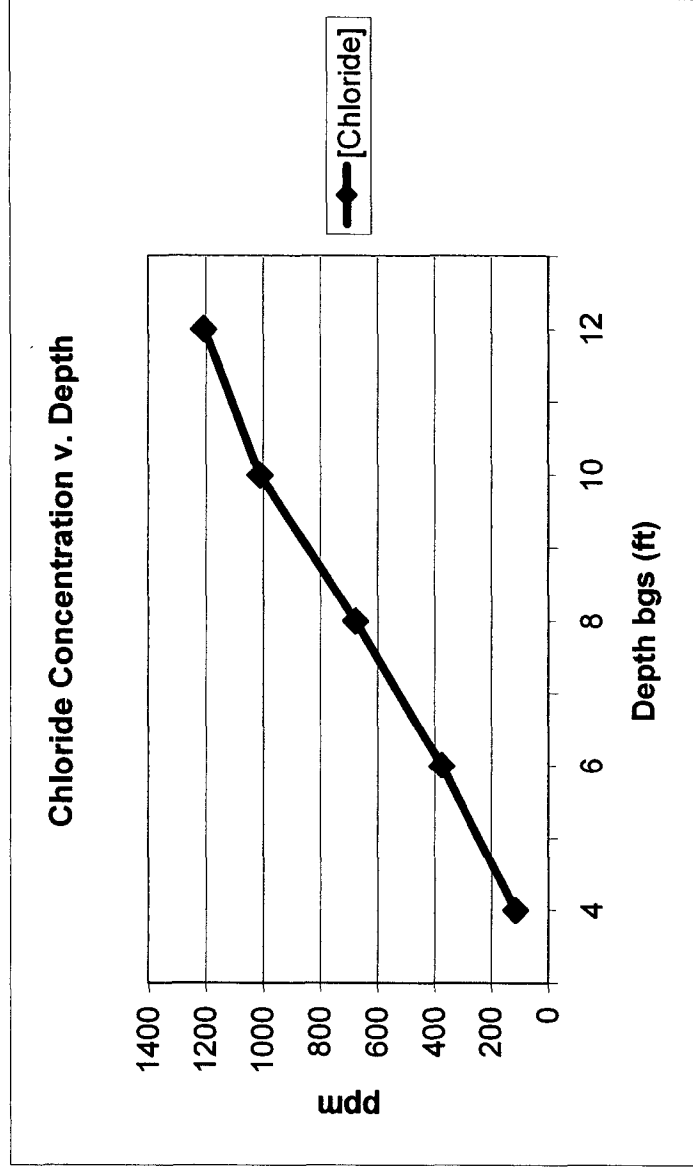
15 ft North of junction

Depth bgs (ft)	[Cl ⁻] ppm
4	115
6	377
8	678
10	1012
12	1208

Groundwater = 40 ft

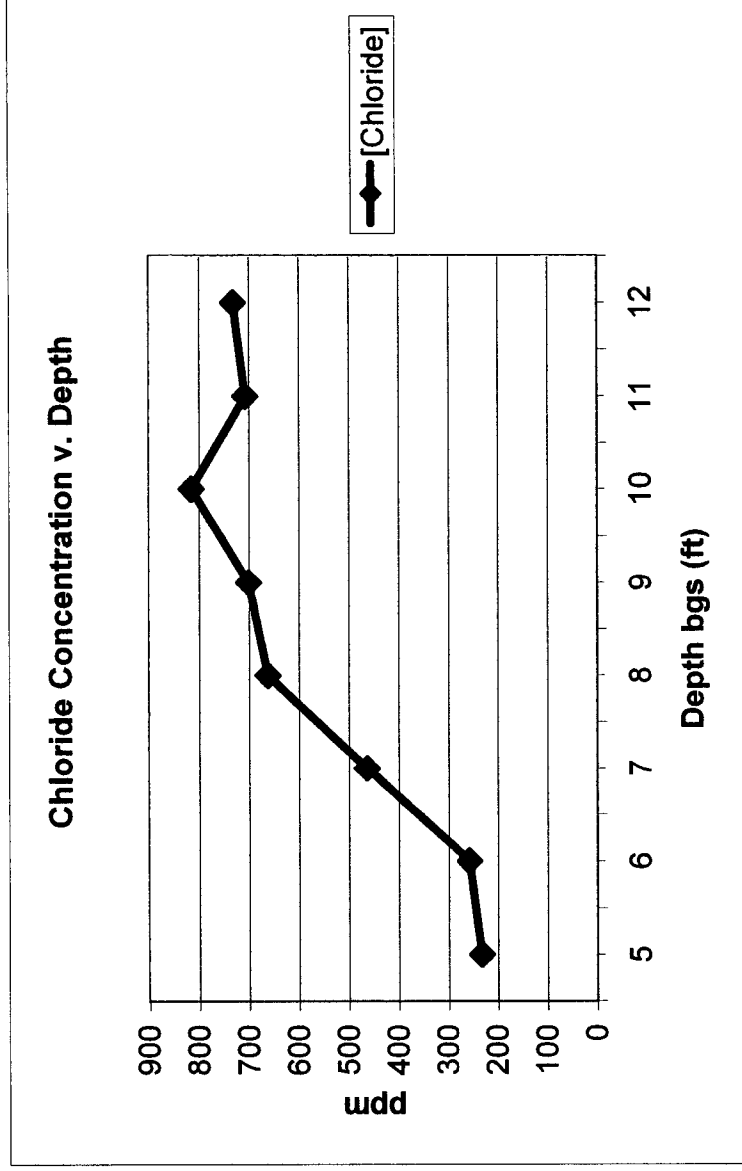
Vertical Delineation at Source

Depth bgs (ft)	[Cl ⁻] ppm
5	233
6	258
7	464
8	663
9	701
10	816
11	708
12	732

Groundwater = 40 ft
