DISCLOSURE REPORT

**RICE OPERATING COMPANY
JUNCTION BOX DISCLOSURE* REPORT**

EME jct. I-13

unit 'T', sec. 13, T20S, R36E

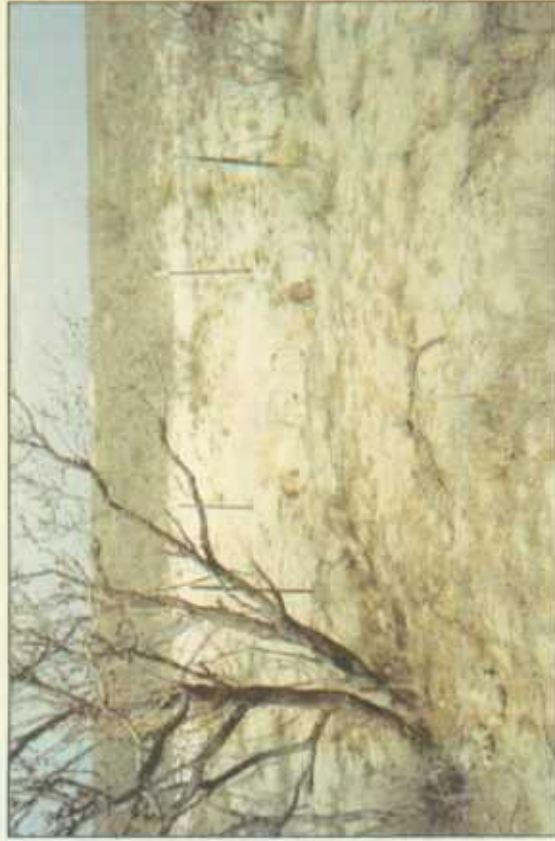
fenced location with box lumber removed (looking north) 1/5/2004

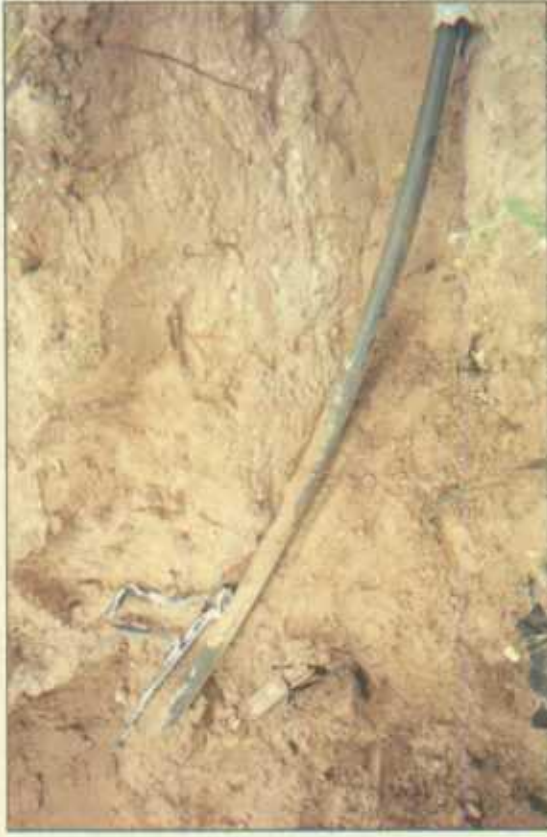
former box site slip-lined with poly pipeline

General Description of Remedial Action: This junction was located between a lease road and an active production battery. The junction was eliminated and the old asbestos-cement pipeline was slipped with a new 4-in. poly pipeline. The site was delineated using a backhoe while PID readings and chloride field tests were conducted at regular intervals. All PID readings were non-detect throughout the 30 x 30 x 12-ft-deep excavation and lab results confirmed TPH concentrations well below NMOCD guidelines. Chloride concentrations generally increased with depth within the excavation (see graphs). The excavated soils were blended on site and then backfilled into the excavation up to 6 ft BGS. At 6 ft, a 1-ft-thick compacted clay barrier was installed to inhibit further downward migration of chloride. The remaining spoils were backfilled on top of the clay and the surface was contoured to the surrounding terrain. The disturbed surface was seeded with a blend of native vegetation and will be monitored for growth. An identification plate has been placed on the surface to mark the site for future considerations. NMOCD has been notified of potential groundwater impact at the location.

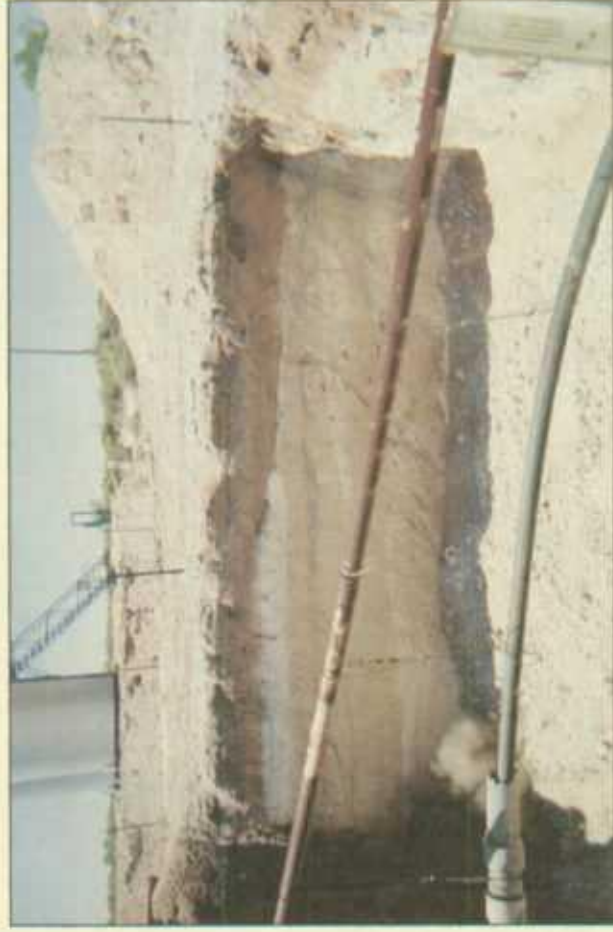
30 x 30 x 12-ft-deep excavation (looking south)

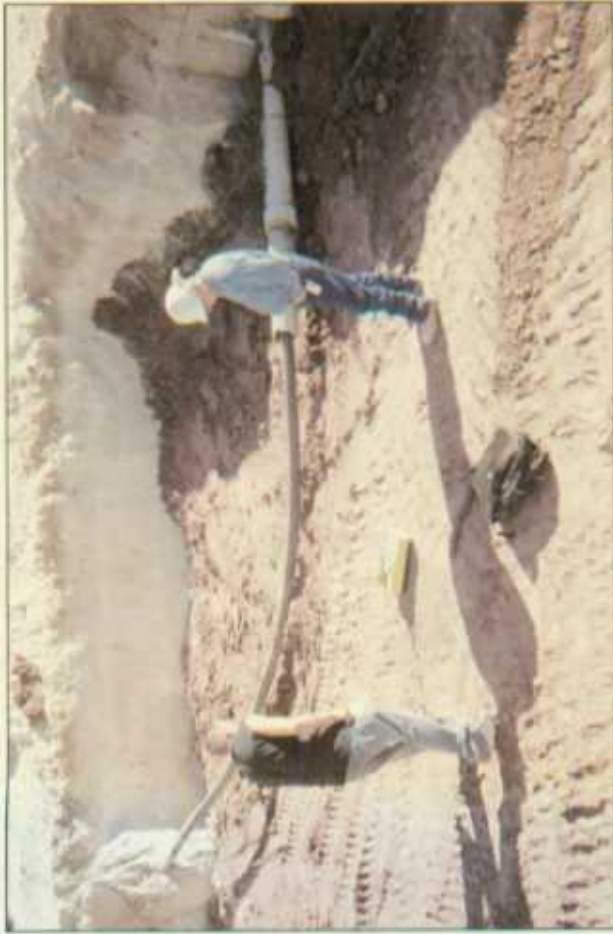
testing compacted clay

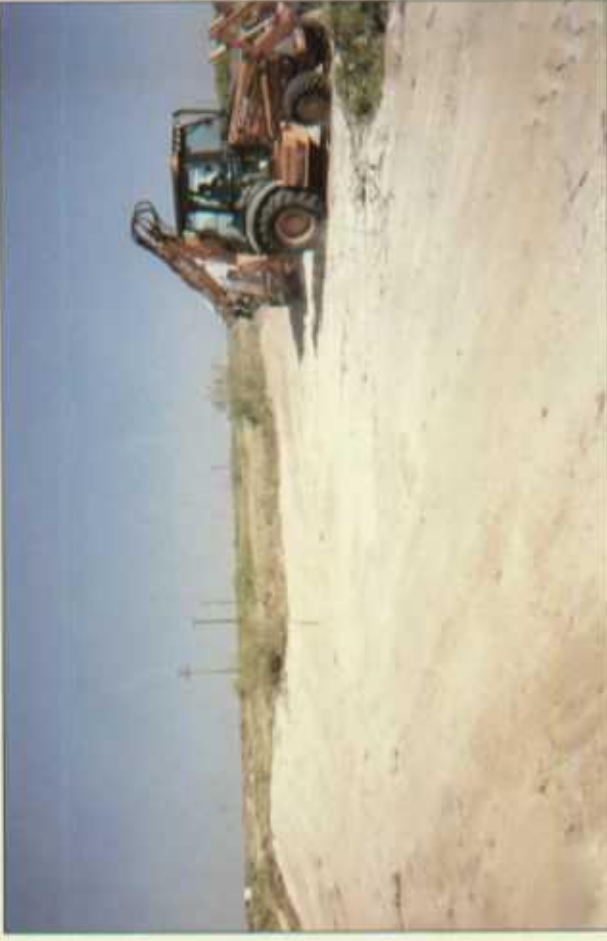
finishing backfill (looking east)

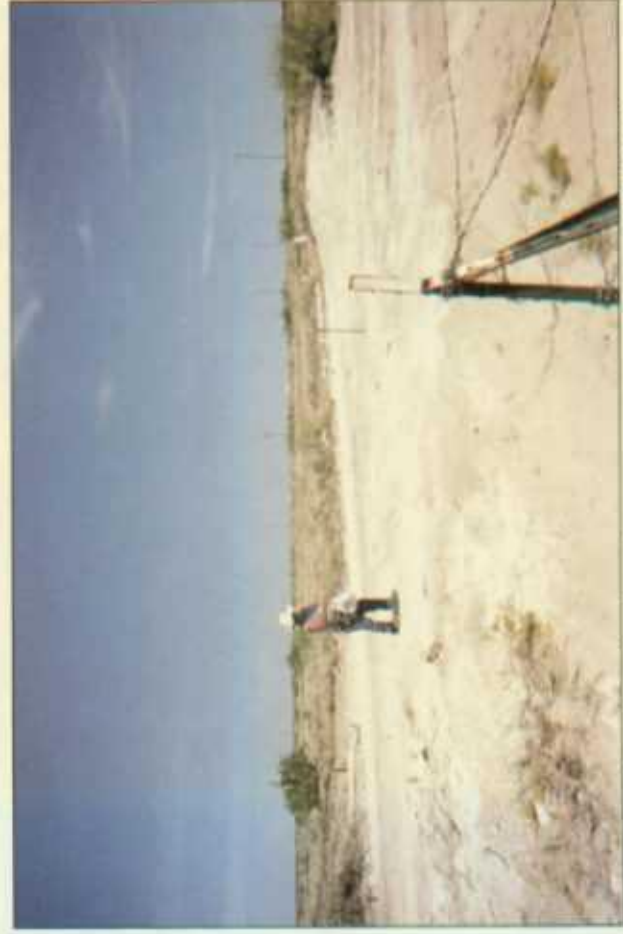
seeding disturbed surface

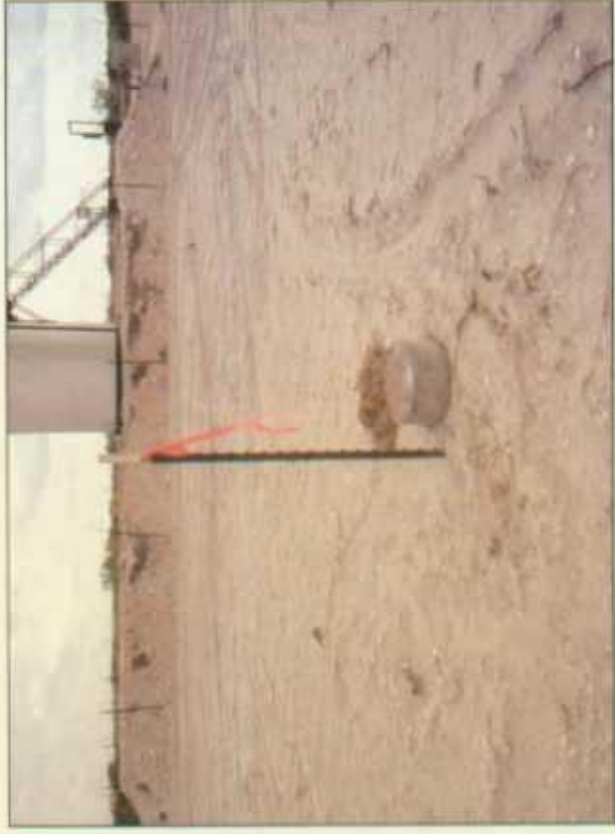
identification plate on surface

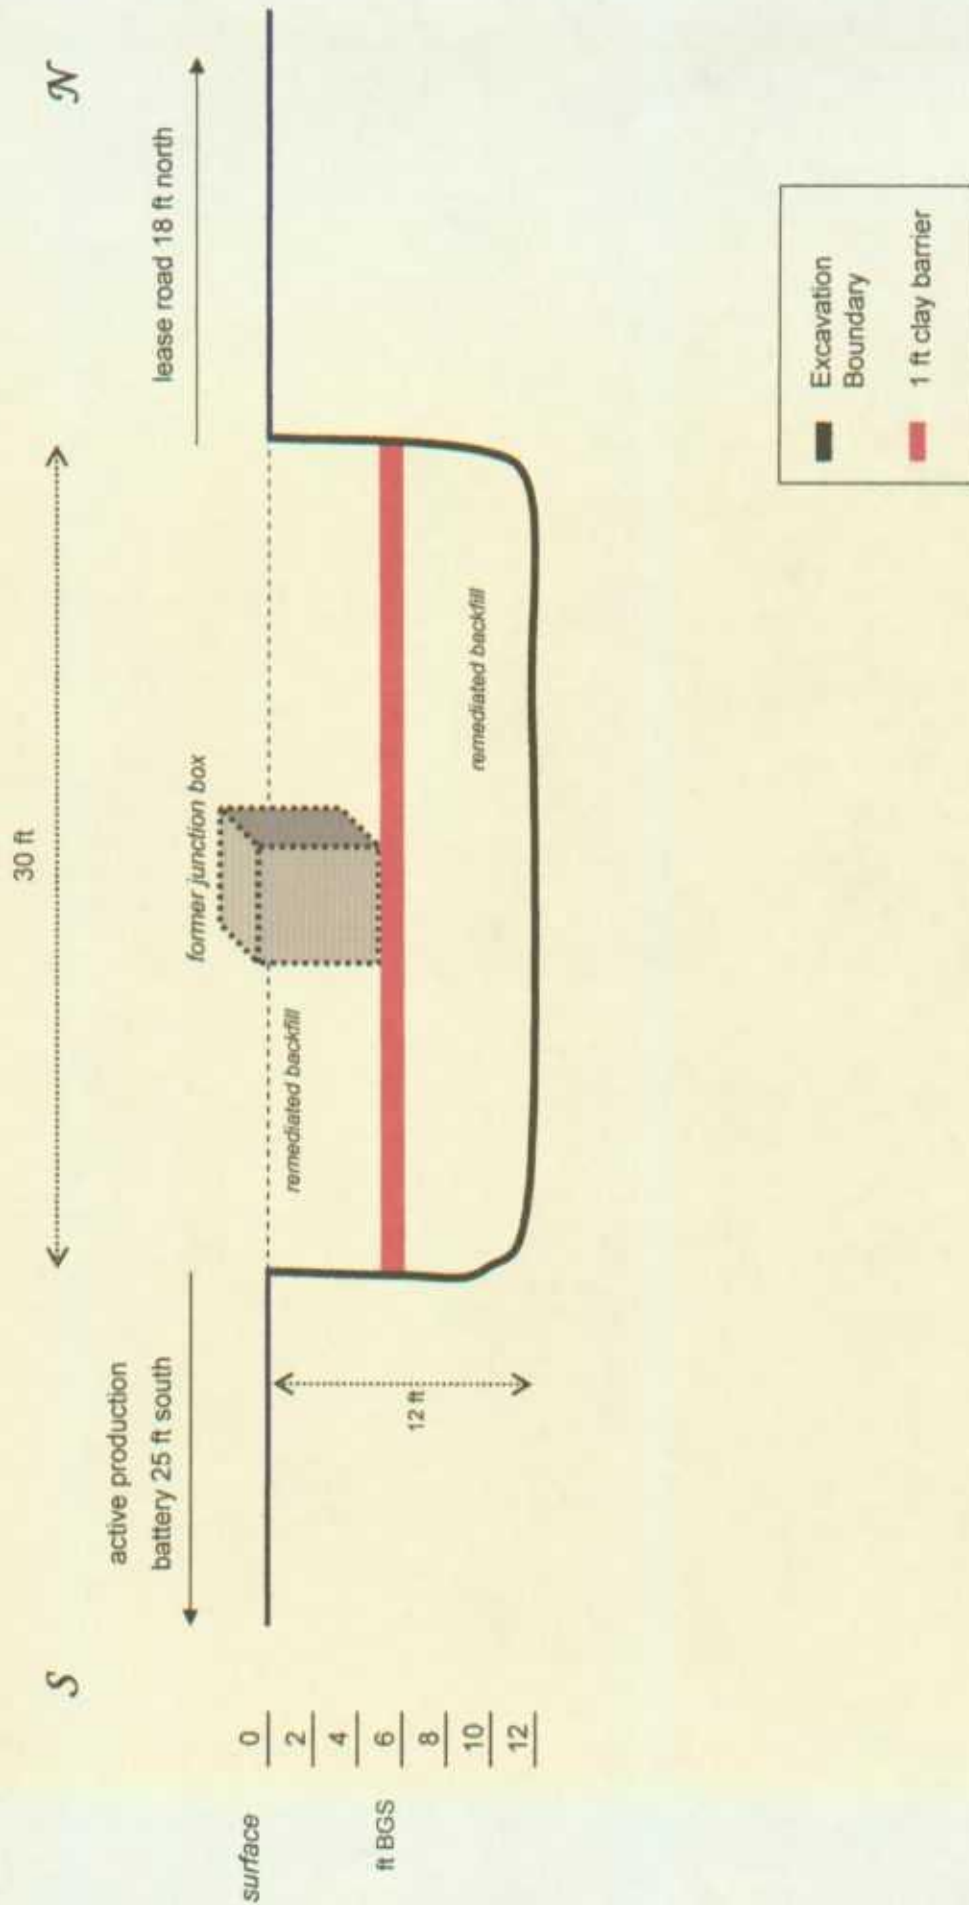
Excavation Cross-Section

30 x 30 x 12 ft

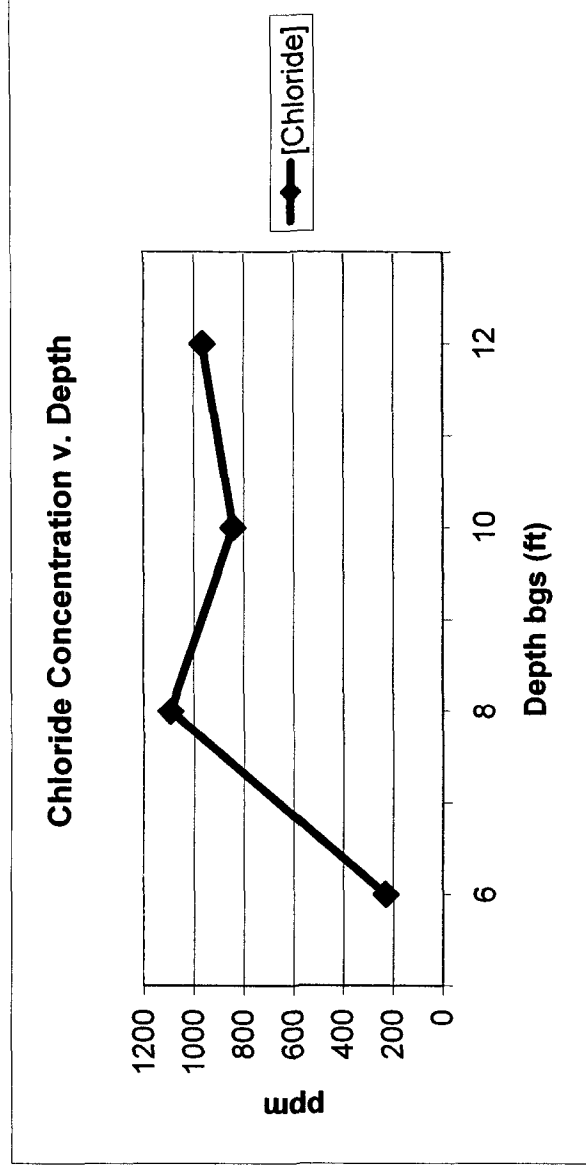
5 ft south of junction

Depth bgs (ft)	[Cl ⁻] ppm
6	231
8	1095
10	843
12	967

Groundwater = 35 ft

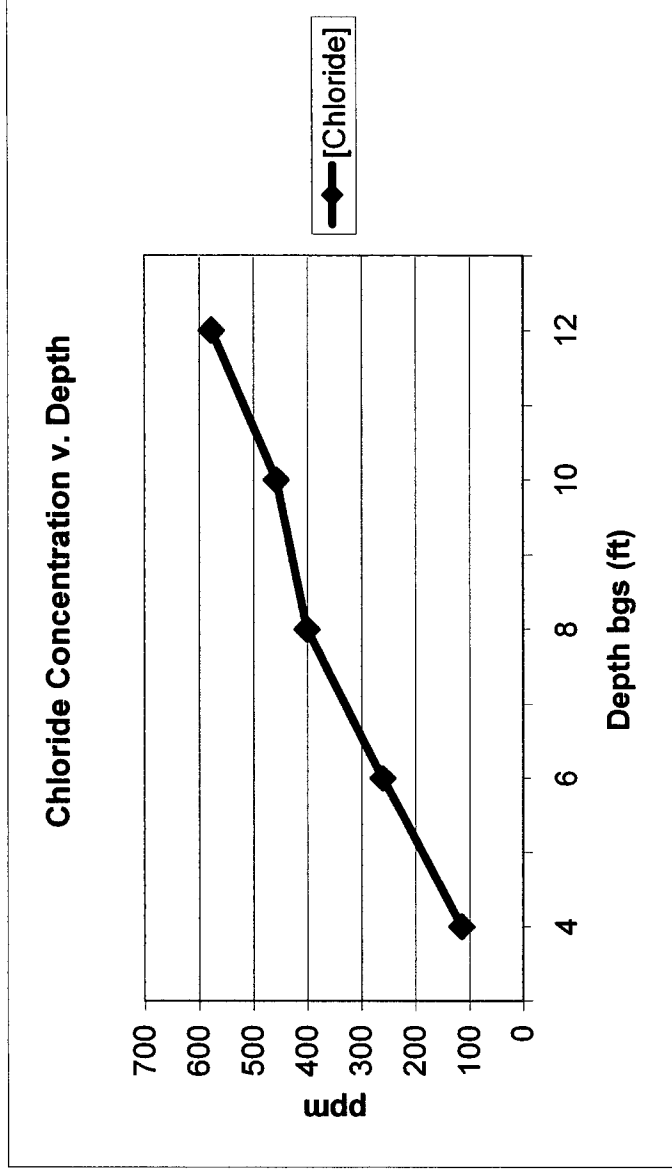
15 ft south of junction

Depth bgs (ft)	[Cl ⁻] ppm
4	115
6	261
8	401
10	458
12	578

Groundwater = 35 ft
