DISCLOSURE REPORT

**RICE OPERATING COMPANY
JUNCTION BOX DISCLOSURE* REPORT**

EME jct. B-7

unit 'B', Sec. 7, T20S, R37E

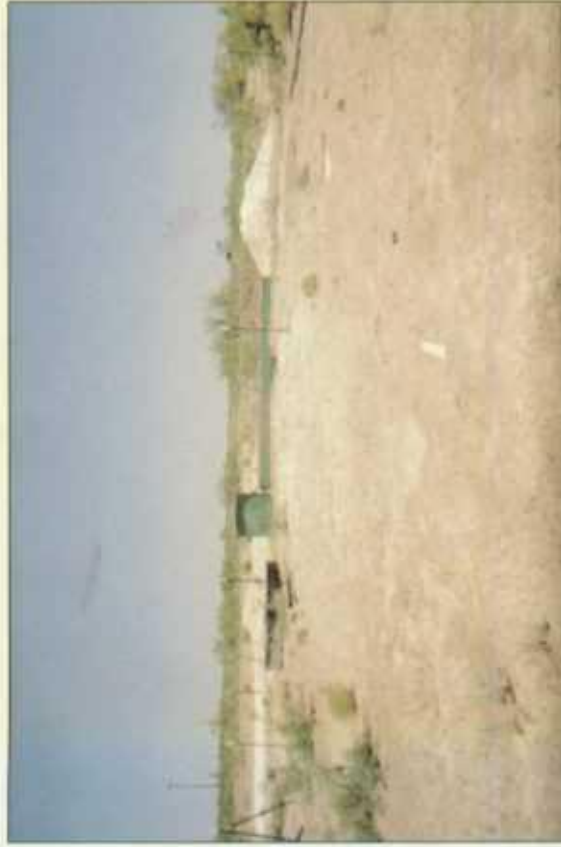
removing old junction box

7/25/2003

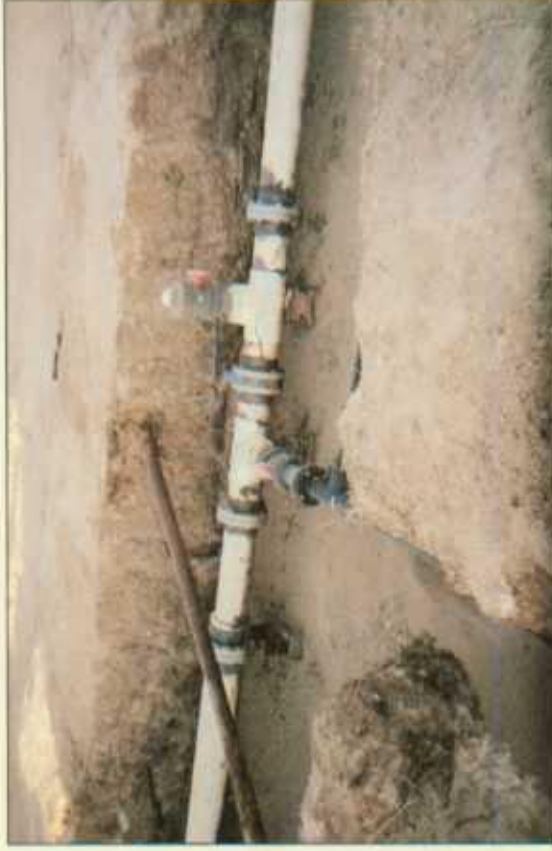
new junction plumbing

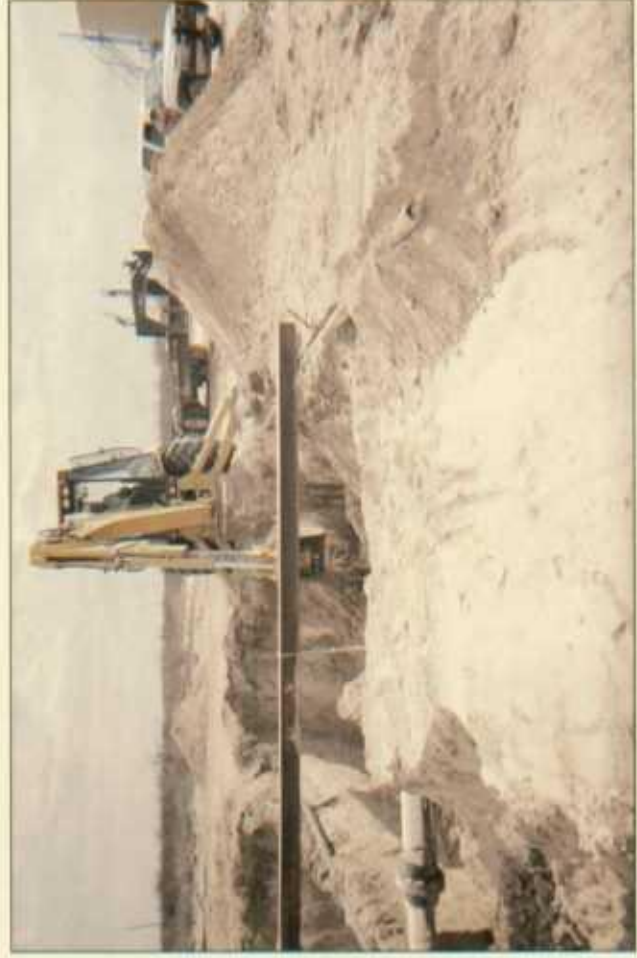
delineation and excavation at junction

March 2004

General Description of Remedial Action: This junction box was delineated

using a backhoe while PID screenings and chloride field tests were performed at regular intervals. In some areas, samples from delineation trenches were collected at a maximum depth of 14 ft BGS (see plat). Although PID readings were minimal, chloride concentrations were elevated and did not decline vertically or laterally. TPH concentrations in the bottom composite and backfill composite samples were just above NMOCD guidelines. At 6 ft, a 25 x 35 x 1-ft-deep compacted clay barrier was installed to inhibit further downward chloride migration (see diagram). On 7/15/2004, a soil bore was initiated to further investigate the depth of chloride impact. No conclusive chloride trend was observed.

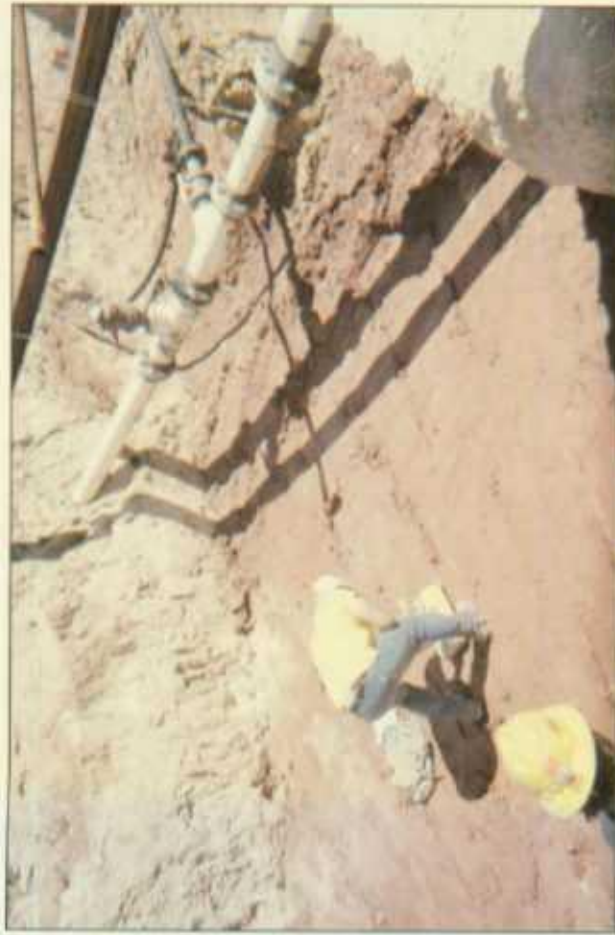
testing compacted clay at 6 ft BGS 4/21/2004

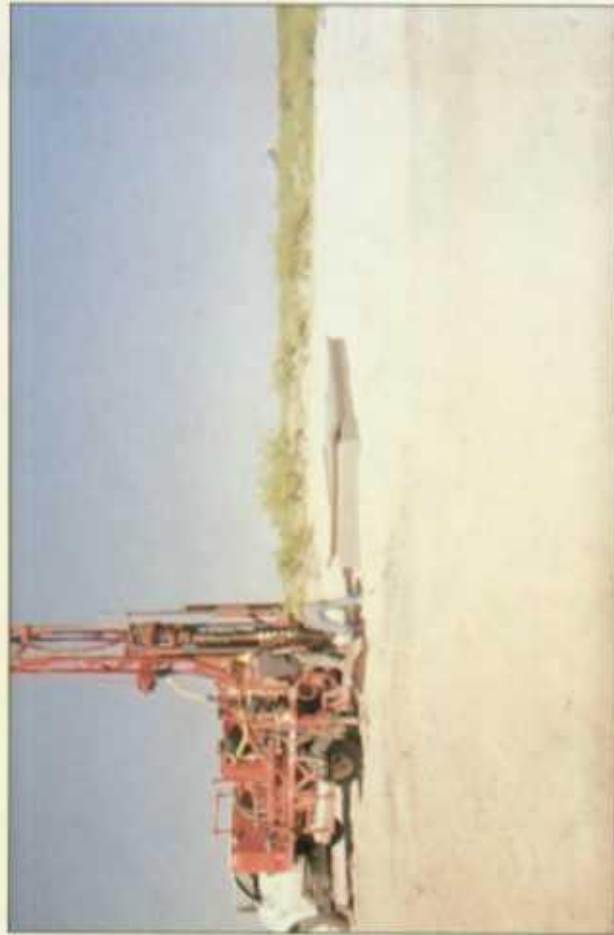
delineation soil bore 7/15/2004

The bore hole was plugged with bentonite clay (see log). NMOCD has been notified of

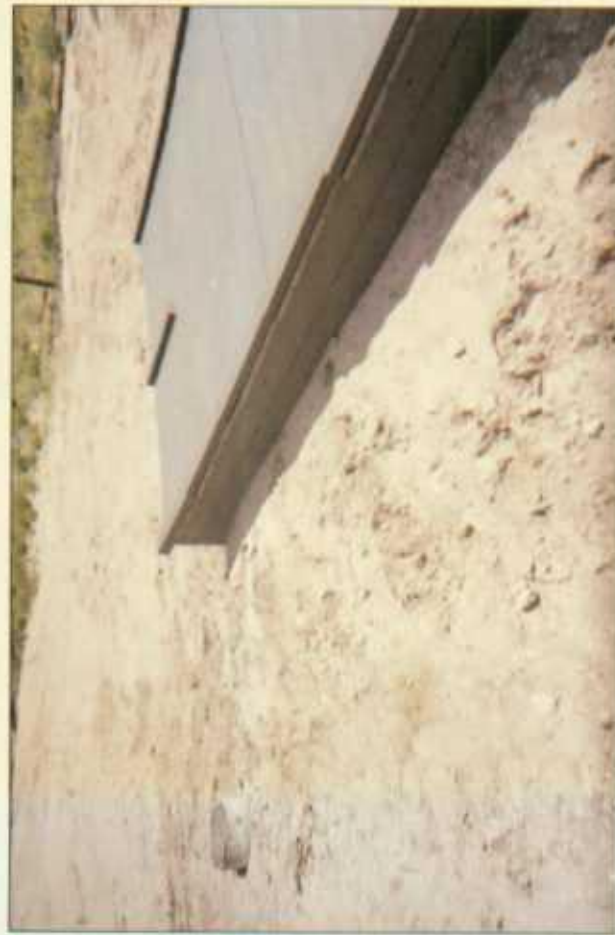
identification plate near new watertight junction box

potential groundwater impact at this site. An identification plate has been placed on the surface of this site for reference in future considerations.

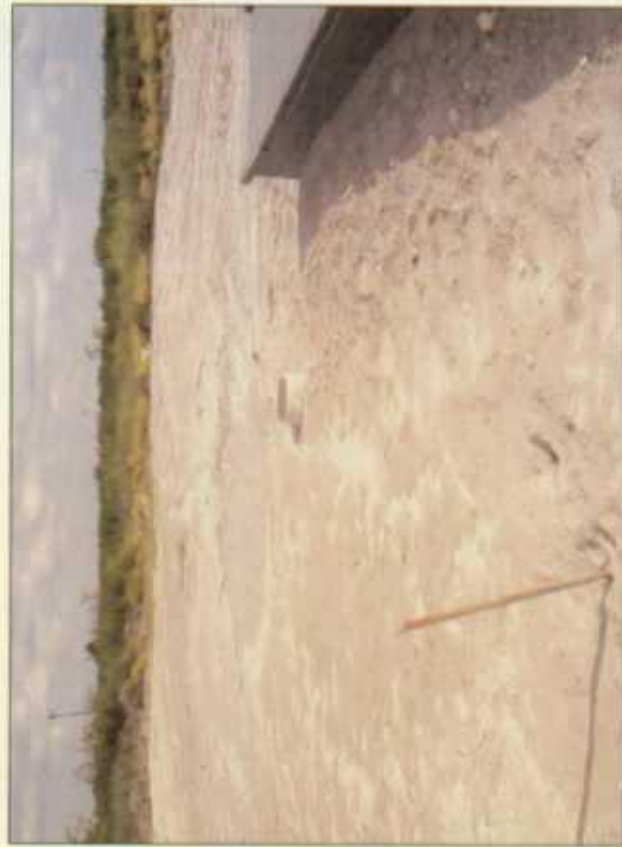
completed site

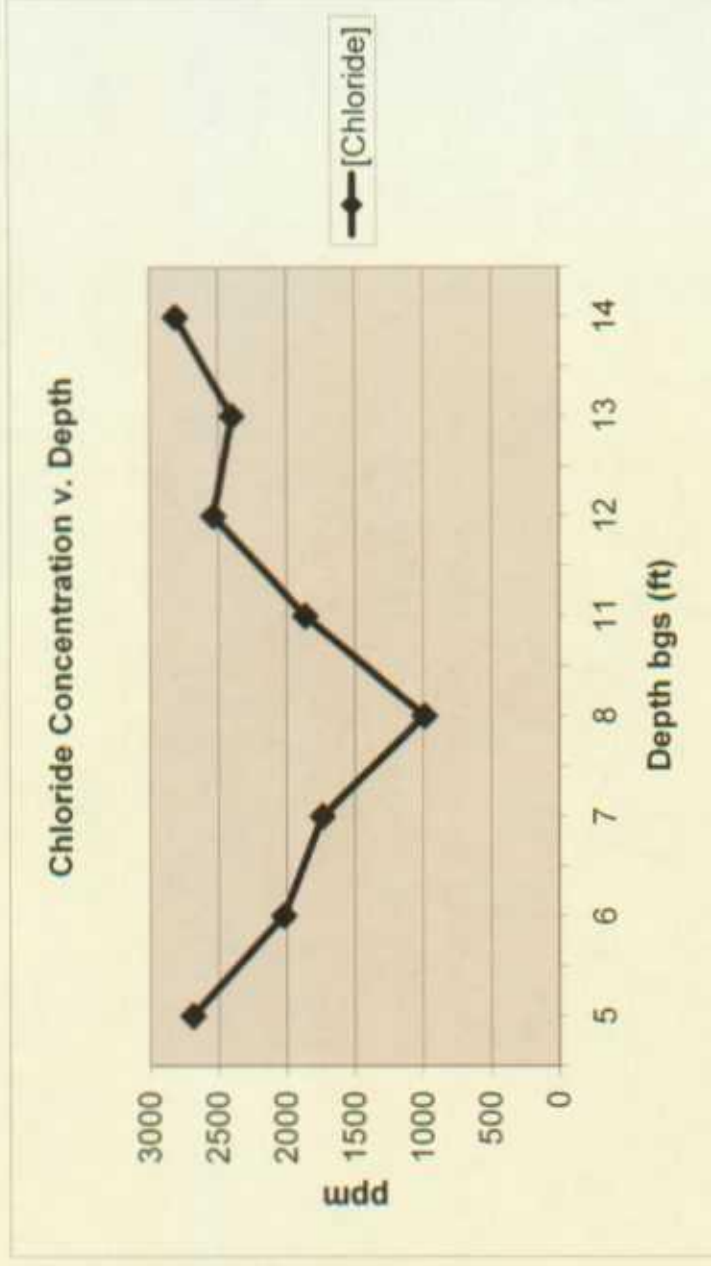
20 ft south of junction

Depth bgs (ft)	[Cl ⁻] ppm
5	2687
6	2022
7	1736
8	989
11	1865
12	2535
13	2399
14	2811

Groundwater = 34 ft

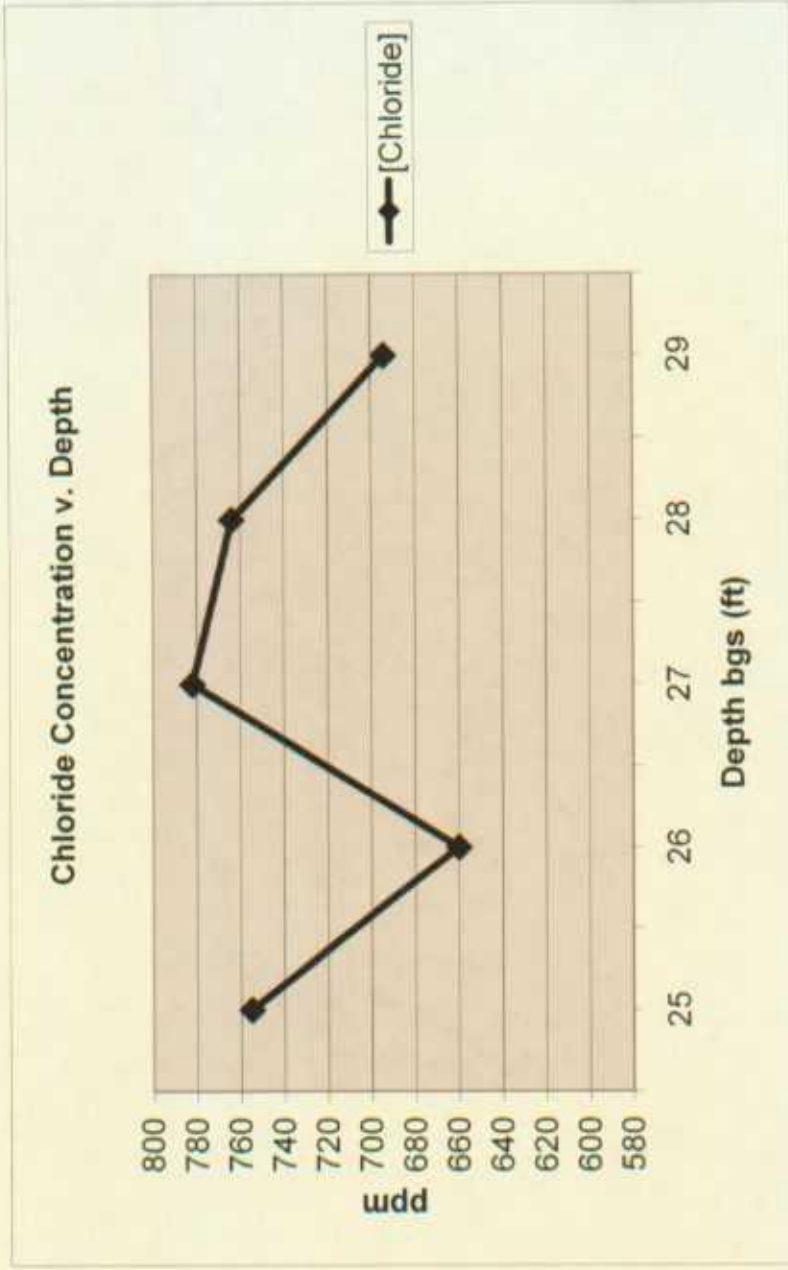
Soil bore 5 ft North of junction

Depth bgs (ft)	[Cl ⁻] ppm
25	755
26	660
27	782
28	764
29	694

Groundwater = 34 ft
