EME State Q EOL
Boot

Disclosure Report

**RICE OPERATING COMPANY
JUNCTION BOX DISCLOSURE* REPORT**

EME State 'Q' EOL boot unit 'J', sec. 16, T20S, R37E

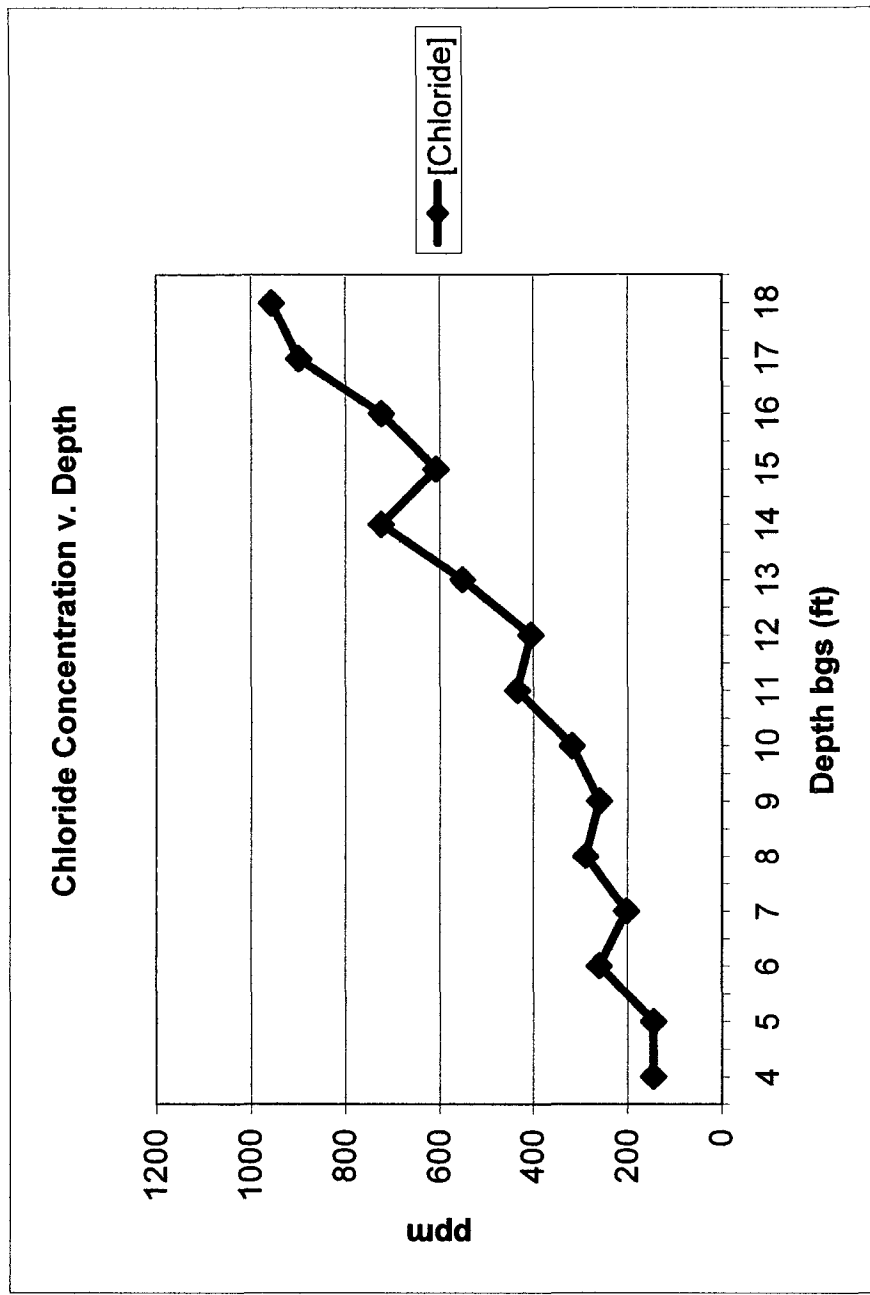
Vertical Delineation at Source

Depth bgs (ft)	[Cl] ppm
4	145
5	145
6	260
7	202
8	289
9	260
10	318
11	434
12	405
13	550
14	724
15	608
16	724
17	898
18	956

Groundwater = 19-50 ft

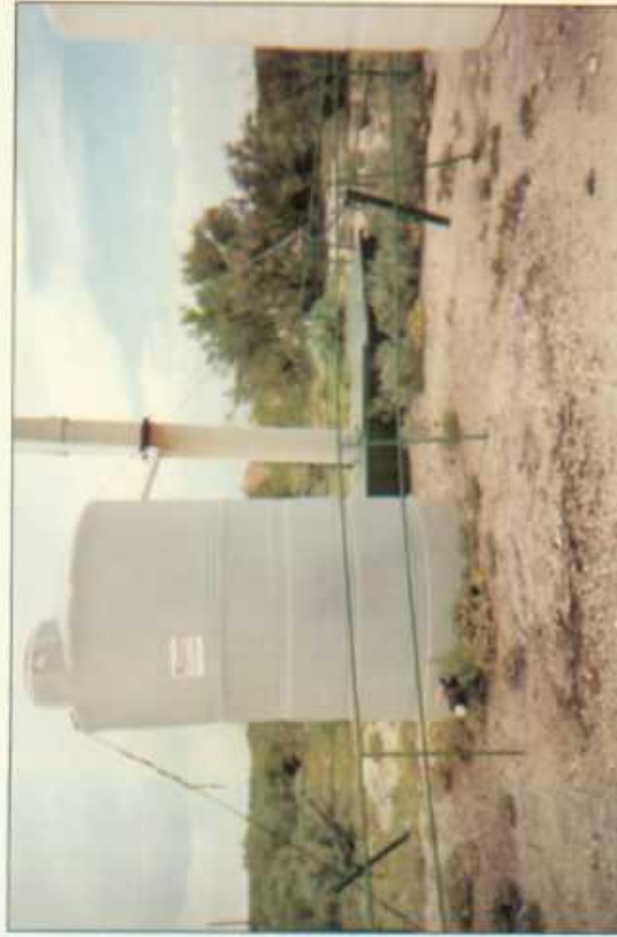
8/17/2004

undisturbed junction box with boot

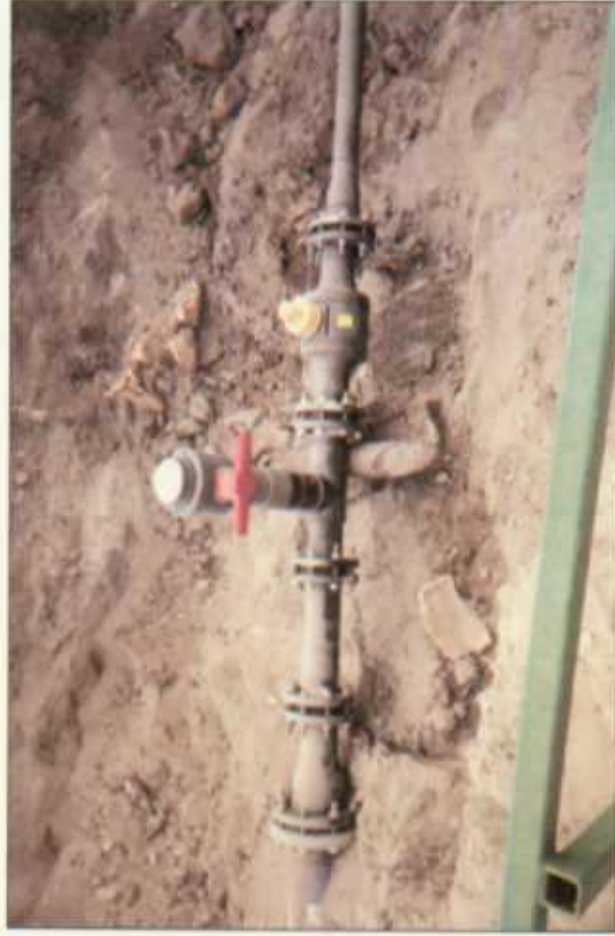
10/6/2004

new pipeline and plumbing

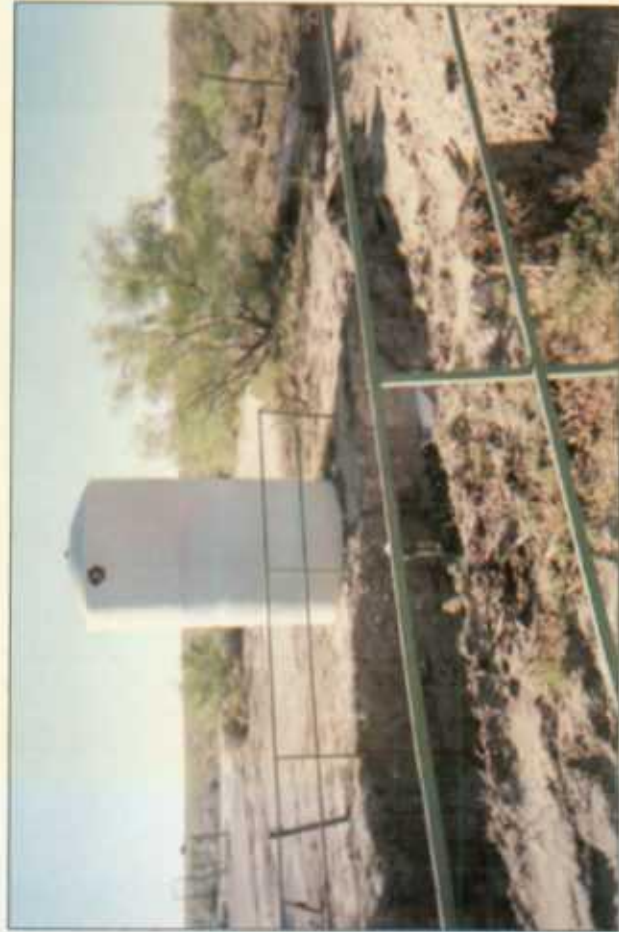
10/6/2004

NORM decontaminated and box removed

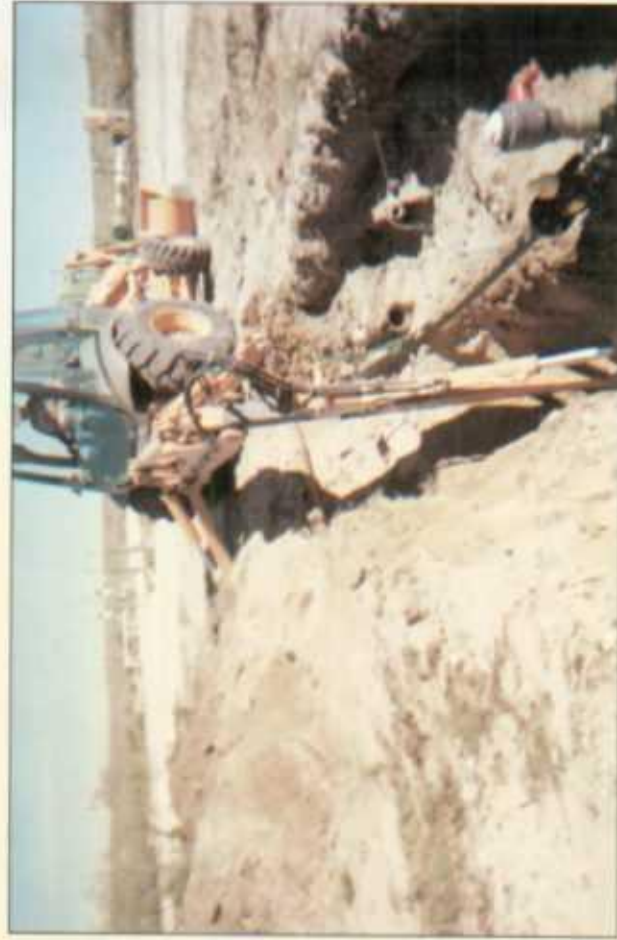
11/5/2004

delineation & excavation

This junction box contained a boot. This box site was delineated using a backhoe while PID screenings and chloride field tests were performed on the soil samples that were collected at regular intervals. Chloride concentrations were elevated and did not relent throughout the 30 x 10 x 12-ft-deep excavation. PID levels were also elevated. Lab results confirmed that TPH concentrations at 12 ft did not meet NMOCD guidelines. The excavation was backfilled with the excavated soil that was blended on site. An identification plate has been placed on the surface to mark the junction box for future environmental considerations. NMOCD was notified on 6/29/2005 of potential groundwater impact at this site.

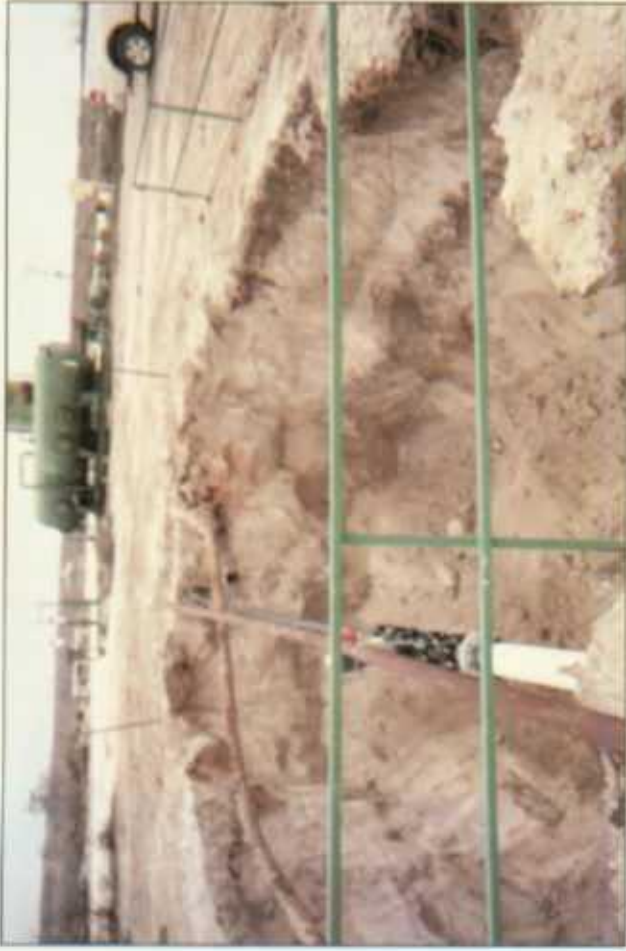
11/29/2004

30 x 10 x 12-ft-deep excavation

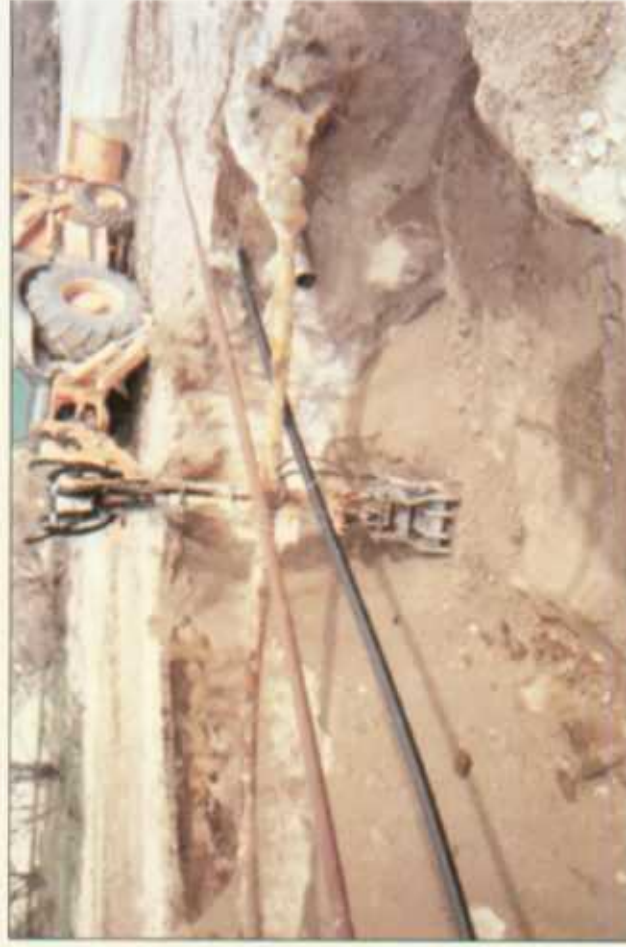
2/8/2005

backfilling and compacting

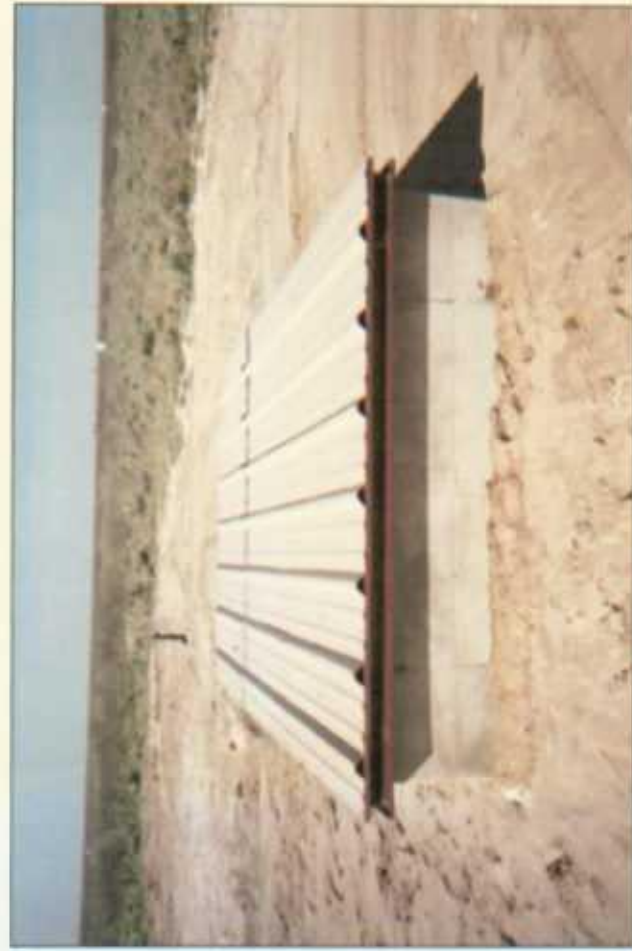
4/14/2005

complete junction box

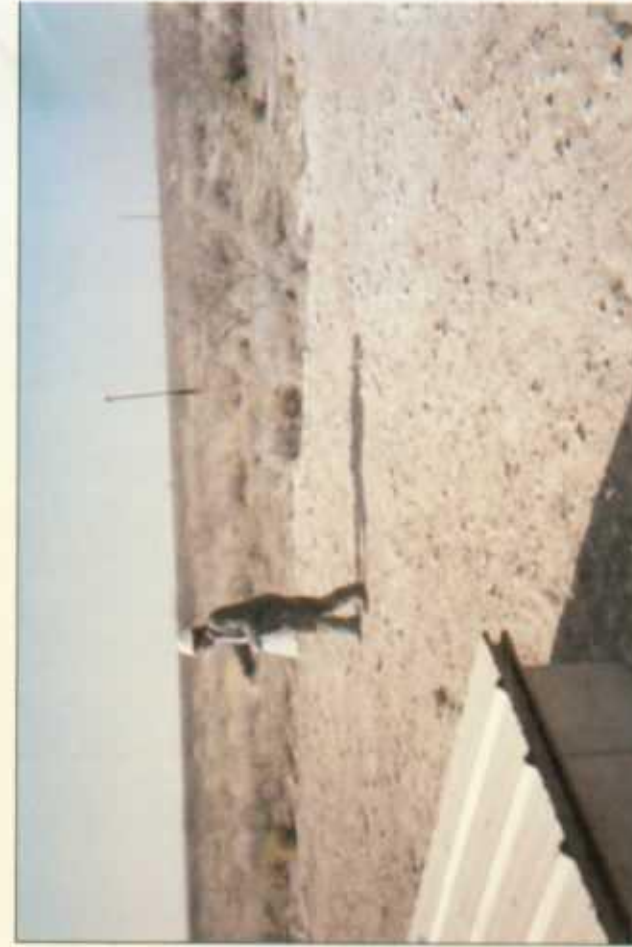
12/6/2005

seeding
