ZME Jct E-2

# DISCLOSURE REPORT

**RICE OPERATING COMPANY  
JUNCTION BOX DISCLOSURE\* REPORT**

## EME jct. E-2

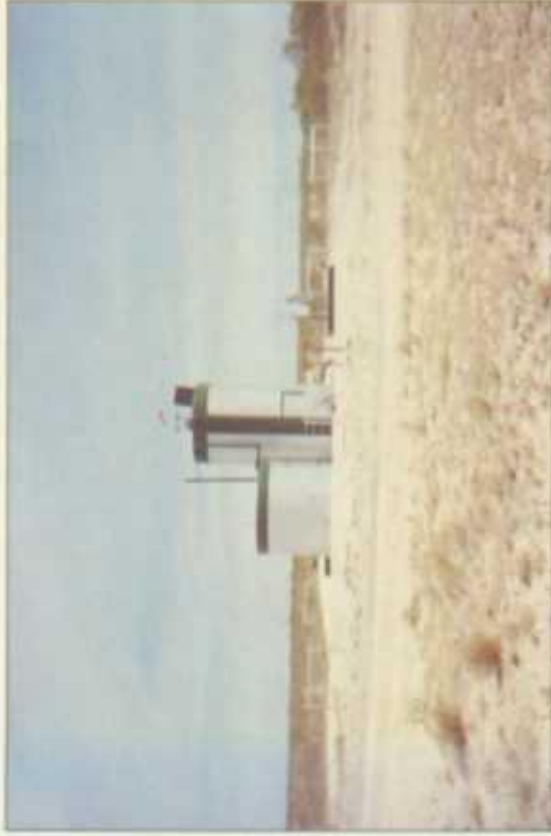
8/19/2003

undisturbed box inside pump station

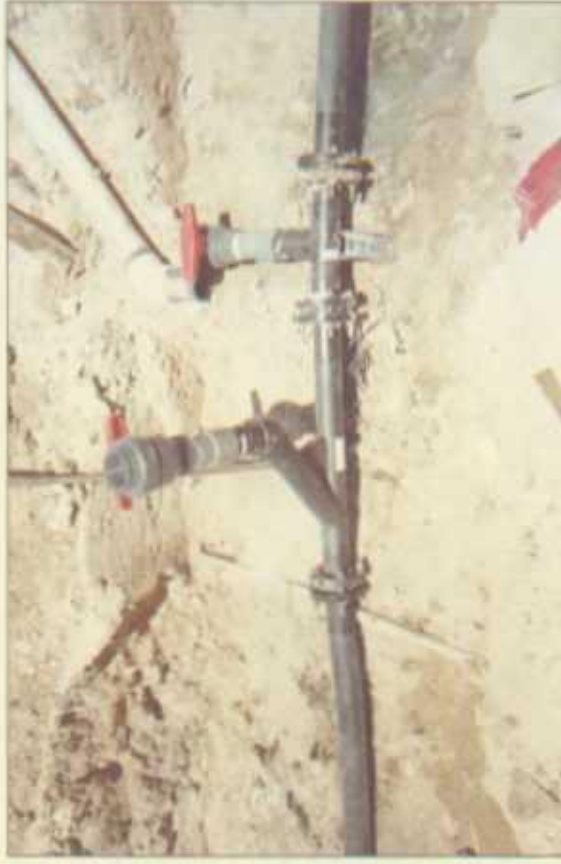
5/6/2004

new plumbing

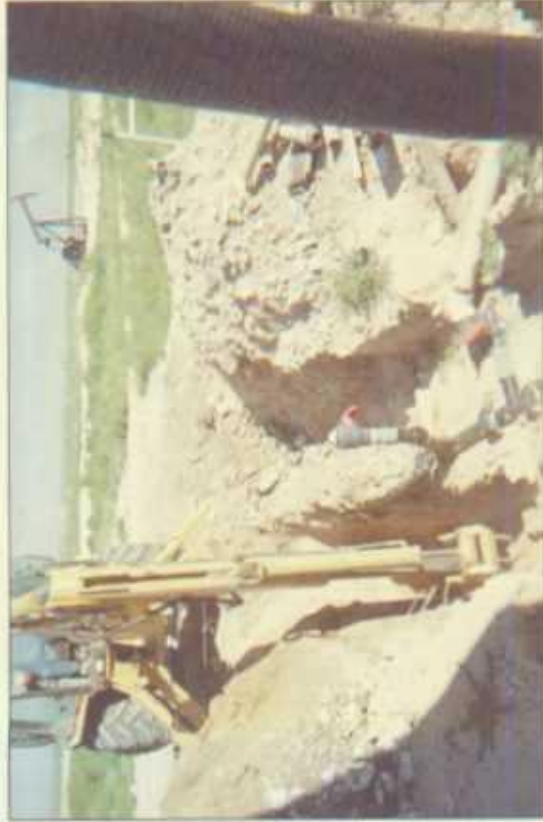
7/28/2004

delineation & excavation

General Description of Remedial Action: This junction box was located within  
the fence of an active ROC pump station 15 ft from a surge tank. A vertical trench was excavated  
while samples were collected every foot from 5-12 ft. The samples were chloride field tested and  
screened using a PID. Chloride concentrations exhibited an inconclusive trend with depth  
and samples showed evidence of TPH impact. Lab results yielded TPH concentrations that did  
not meet NMOCD guidelines. Because this is the site of an active facility, remediation will be  
conducted with the future abandonment of the facility. The excavated soils were backfilled into  
the trench and a new watertight junction box was built over the location. Remaining TPH will  
naturally attenuate.

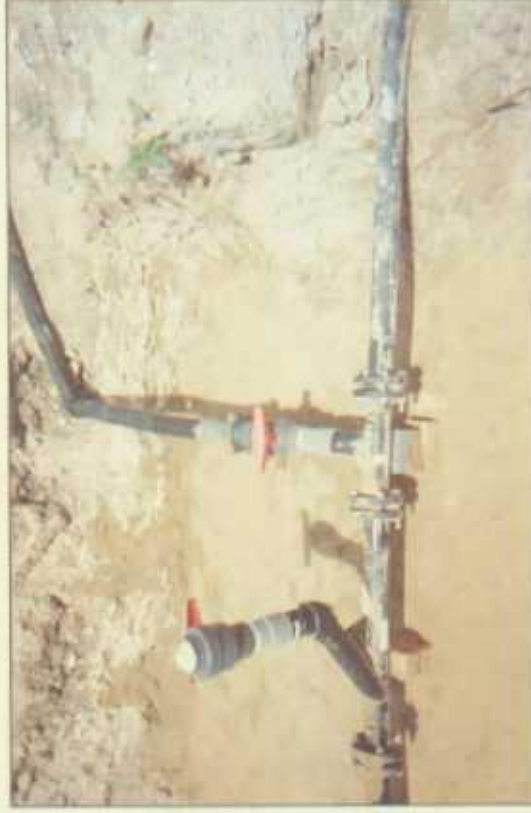
8/2/2004

backfilled and ready for new box

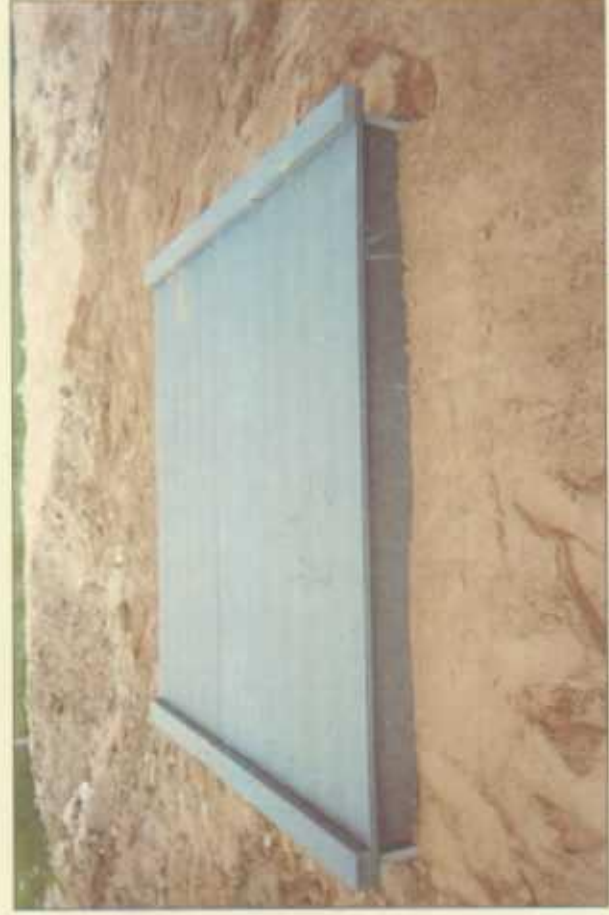
8/19/2004

completed junction box
