EME Jct E-25

FINAL REPORT

**RICE OPERATING COMPANY
JUNCTION BOX FINAL REPORT**

SWD SYSTEM	JUNCTION	UNIT	SECTION	TOWNSHIP	RANGE	COUNTY	BOX DIMENSIONS - FEET		
							Length	Width	Depth
EMIE	E-25	E	25	19S	36E	Lea	no box—eliminated

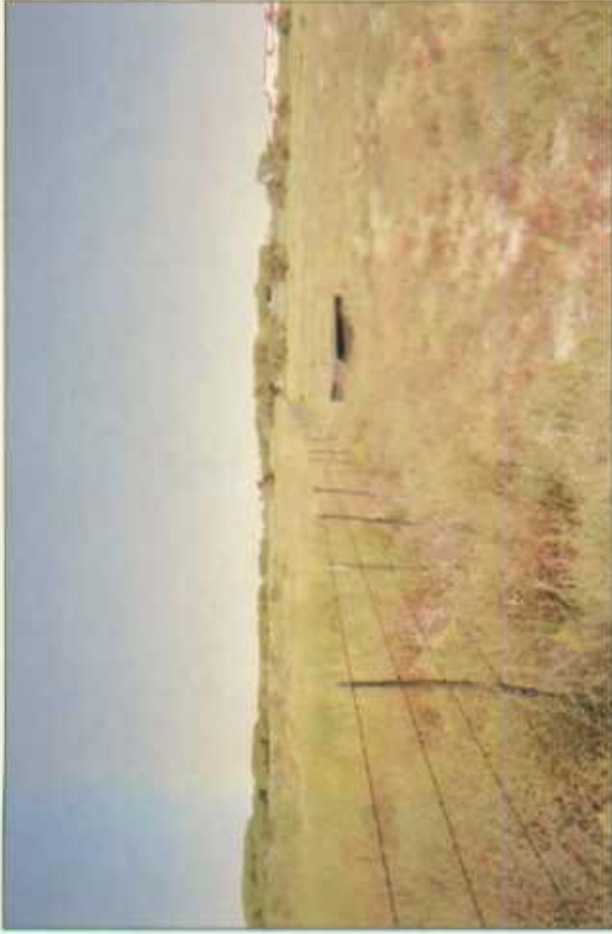
undisturbed box (looking west)

8/20/2004

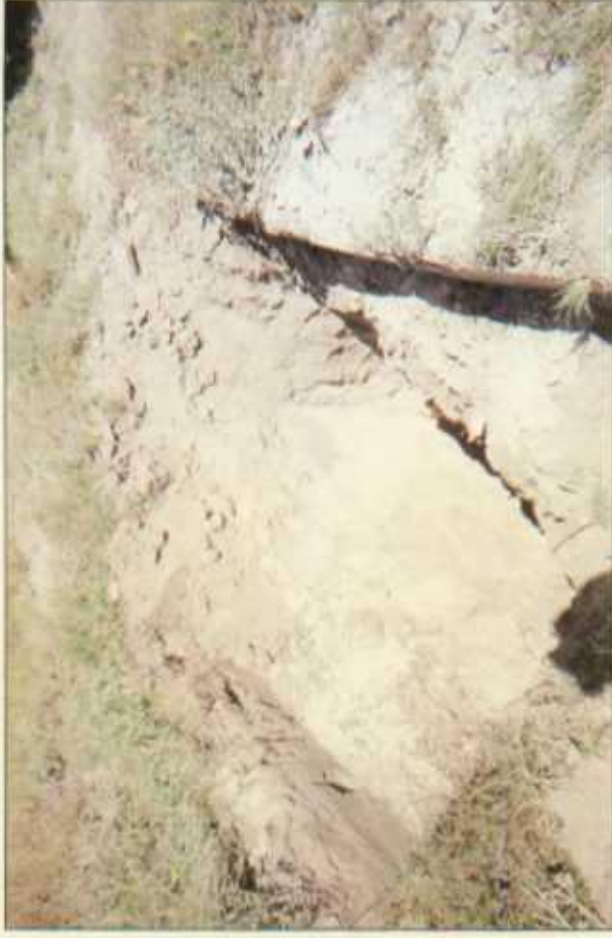
delineation trenches at former box site

9/15/2004

General Description of Remedial Action: This junction has been eliminated/
There were no physical indications of chloride or hydrocarbon impact. The box lumber was removed and the site was delineated using a backhoe while PID screenings and chloride field tests were conducted at regular intervals. Two excavation trenches were completed—one directly under the former box location and one 5 ft north of the junction. All PID readings were 0.0 ppm except for two samples which were only slightly above at 1.7 and 1.5 ppm. Chloride field tests revealed very low concentrations, indicative of background levels. Both trenches exhibited chloride levels with concentrations that conclusively declined with depth. A representative grab sample was collected for lab analysis at 12 ft BGS from the trench at the junction box site. Analysis yielded non-detect TPH (<10.0 ppm) and chloride (<20 ppm) concentrations. The trenches were backfilled with the excavated soil. The disturbed surface is expected to return to productive capacity at a normal rate.

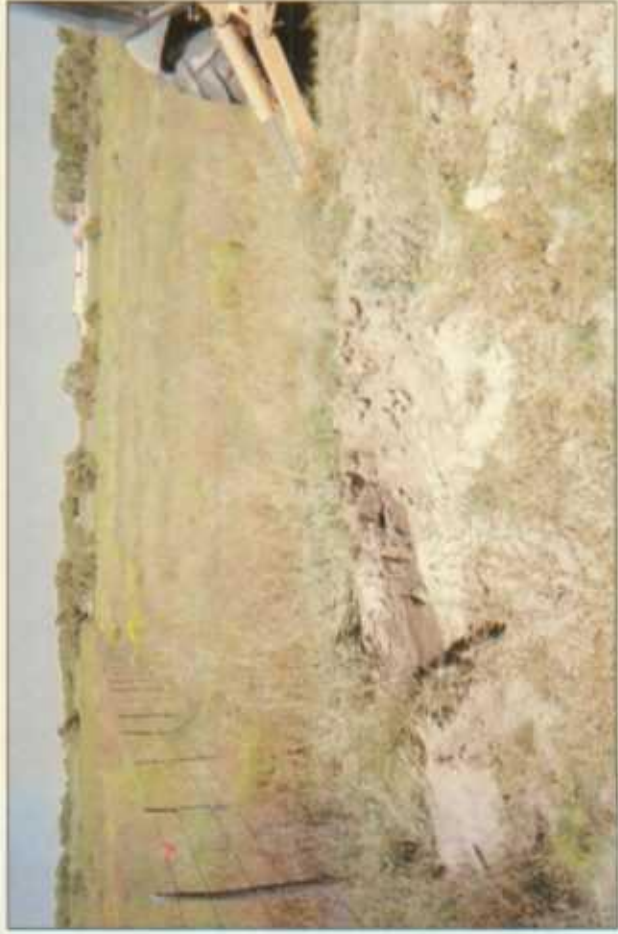
delineation trenches (looking west)

9/15/2004

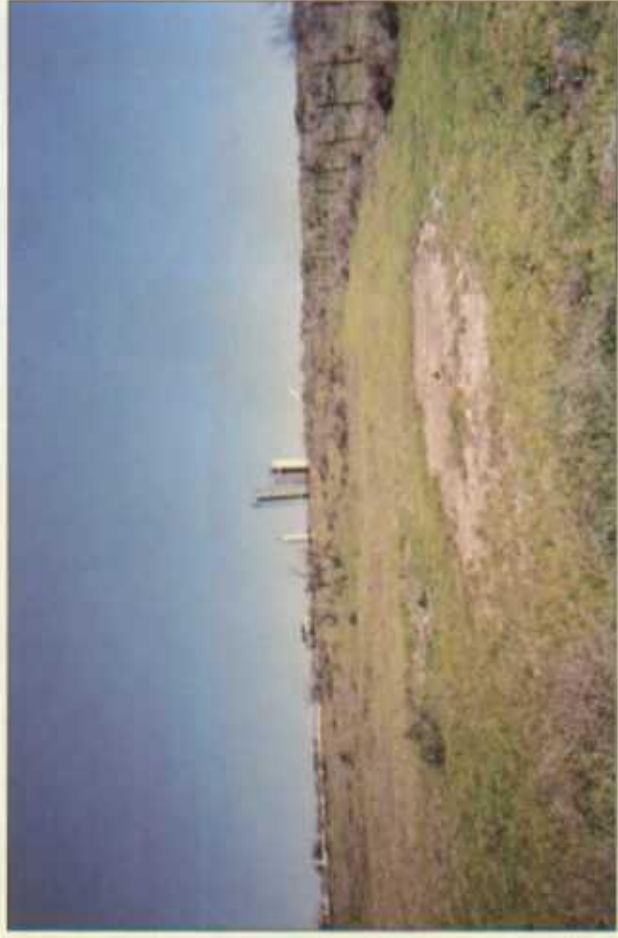
backfilled

4/5/2004
