EME Jct C-19

FINAL REPORT

**RICE OPERATING COMPANY
JUNCTION BOX FINAL REPORT**

unit 'C', sec. 19, T19S, R37E

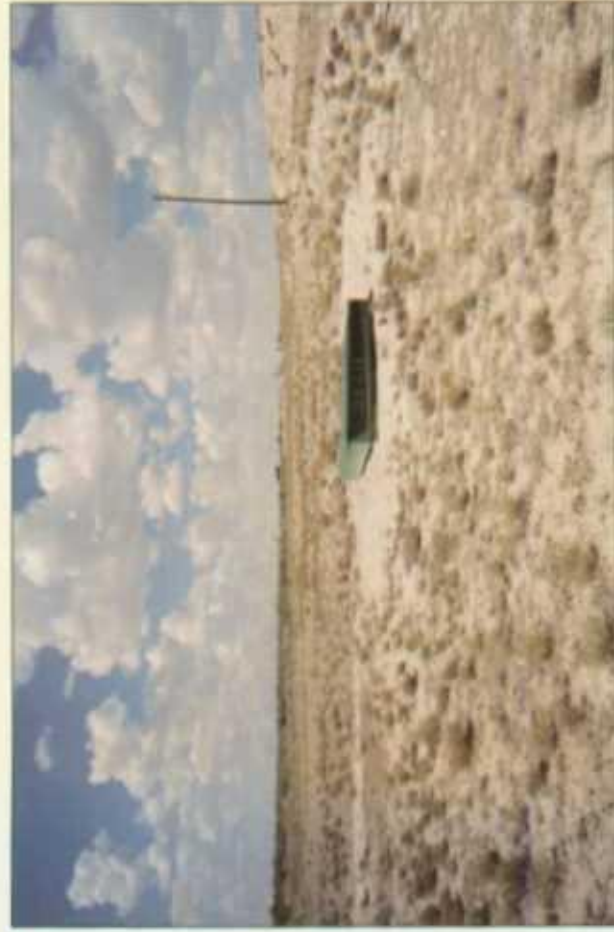
undisturbed junction box

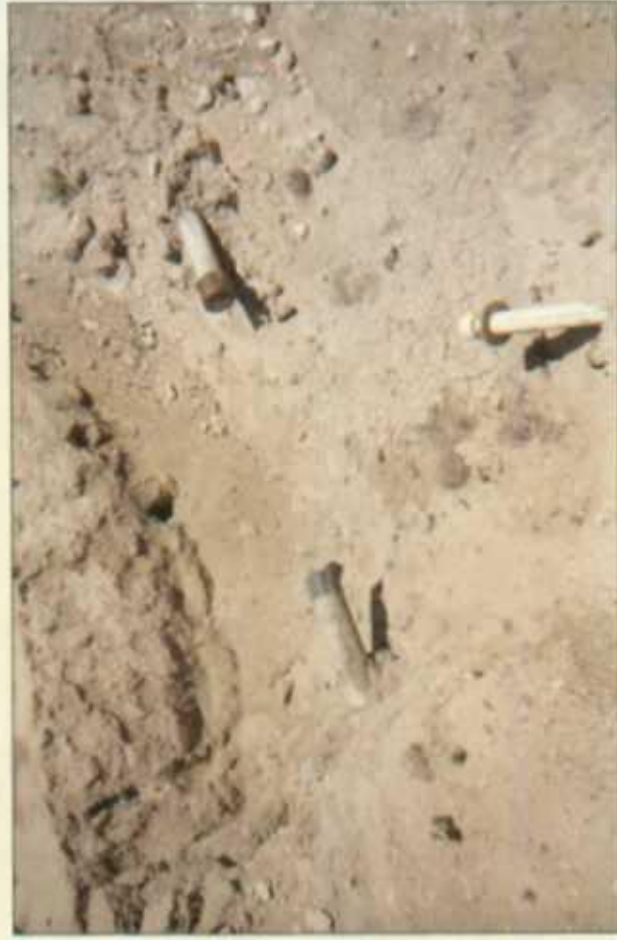
former box site; junction removed

This section of SWD pipeline has been isolated. The box lumber was removed and the site was decontaminated for NORM. The location was then delineated using a backhoe while PID screenings and chloride field tests were conducted at regular intervals on the soil samples. Caliche was found a few inches below the surface and the samples did not exhibit any indications of salt or hydrocarbon impact. All PID readings were very low and lab results on the samples from the final 20 x 25 x 8-ft-deep excavation yielded non-detect (<10 ppm) TPH concentrations, meeting NMOCD guidelines. Chloride concentrations exhibited conclusive trends of decline with depth and breadth. The excavated soil was blended on site and then backfilled into the excavation and contoured to the surrounding surface. The disturbed surface was seeded on 10/4/2004 with a blend of native vegetation and is expected to return to productive capacity at a normal rate.

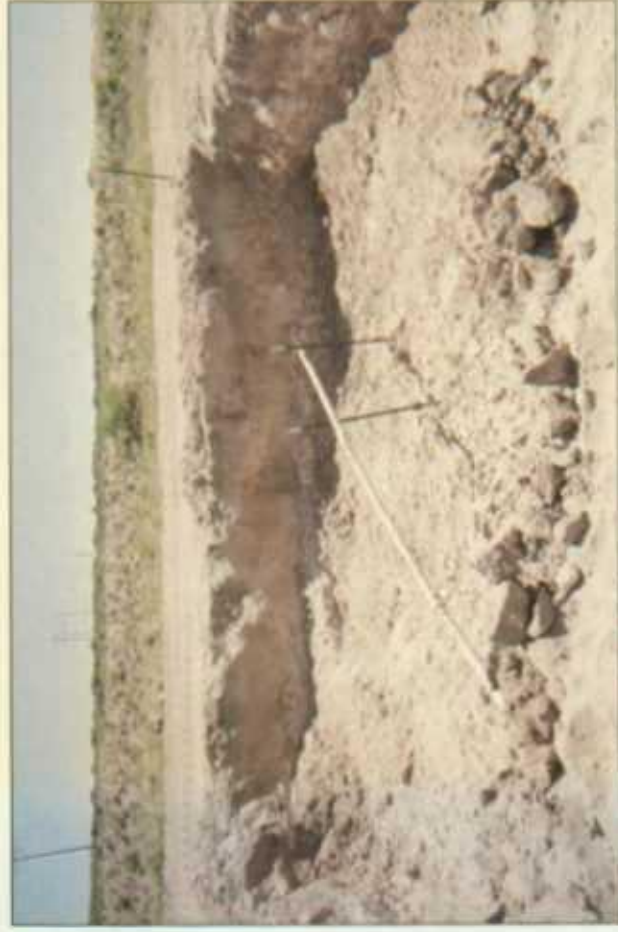
June 2004

final 25 x 20 x 8-ft-deep excavation

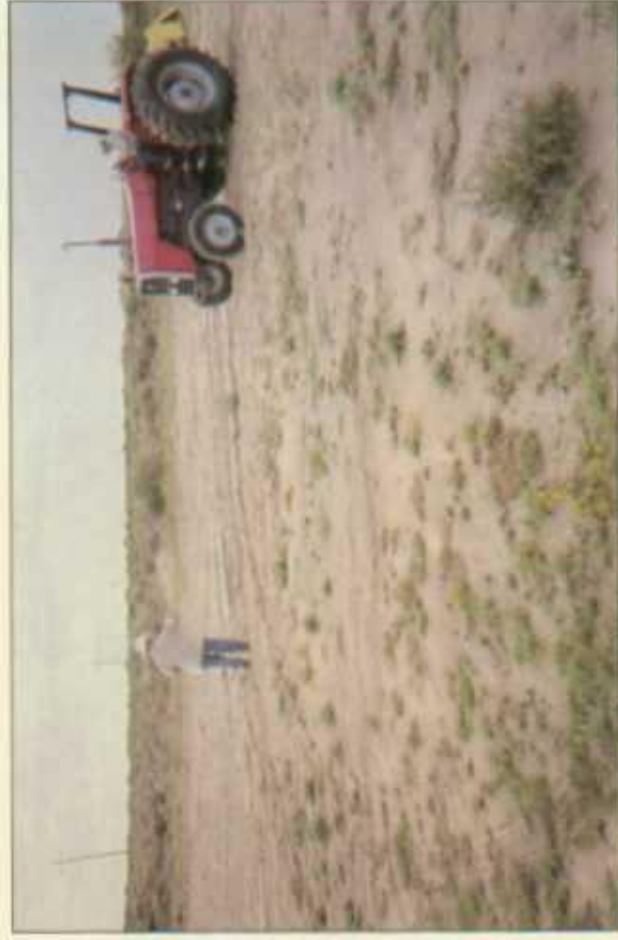
10/4/2004

seeding disturbed surface
