EME EL Paso EOL
G-5

Final Report

**RICE OPERATING COMPANY
JUNCTION BOX FINAL REPORT**

Unit 'G', Section 5, T21S, R36E

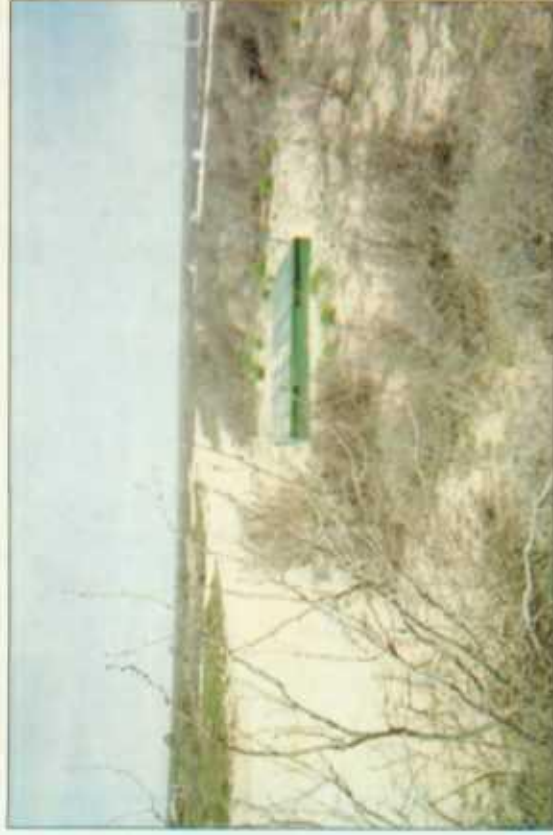
undisturbed junction box

3/28/2005

This junction was replaced with the pipeline replacement program. The box was removed and the location was delineated using a backhoe to excavate an 12-ft-deep trench at the junction site. Chloride field tests and PID screenings were performed on every vertical foot of soil samples from 6-12 ft. Chloride concentrations were all very low and declined with depth to background level. All PID screenings were also low and TPH concentrations from the laboratory were non-detect (<10.0 ppm). The soil samples did not exhibit any physical indications of hydrocarbon or salt impact and the location was surrounded by healthy native vegetation. The excavated soils were backfilled into the trench and contoured to the surrounding surface. The disturbed surface is expected to return to productive capacity at a normal rate. A new watertight junction box is to be built over this location.

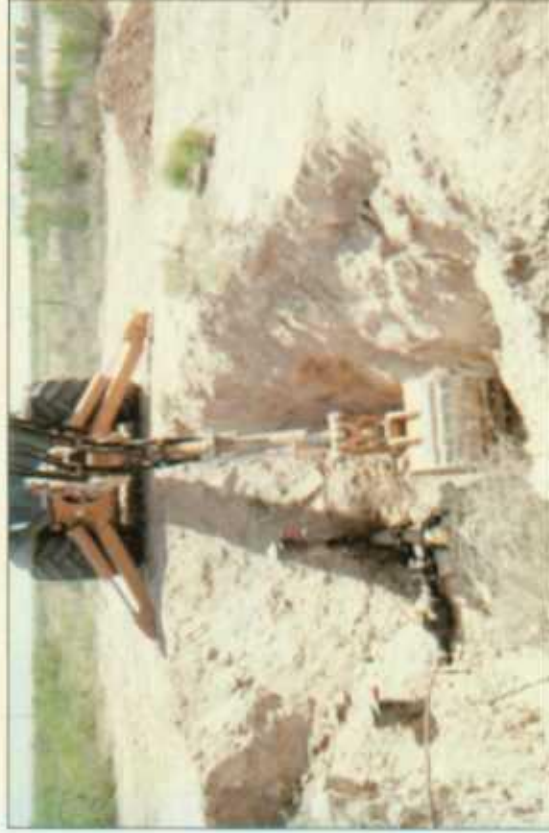
delineation trench

6/22/2005

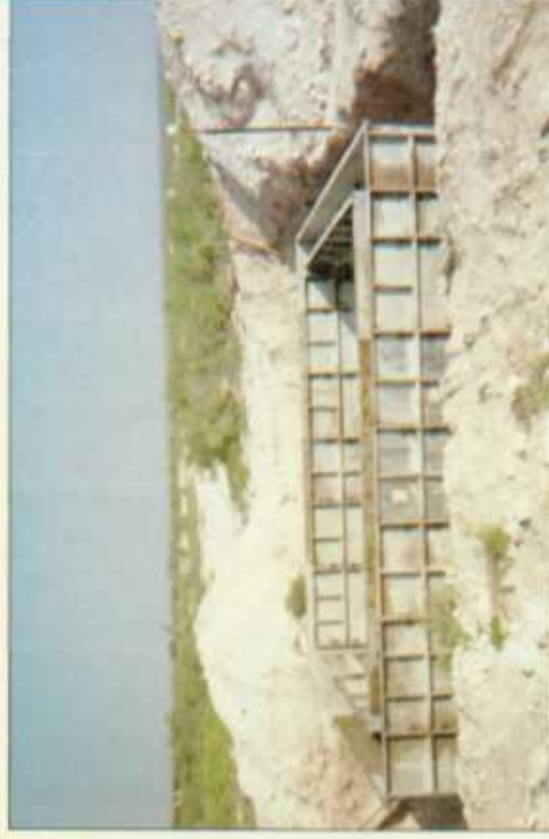
form for new watertight replacement box

9/7/2005
