EME JcT A-6

Final Report

**RICE OPERATING COMPANY
JUNCTION BOX FINAL REPORT**

EME jct. A-6

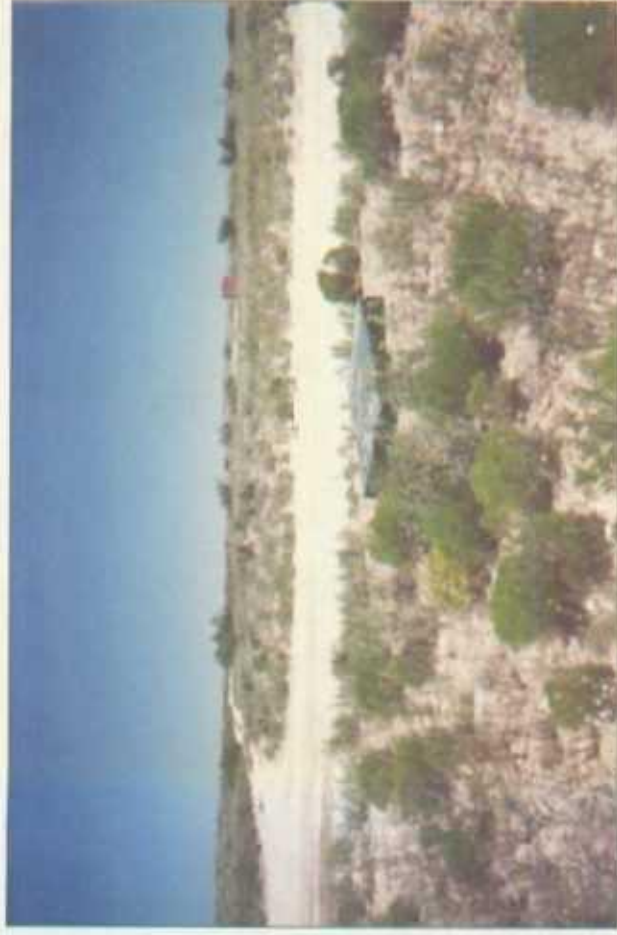
8/26/2004

undisturbed junction box

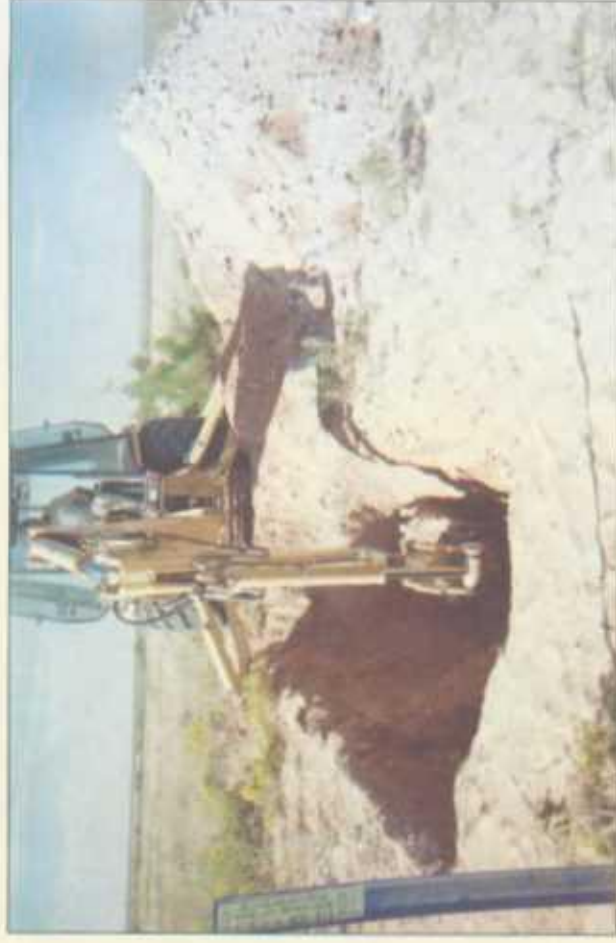
9/17/2004

delineation & excavation

pipeline replacement program. After the box materials were removed, a delineation trench was

made at the former junction site using a backhoe while soil samples were collected at regular

intervals to 12 ft BGS. Chloride field tests were performed on each sample and yielded a conclusive trend of decline of concentrations with depth.

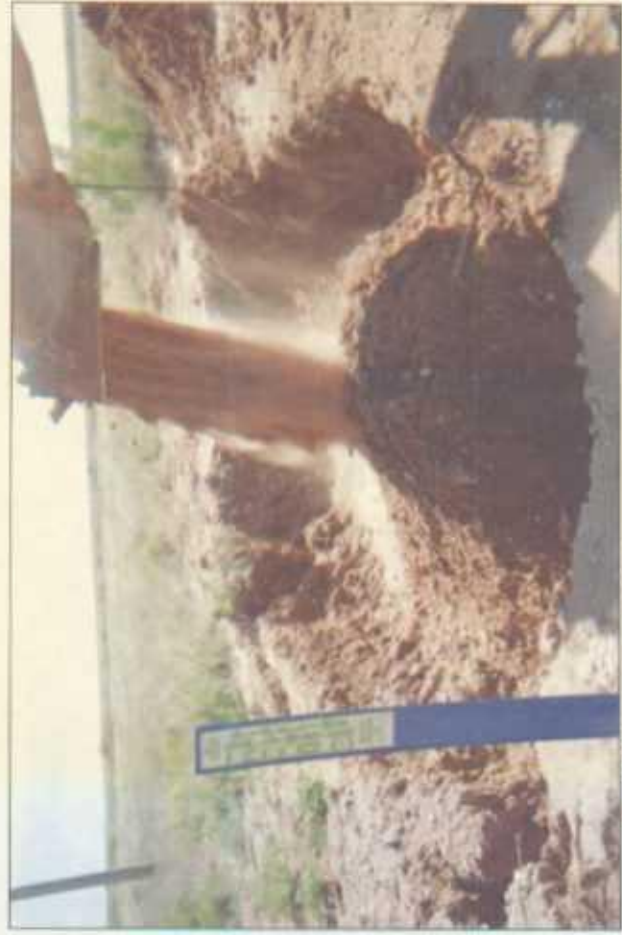
10/7/2004

backfilling excavation

within the lab's detection limits. Chloride concentrations at 12 ft were also less than the lab's detection limit of 20 ppm. The excavated soil was blended

on site and then backfilled into the trench and contoured to the surrounding terrain. The disturbed surface was seeded with a blend of native

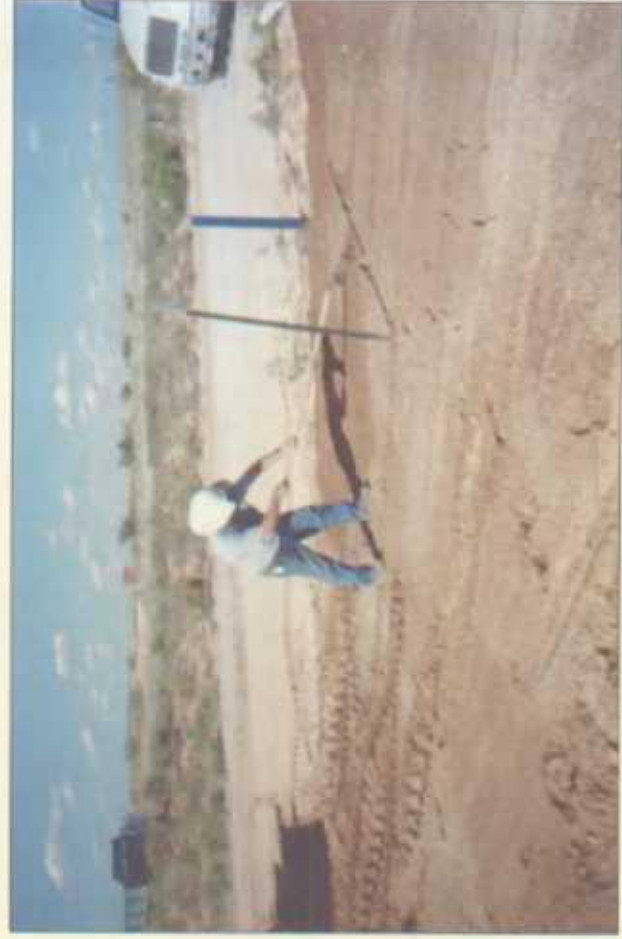
10/7/2004

seeding backfilled site

vegetation and is expected to return to productive capacity at a normal rate. Since the junction has been eliminated, a new box is not required.
