BD Jct C-2-1

FINAL REPORT

**RICE OPERATING COMPANY
JUNCTION BOX FINAL REPORT**

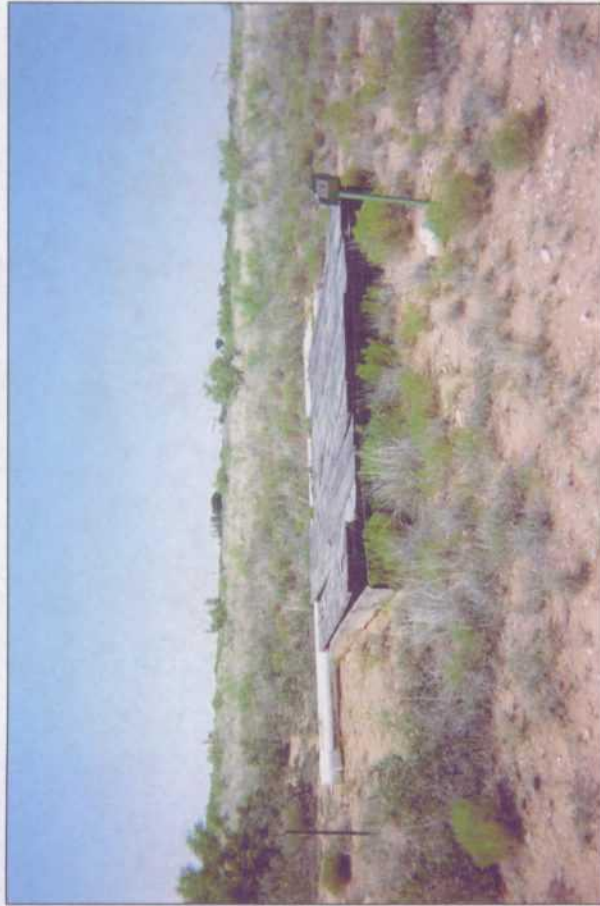
undisturbed junction box 7/14/2003

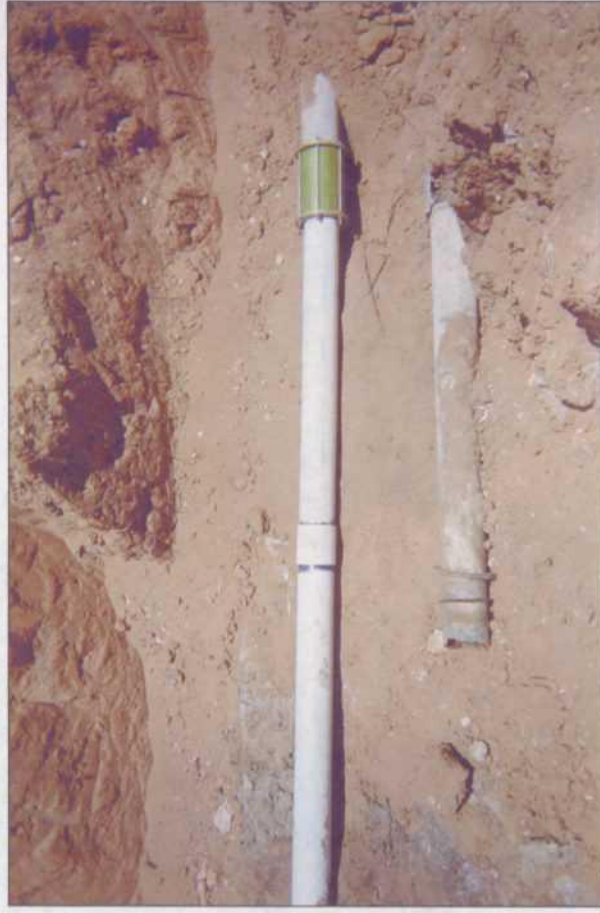
new plumbing; junction removed 7/16/2003

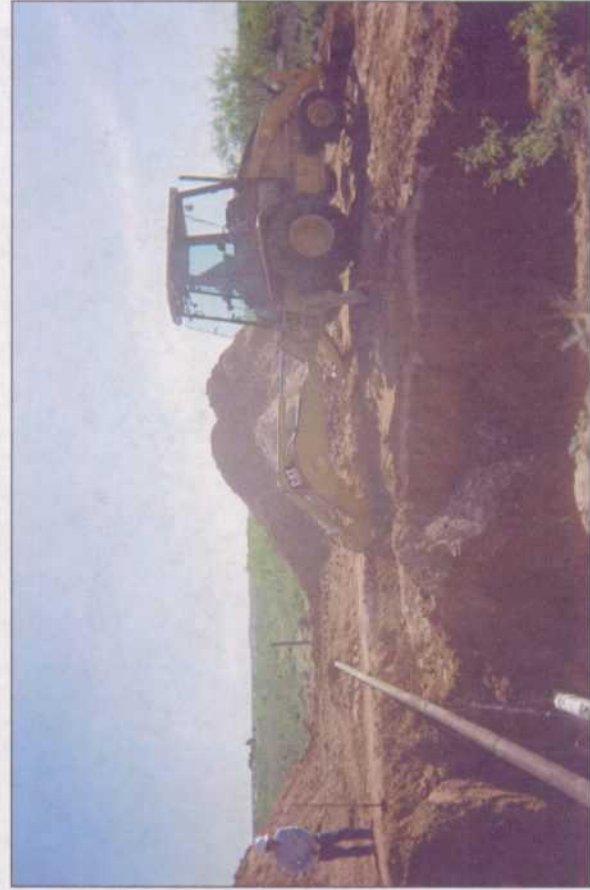
delineation & excavation April 2004

General Description of Remedial Action: This junction has been eliminated
and was located in pasture land with healthy vegetation. The site was delineated with a backhoe while PID field screenings and chloride field tests were conducted at regular intervals. Vertical delineation at the source yielded at conclusive trend of chloride declination to 20 ft bgs, indicative of non-saturated vadose conditions. Chloride concentrations also exhibited lateral declines in chloride concentrations. All PID readings were 0.0 ppm and lab results confirm TPH concentrations well below NMOCD guidelines. The excavated soil was blended and backfilled into the 30 x 30 x 12-ft deep excavation. The surface was contoured to the surrounding landscape and has been seeded with a blend of native vegetation and will be monitored for growth.

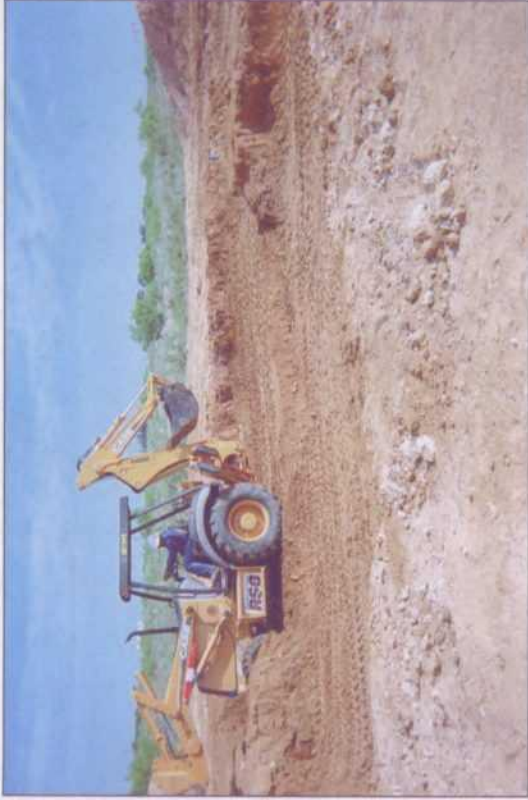
backfilling & compacting
May 2003

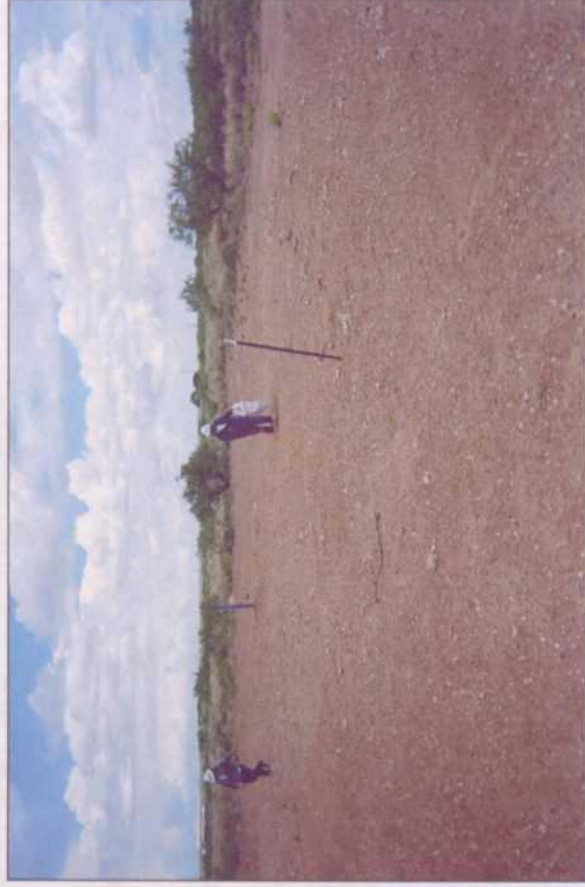
seeding backfilled location 5/24/2004
