**1R - 427 - 71**

# FINAL REPORT

**RICE OPERATING COMPANY  
JUNCTION BOX FINAL REPORT**

SWD SYSTEM	JUNCTION	UNIT	SECTION	TOWNSHIP	RANGE	COUNTY	BOX DIMENSIONS - FEET		
EME	G-36A	G	36	19 S	36 E	Lea	Length 0	Width 0	Depth No Box

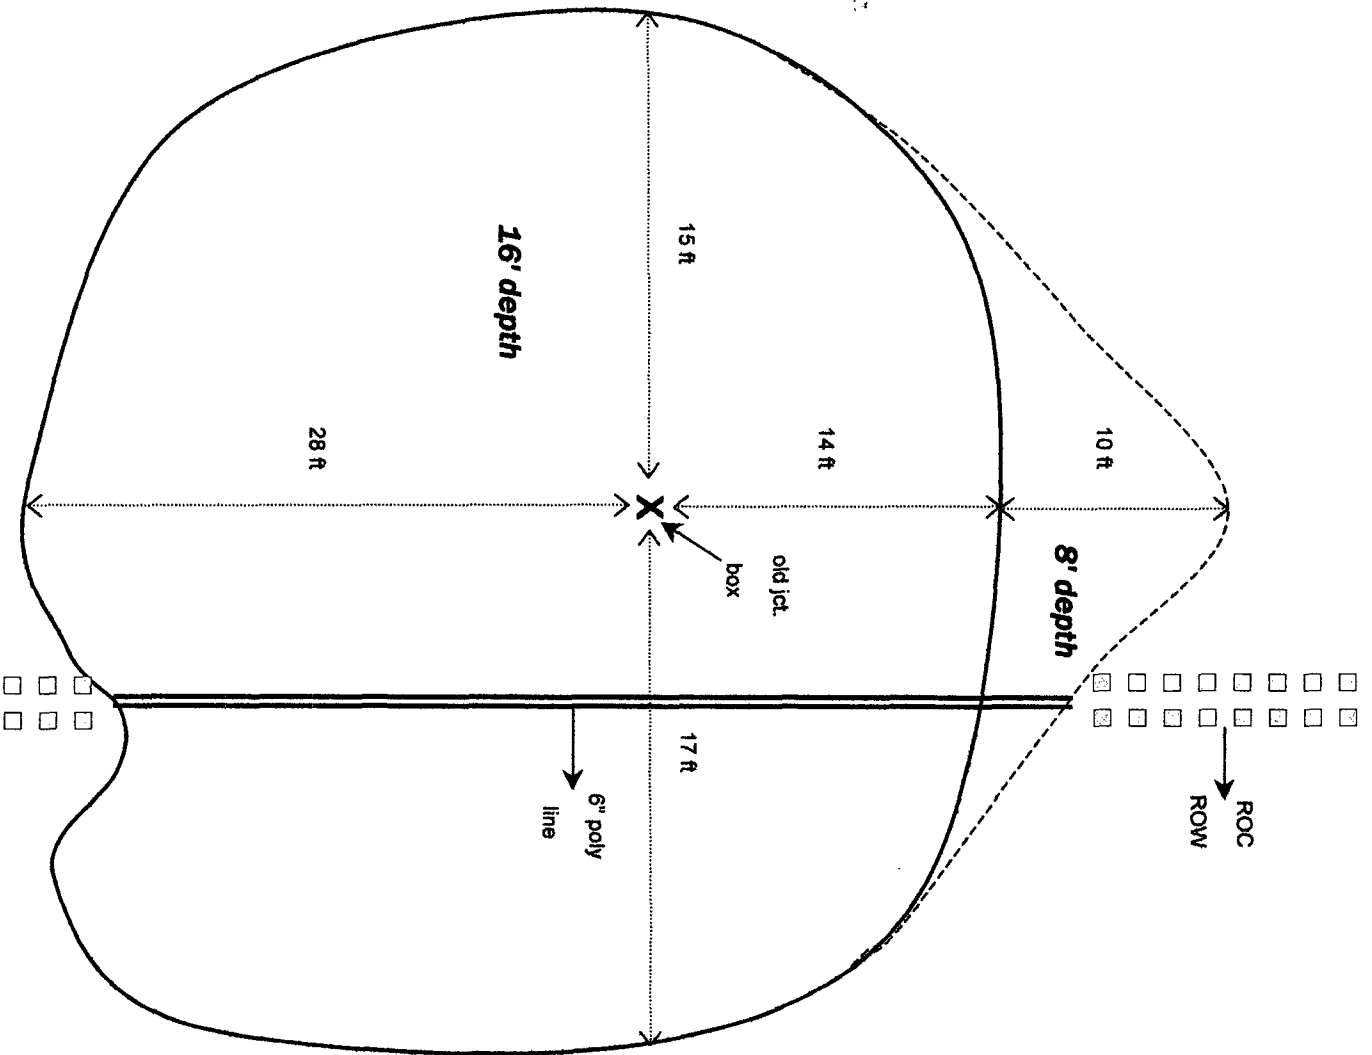
# EME G-36A

X  
background sample  
(50' WSW)

Diagram illustrating a wellbore completion system. The wellbore is shown with a 'new 6" poly line' and a '12 mil poly liner'. The wellbore is surrounded by 'ROCK'. A dashed line indicates the 'old box location'. The wellbore is divided into sections of 28 ft, 14 ft, and 10 ft. A scale on the left indicates depths from 1 to 18 ft BGS. The wellbore is labeled 'S' at the top and 'N' at the bottom.

A background sample at 16' tested 1010 ppm which suggests that there is a natural occurrence of high chlorides at this depth. A 42' x 32' area was excavated to 16' BGS and on the north side a shelf was excavated to 8' to completely remove hydrocarbons from the rock. A poly liner was installed at 16' BGS to prevent impact migration. The excavated soil was landfarmed on location and then backfilled. The surface is expected to resume growth at a normal rate. Based on local boring results by Amerada Hess in 1992, ROC concludes that there is no groundwater at this location. A junction box is not required.

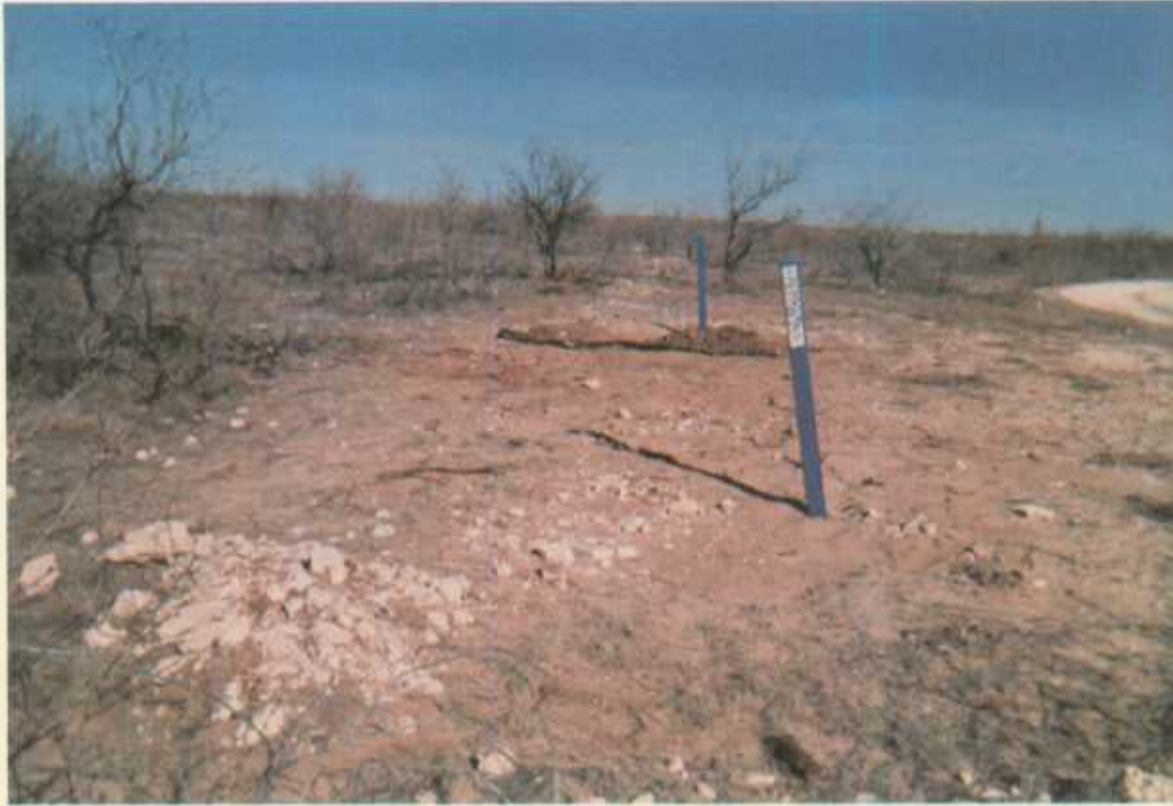
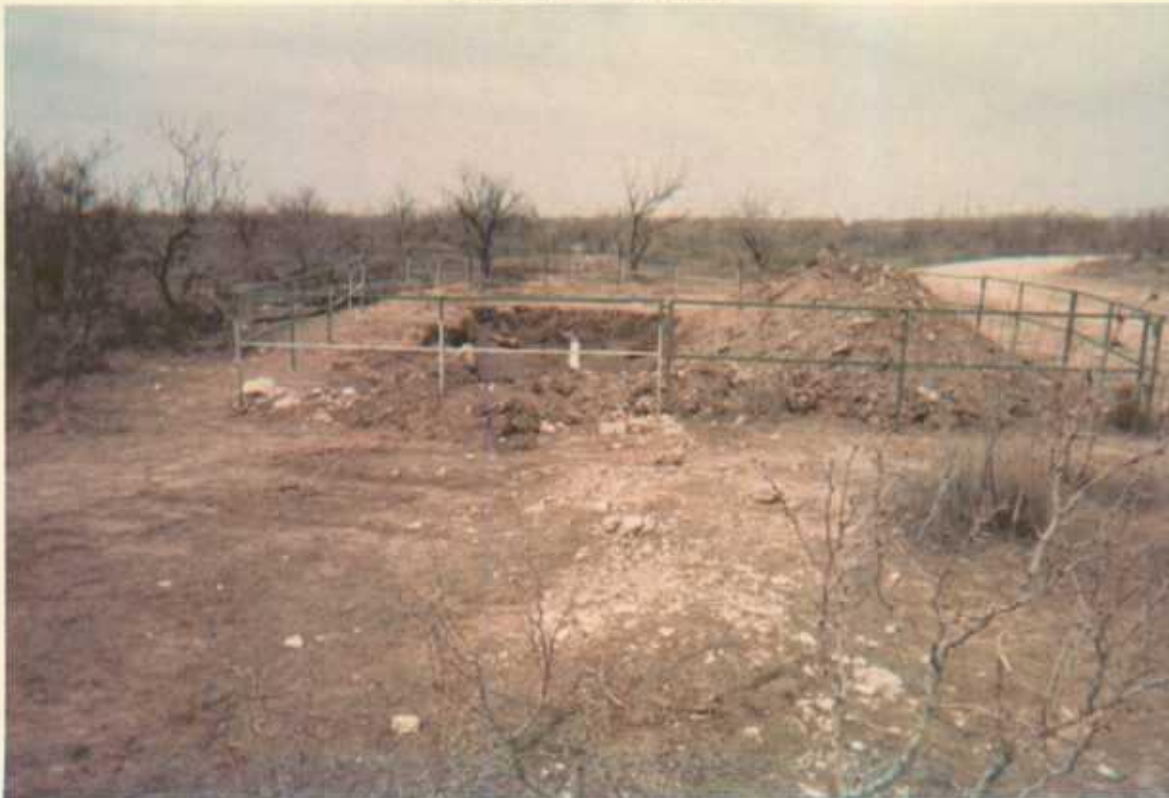
Before Remediation

General Description of Remedial Action: A cemented rock layer occurred below the

location at 2-8 ft BGS. The rock that was visibly impacted with hydrocarbons was removed.

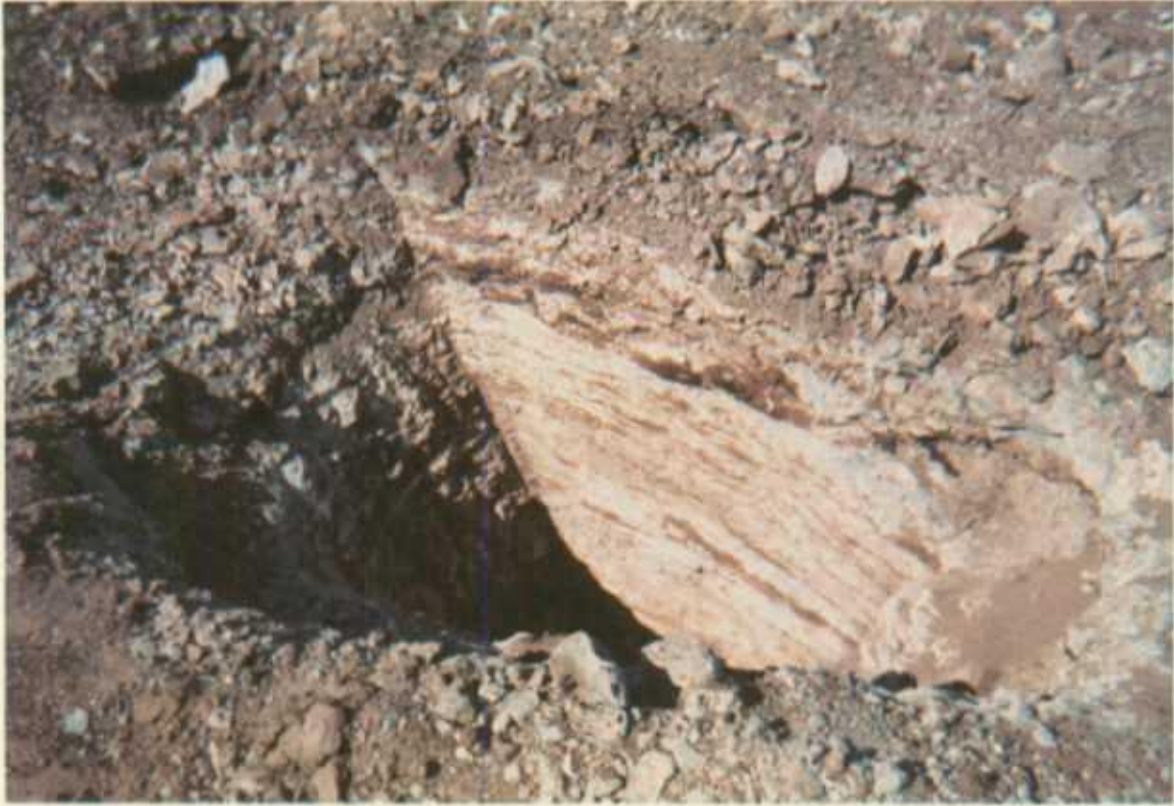
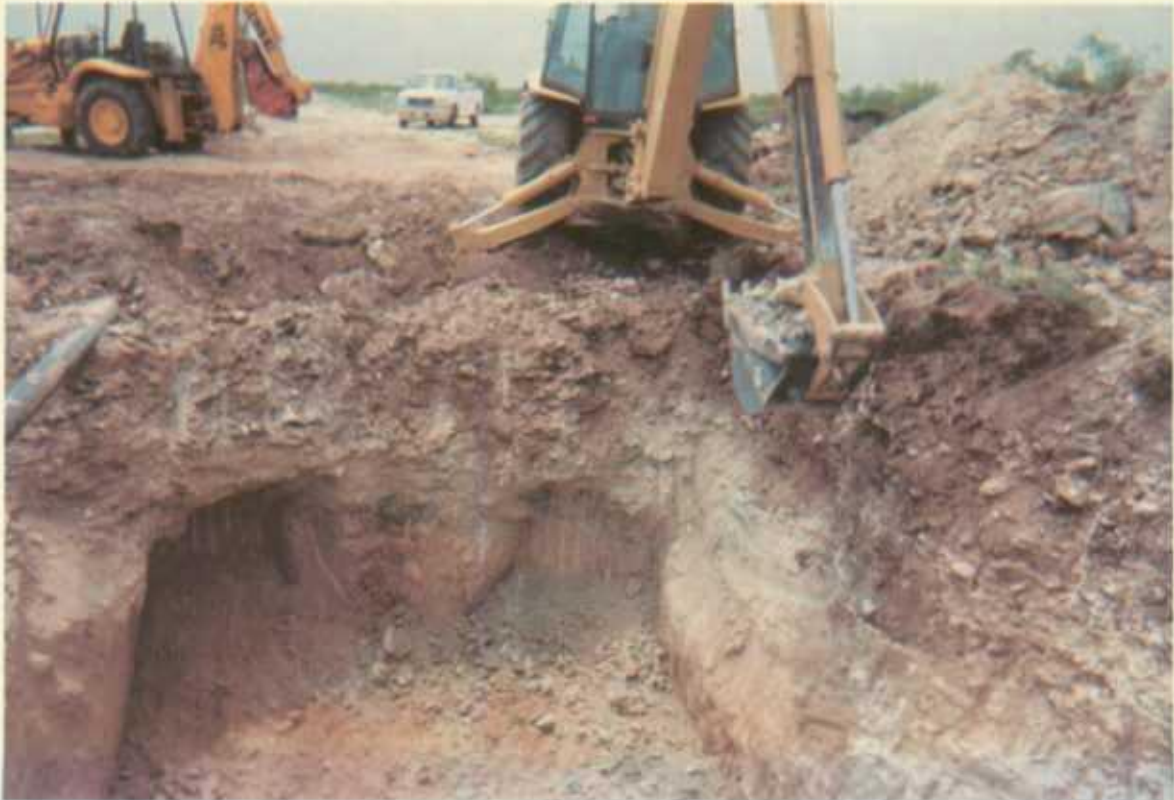
Impact Excavation

Impact continued vertically directly below the old vent with a field test of 16,330 ppm TPH at 16', however, a bottom composite of the excavation at this depth revealed 1478 ppm. Chloride impact was minimal throughout except at 16' when impact consistently ranged 1000-1500 ppm.

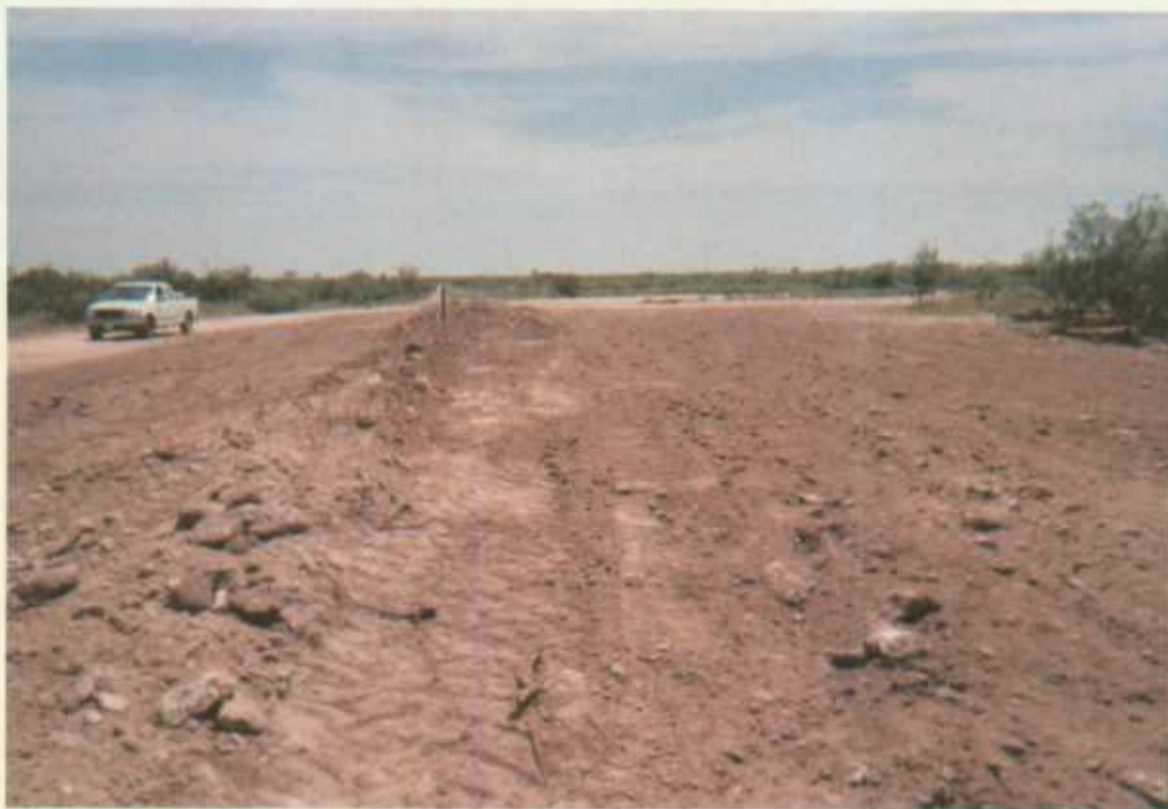
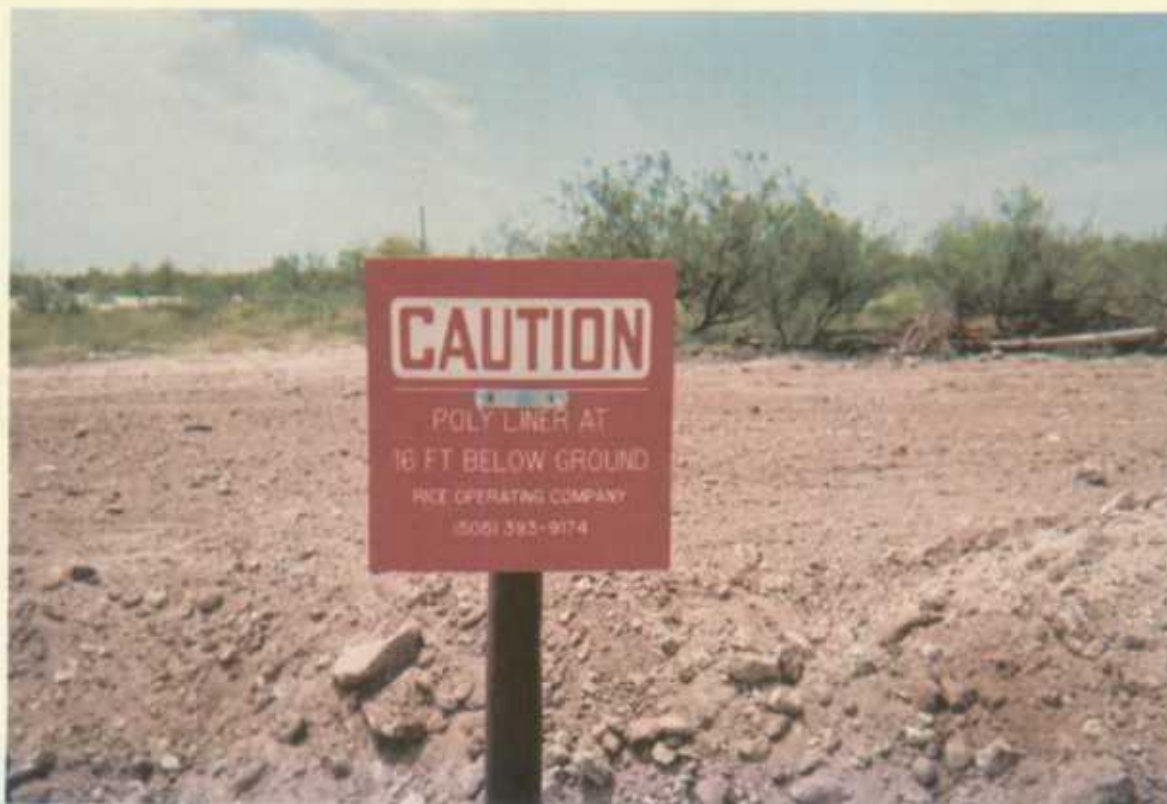
Backfilled

Sample Location	Benzene mg/kg	Toluene mg/kg	Ethyl Benzene mg/kg	Total Xylenes mg/kg	GRO mg/kg	DRO mg/kg	Chlorides mg/kg
SIDEWALLS	<0.025	<0.025	<0.025	<0.025	<10	<10	753
BOTTOM	<0.025	<0.025	0.029	<0.12	567	911	709
REMEDIED	<0.005	<0.005	<0.005	<0.015	<10	205	432
