1R - 451

REPORTS

**Re: Pipeline Spill Investigation Report, Dynegy Midstream Services, L.P., Unit Letter J
(NW/4, SE/4) Section 12, Township 22 South, Range 37 East, Lea County,
New Mexico**

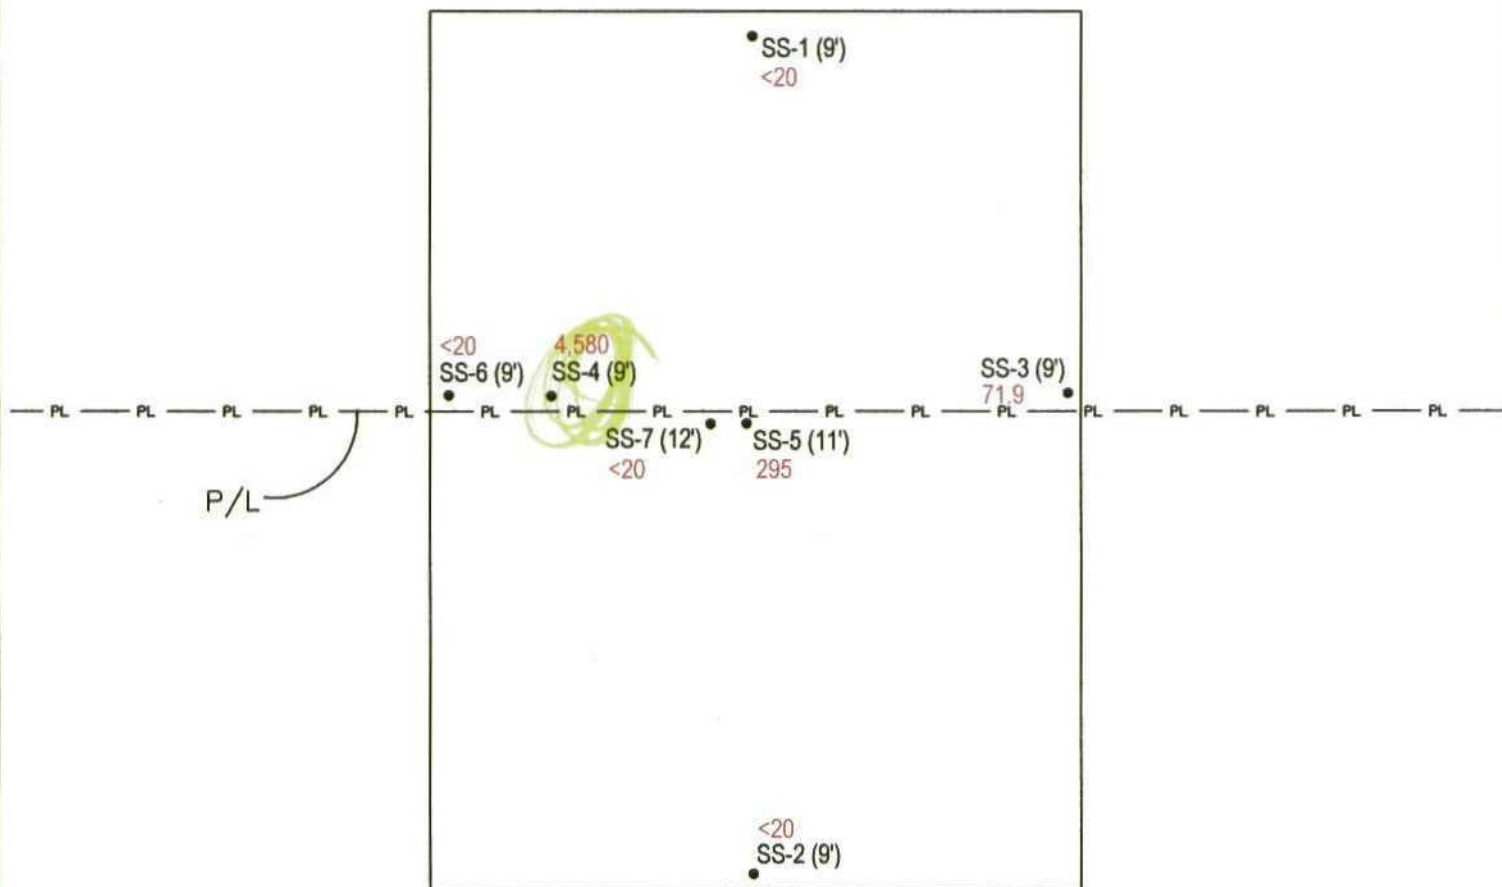
FIGURE #2

- PIPELINE LOCATION
- SS-1 SOIL SAMPLE LOCATION
WITH DEPTH (FEET BGS)
AND TPH CONCENTRATION
(MG/KG)

SITE DETAILS

Referring to Table 1, soil samples collected from the north (SS-1), south (SS-2), and east (SS-3) sides of the excavation reported TPH concentrations below the RRAL. Soil samples collected from the west (SS-4) side and the bottom (SS-5) of the excavation reported TPH concentrations that exceeded the RRAL (4,580 mg/kg and 295 mg/kg, respectively).

Excavation continued along the west wall and bottom of the excavation, until soil samples were collected on June 14, 2004, from the west side (SS-6) at a depth of nine (9) feet bgs, and from the bottom (SS-7) at a depth of 12 feet bgs. The soil samples were placed in clean glass sample jars, labeled, chilled in an ice chest, and hand delivered under chain-of-custody control to ELOT. Duplicate samples were collected for headspace analysis, as described above. Soil samples were analyzed for TPH by EPA method SW-846-8015. No analysis was conducted for BTEX, as the PID readings were below 100 ppm. Table 1 presents a summary of the laboratory analyses and PID readings of soil from the excavated area. Figure 2 shows the sample locations and TPH concentrations. Appendix A presents laboratory data and chain of custody documentation.

Referring to Table 1, soil samples collected from the west side (SS-6) and the bottom of the excavation (SS-7) reported TPH concentrations below the test method detection limit. Soil from the excavation was placed adjacent to the hole, and taken to an NMOCD approved landfarm. As all final samples obtained from Site #64 were below the RRALs, the excavation was filled with clean soil.
