**FINAL CLOSURE REPORT**

**UNLINED SURFACE IMPOUNDMENT CLOSURE**

**PHILLIPS PETROLEUM COMPANY**

**JAMES A LEASE  
NW SE OF SECTION 2  
TOWNSHIP 22 SOUTH, RANGE 30 EAST  
EDDY COUNTY, NEW MEXICO**

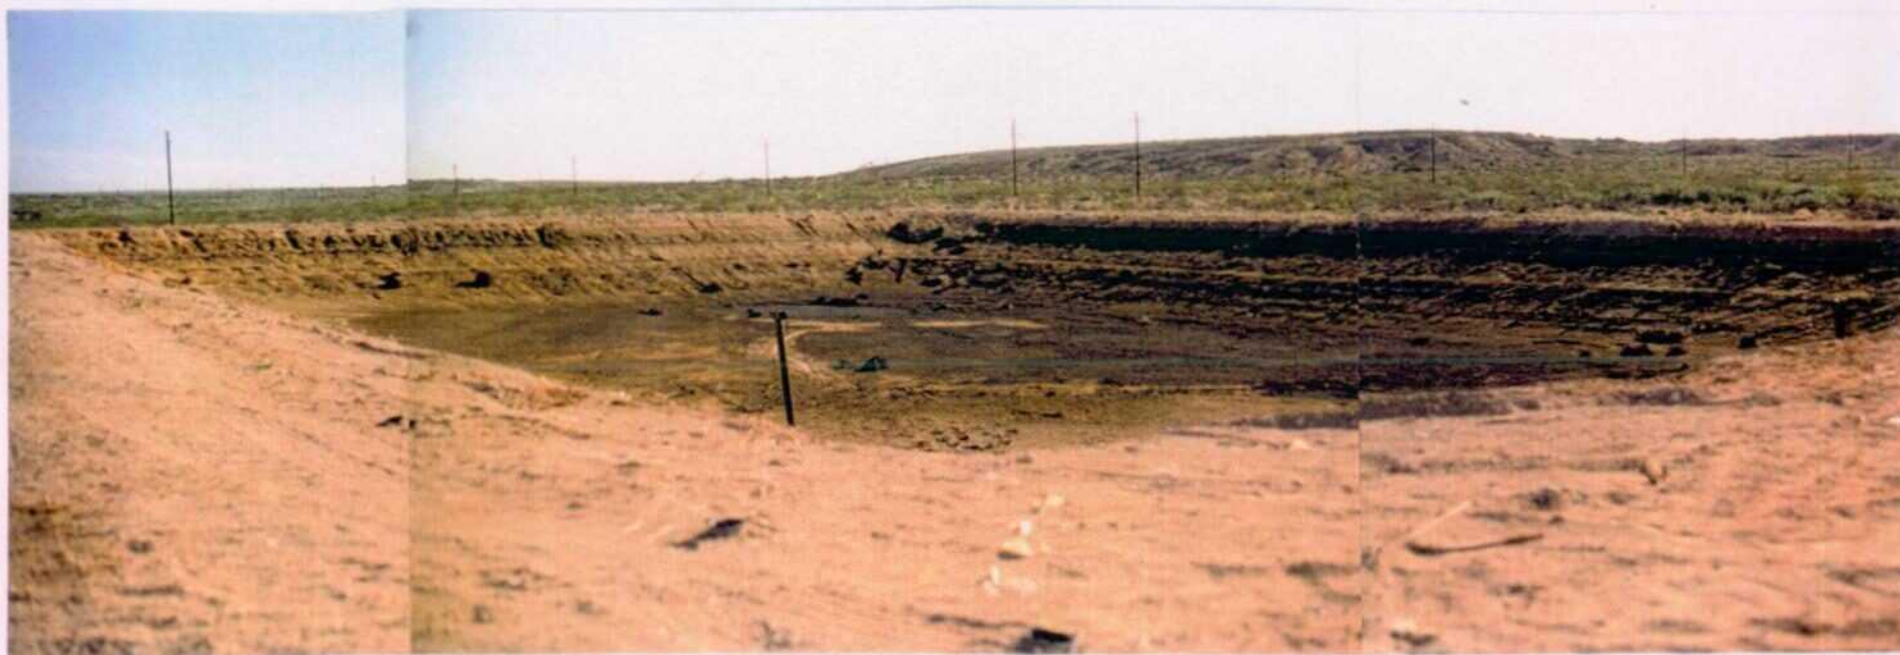
5/93

**JAMES A. PIT**

**FORMER CONTENT: PRODUCED WATER & CRUDE**

1. Prior to treatment, looking NE from SW corner

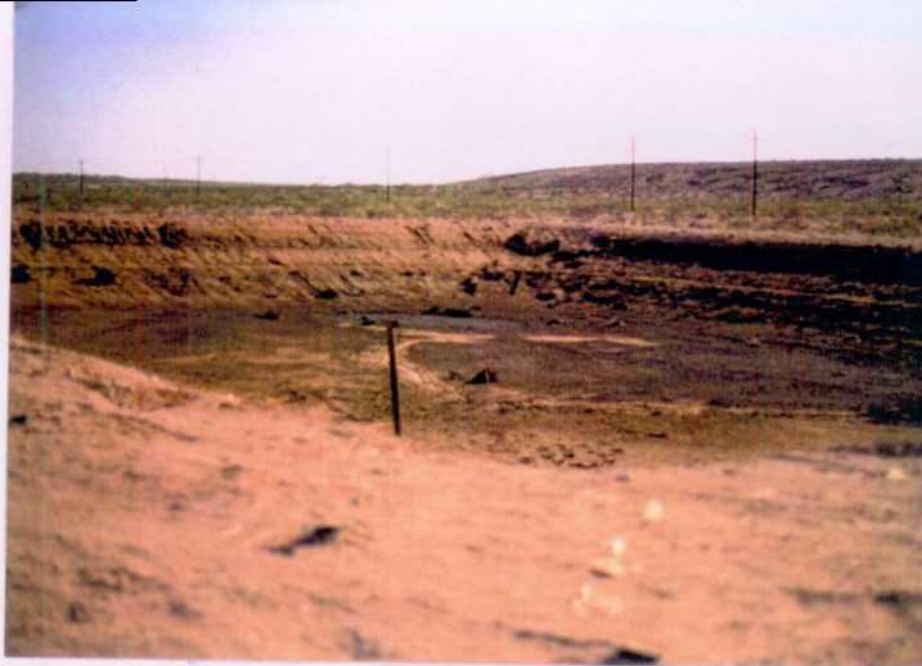
2. Looking north from SW corner

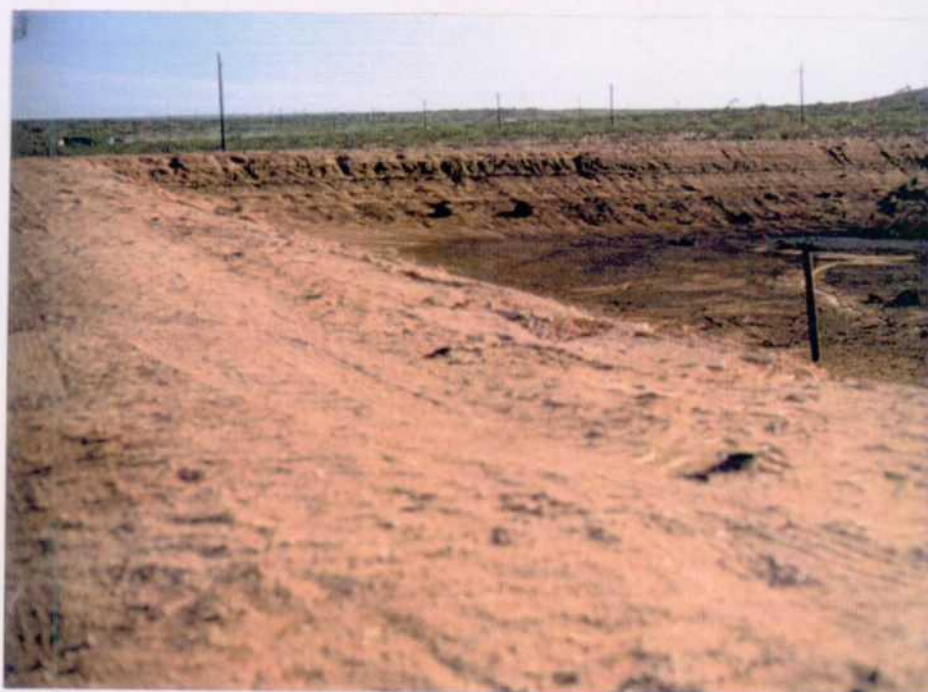
3. Heaviest concentration of hydrocarbons, NE corner of surface

Heavy staining was particularly noted to be associated with the area surrounding the inlet piping that supplies the produced water to the impoundment. The floors and walls were scraped until no visibly affected or odorous soils remained. The affected soils were piled along the east wall in preparation for treatment. An elevated berm was built near the east center of the impoundment floor to assist in the treatment process. Cementitious materials were then thoroughly mixed with the affected soils while adding fresh water. Areas of approximately 30' X 20 feet were mechanically mixed and subsequently allowed to harden and cure. Core sampling of each day's mixing was performed prior to hardening. Proper sample techniques and protocol were utilized in the acquisition, handling and transport of all samples. Analytical results are presented in the following section of this report. After all affected soils were thoroughly mixed and solidified, a smooth finish was placed on the mixture. After allowing approximately 120 hours (5 days) of curing time, the remaining impoundment walls were utilized to cover the solidified materials and bring the impoundment back to grade. The area of solidified soil was bermed one to two feet above the surrounding terrain to prevent rain water pooling and run-on from up gradient rain water.

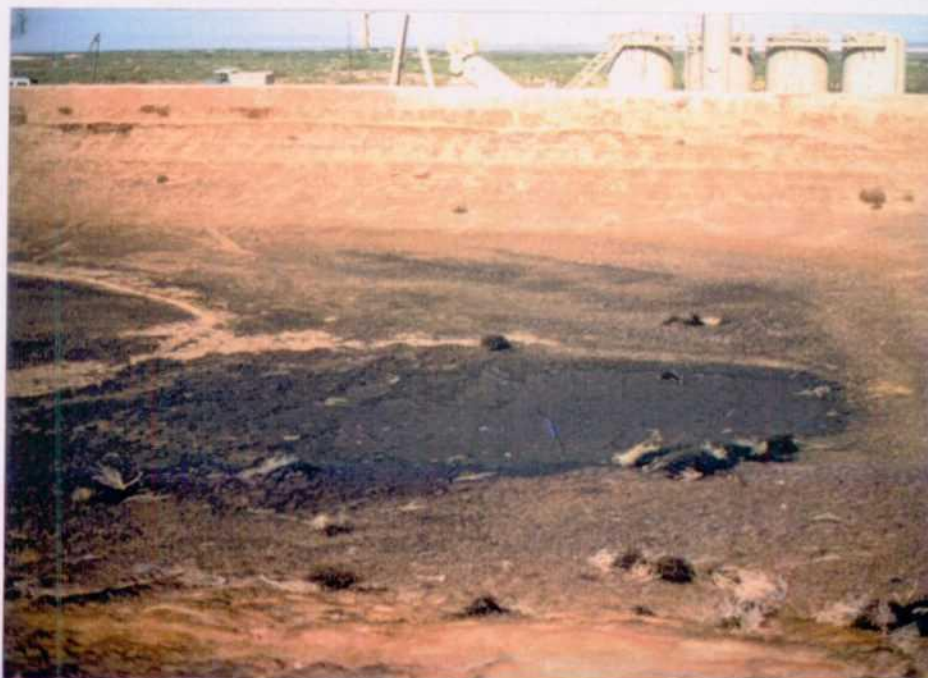
4. Pushing wall materials  
into pit area

The operations began by scraping the interior sloped walls of the impoundment into the level impoundment area. The floor of the impoundment was then mechanically scraped and pushed (crowded) to the east side of the interior of the impoundment. The impoundment was dewatered at the time of the remedial action. It was noted that discolored soil was found in spotty patches to a depth of approximately four (4) feet.

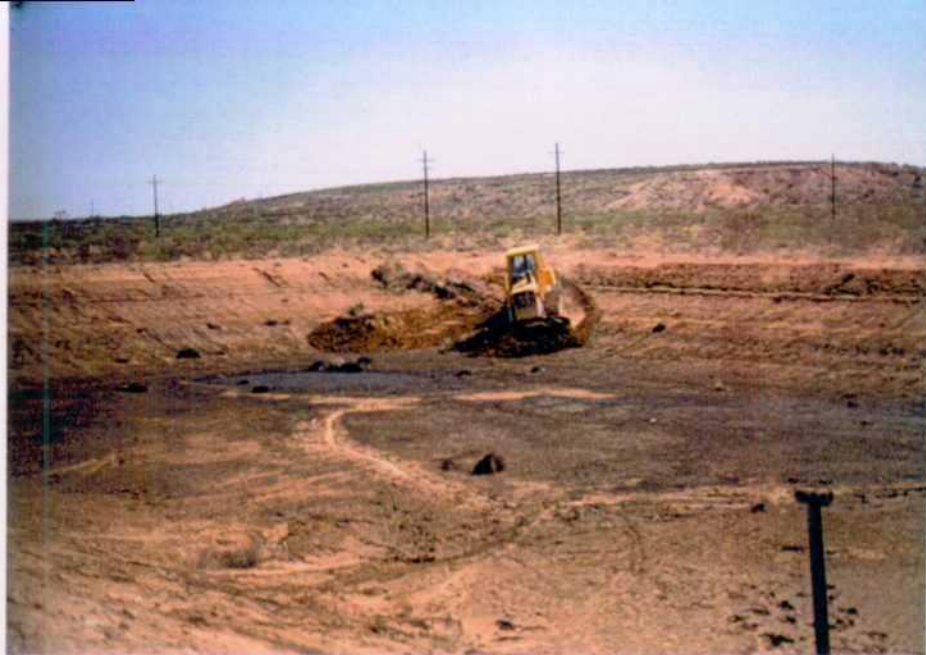
5. Excavation of heaviest section  
of sludge to 4 feet deep

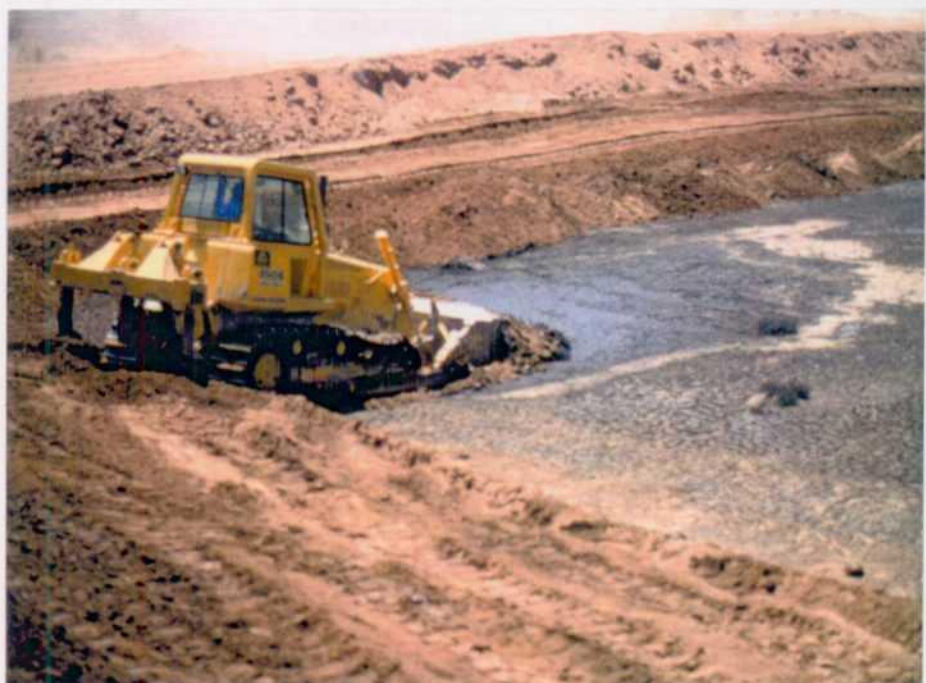
6. Unaffected soil below 3-4 feet

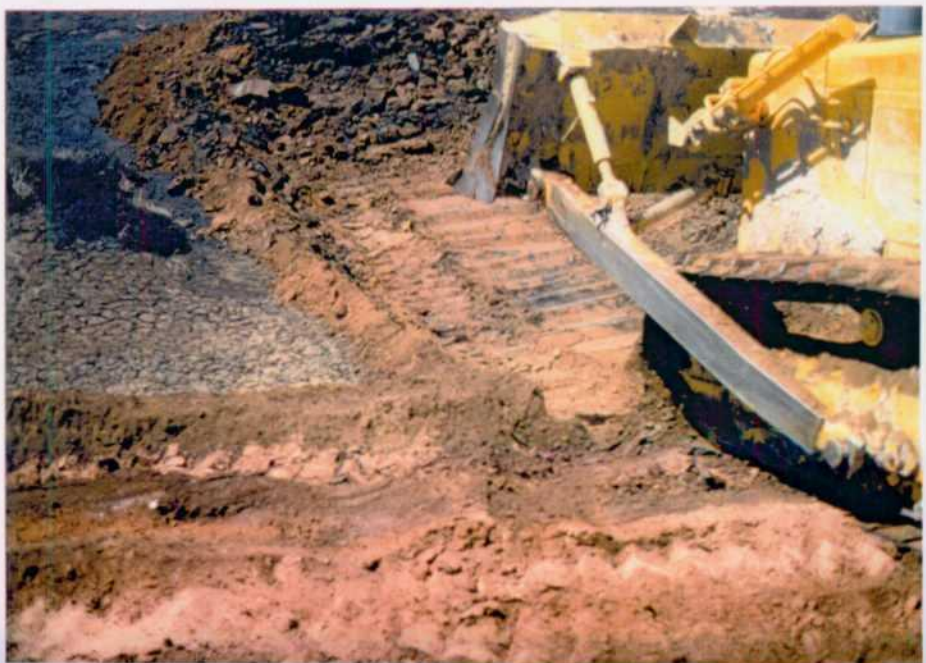
7. Unaffected soil below 3-4 feet

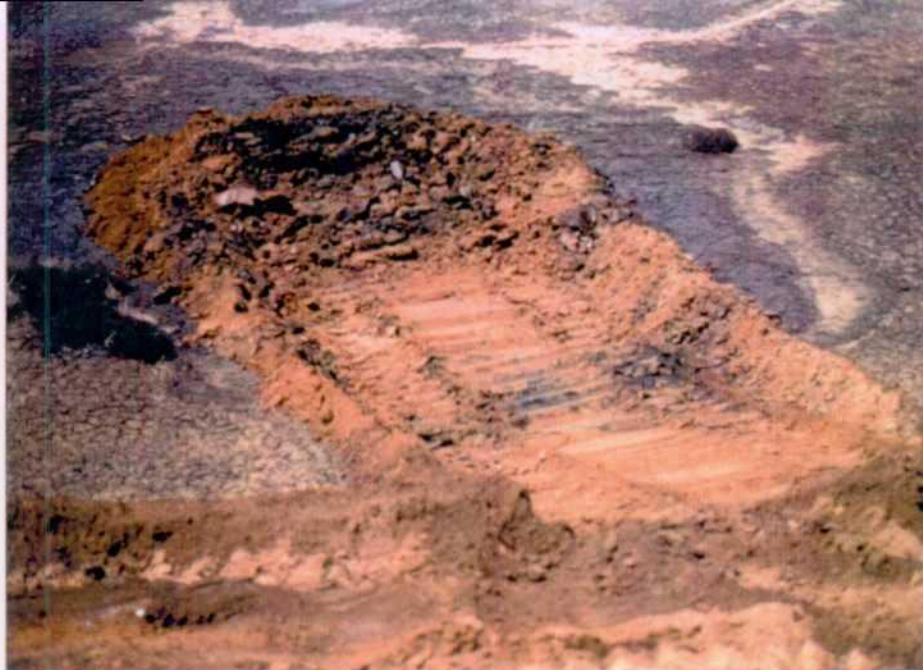
8. Crowding pit to east side

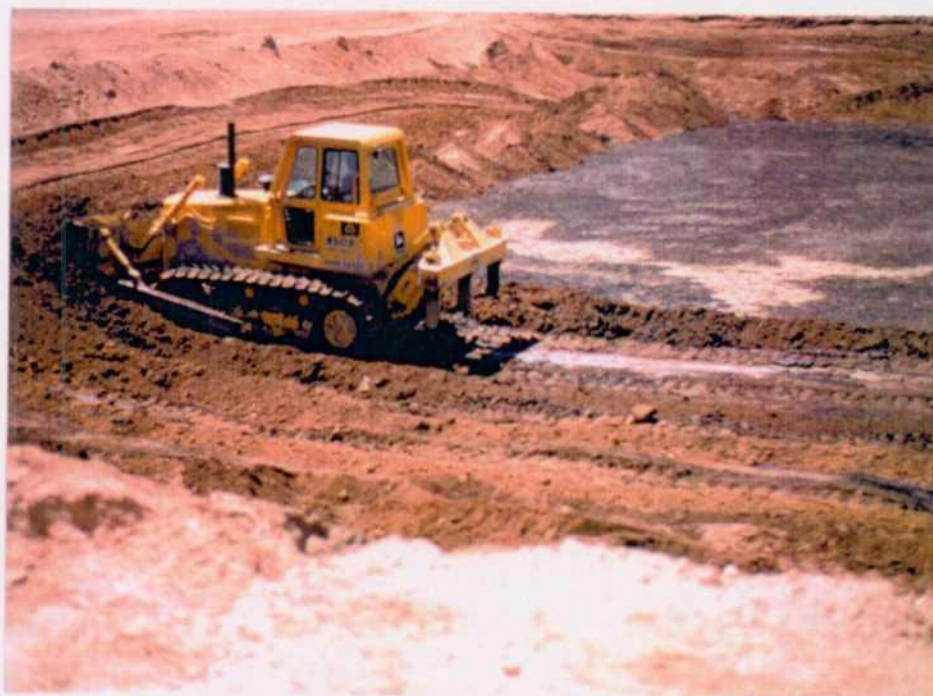
9. Crowding pit

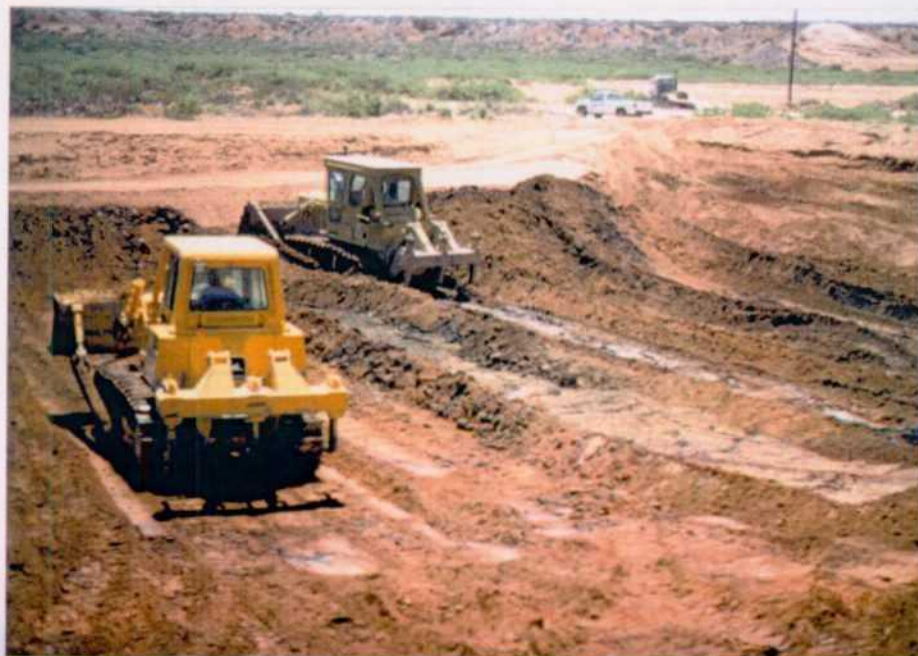
10. Crowding pit after pushing  
in wall material

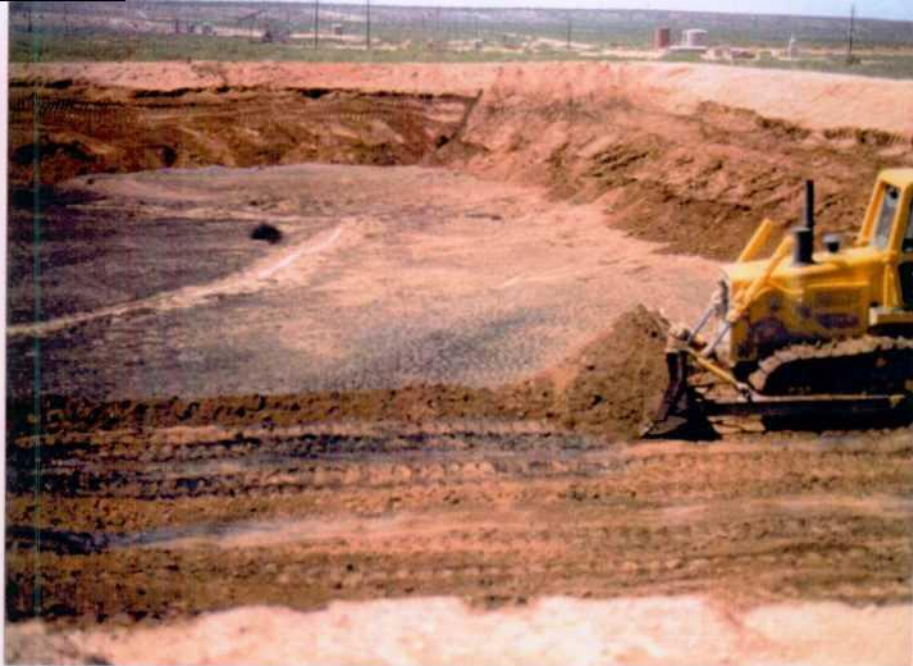
11. Visual staining

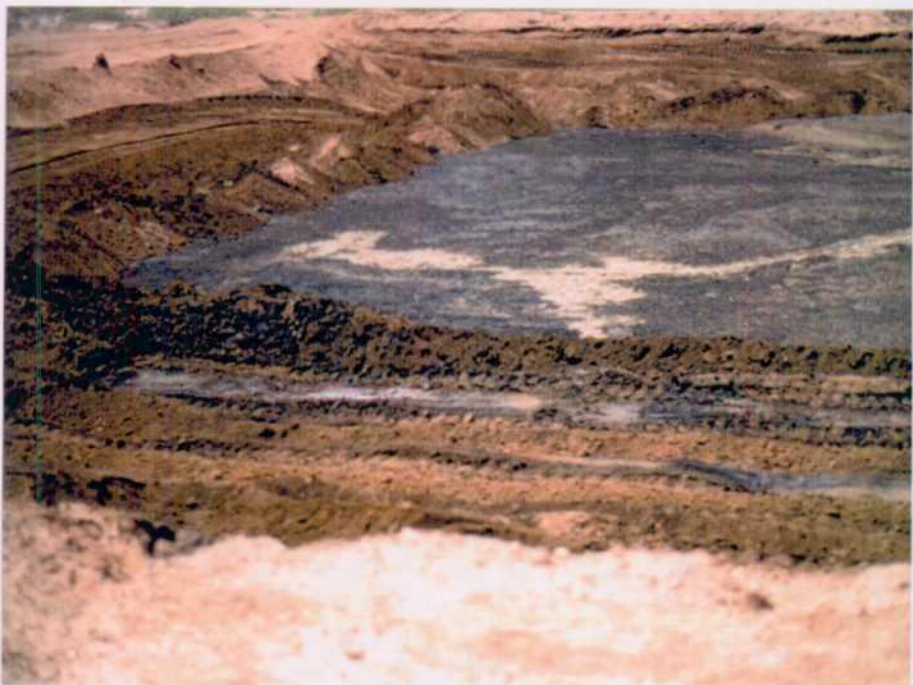
12. Building treatment area

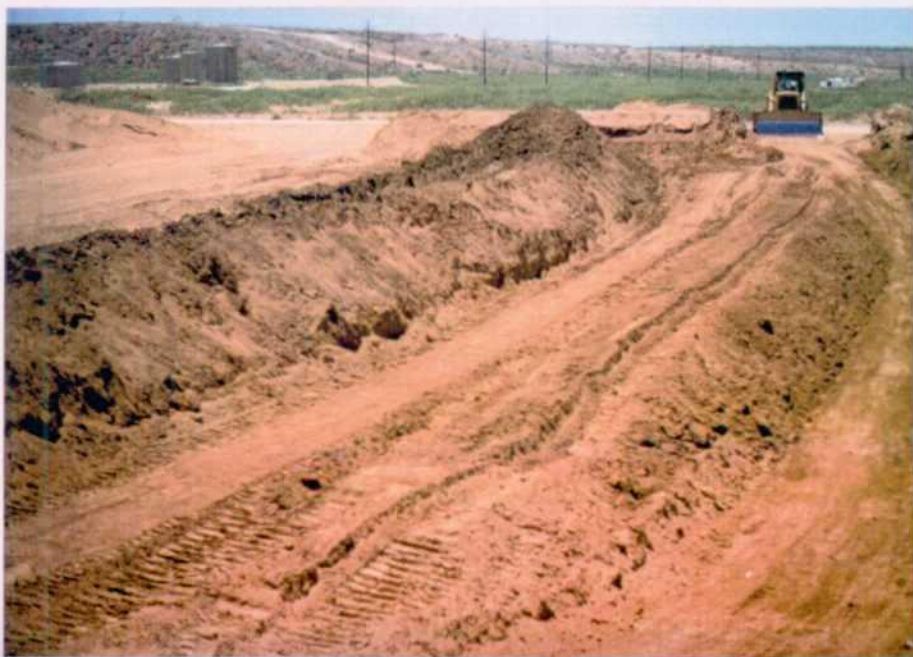
13. Solidified Pit

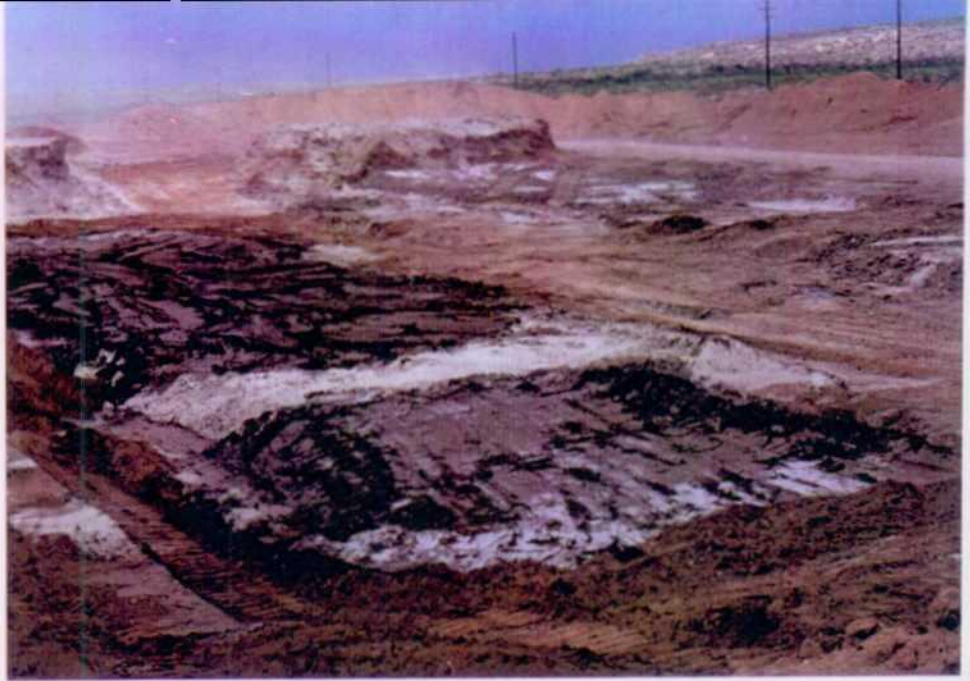
14. Solidified Pit

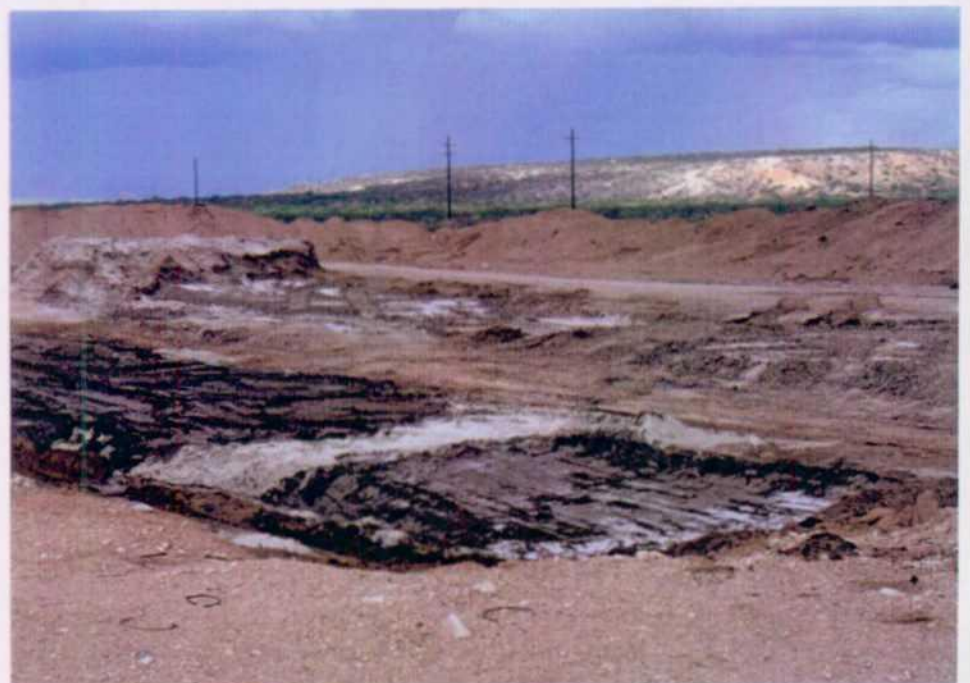
15. Reclaiming pit to original grade

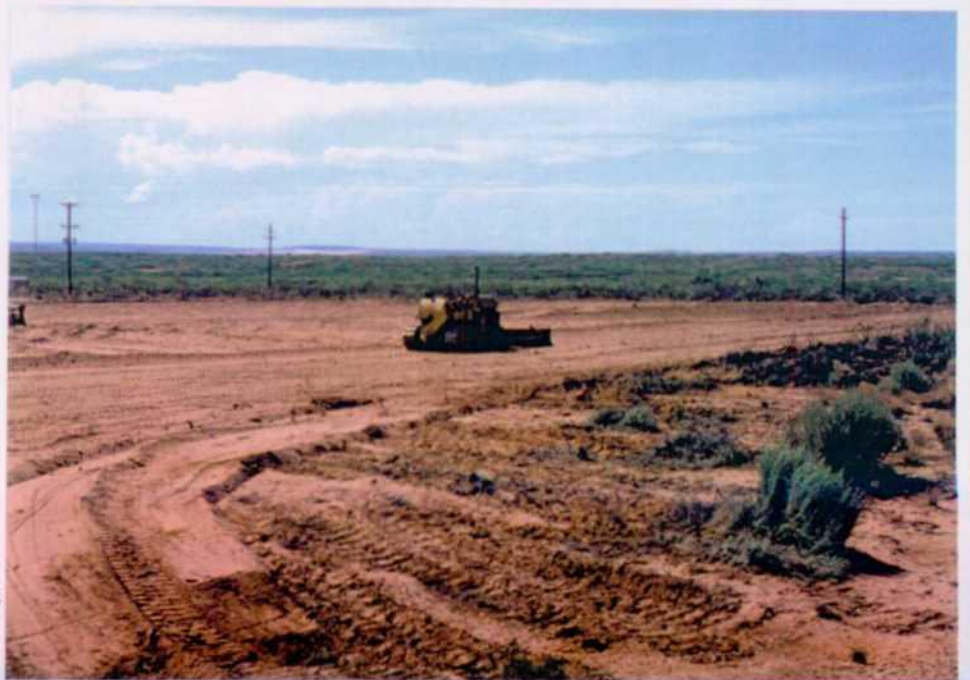
16. Covering pit and berming

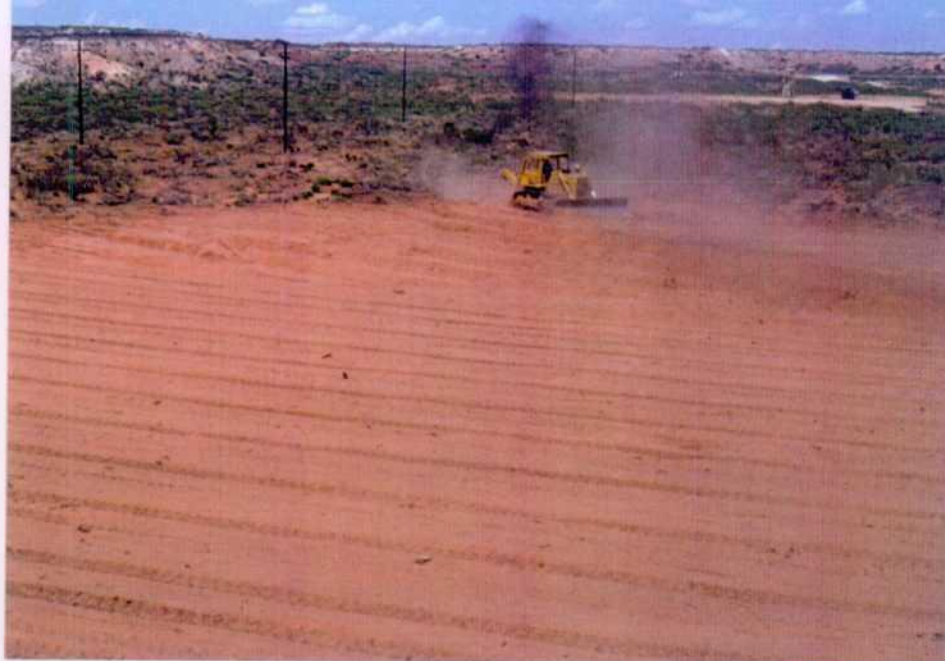
17. Covering pit

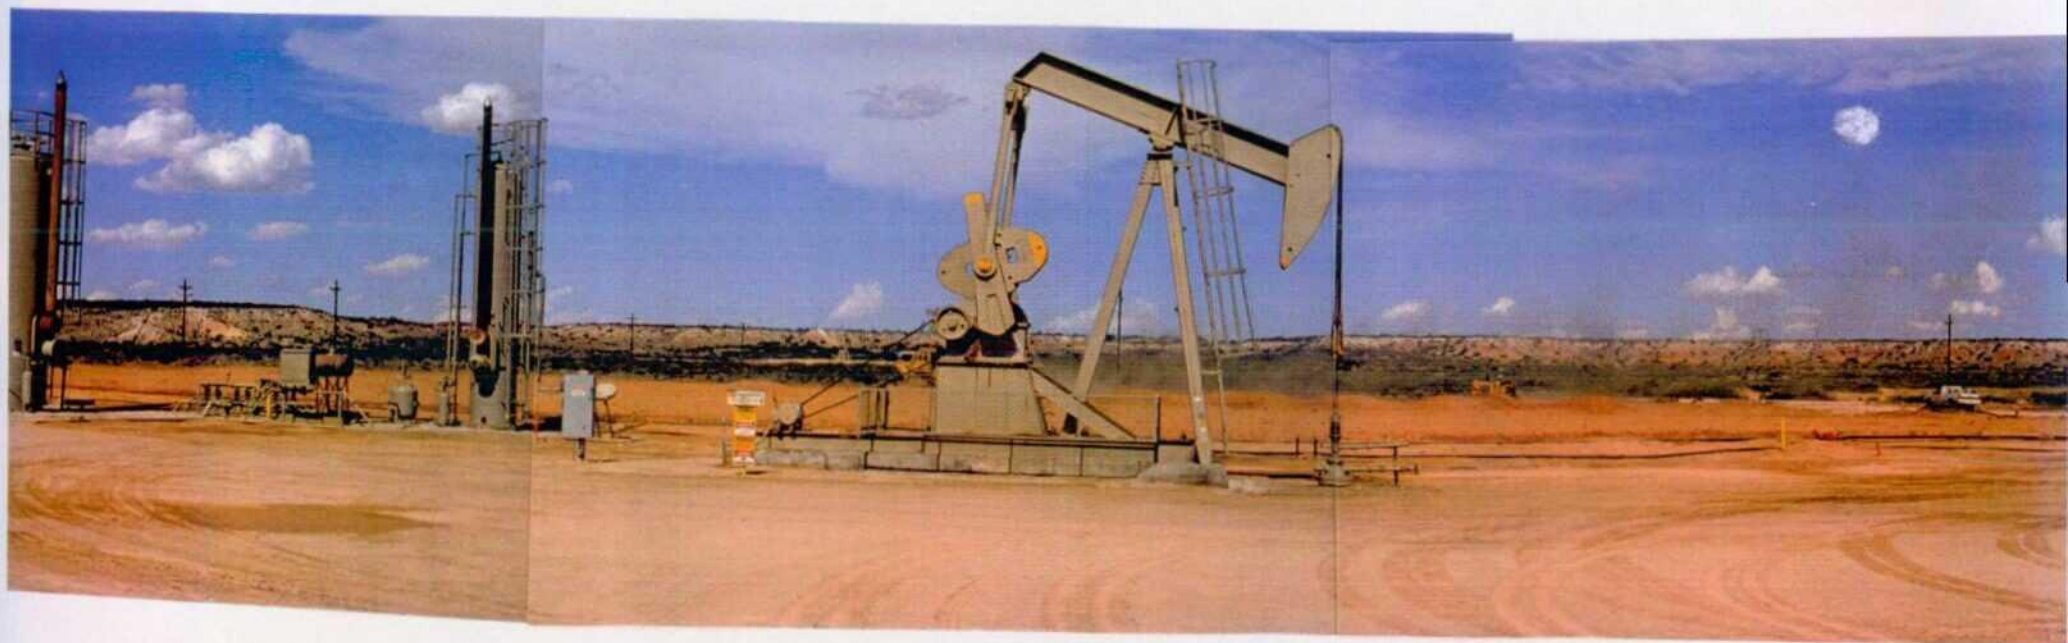
**REMEDIATION AND RECLAMATION COMPLETE**
