2R - 38

**REMEDIATION AND CLOSURE REPORT
TRICO INDUSTRIES
OLD ARTESIA SITE
ARTESIA, NEW MEXICO**

- FIGURE 1 Site Plan
- FIGURE 2 Asbestos Sample Locations
- FIGURE 3 Verification Sample Locations

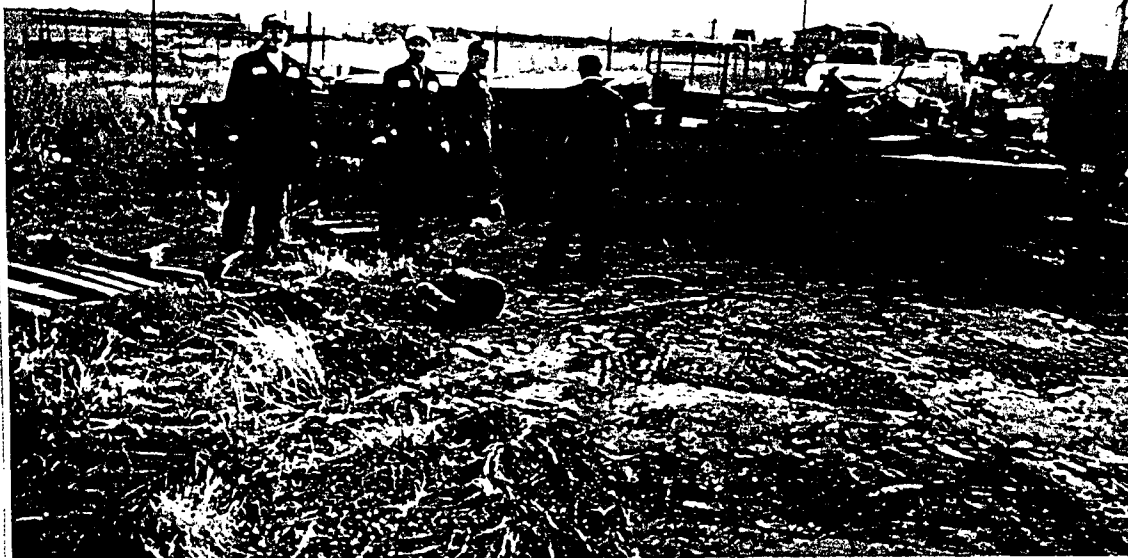
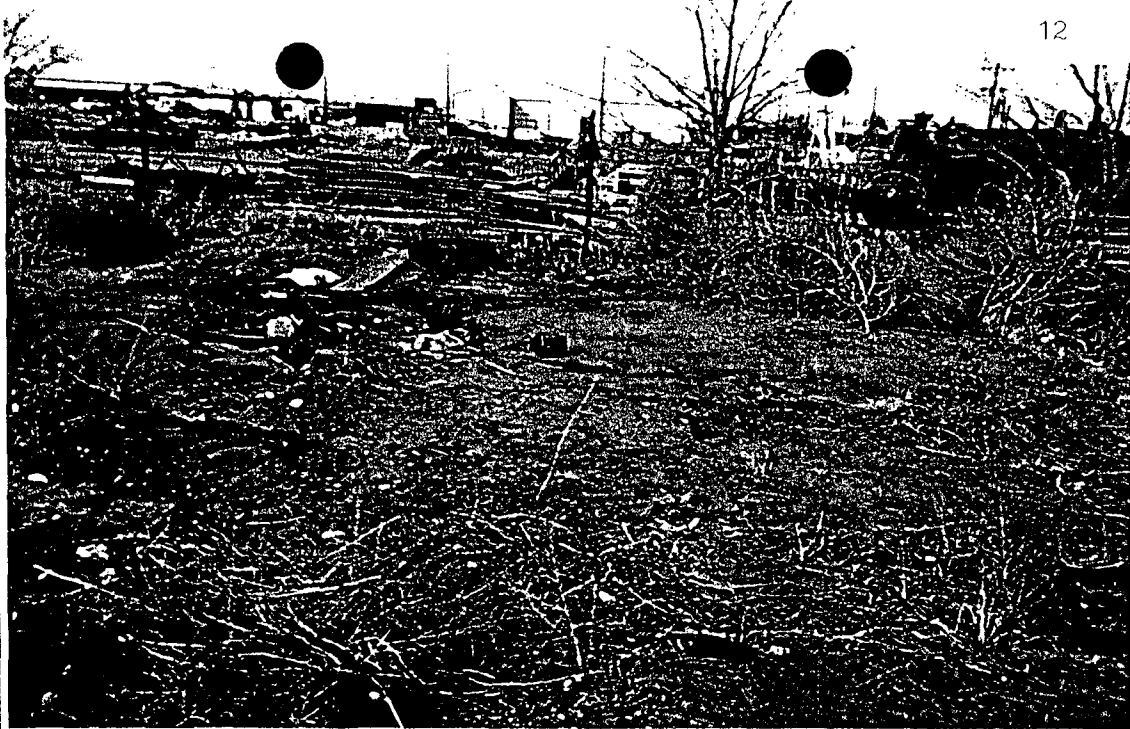
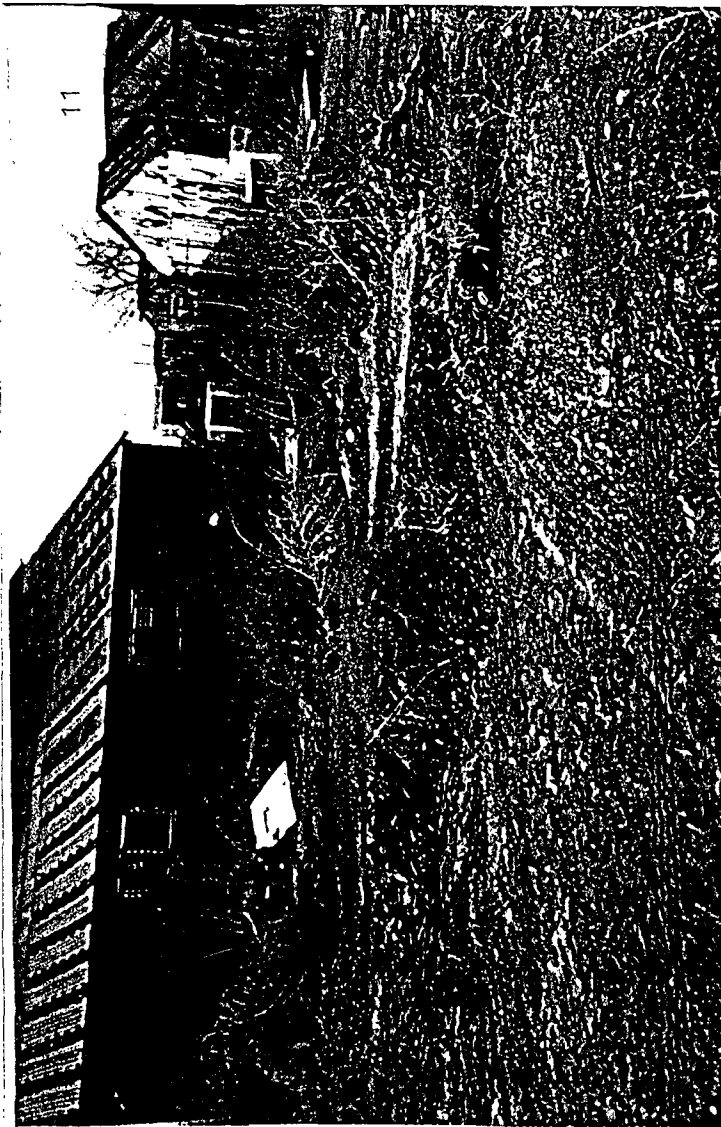
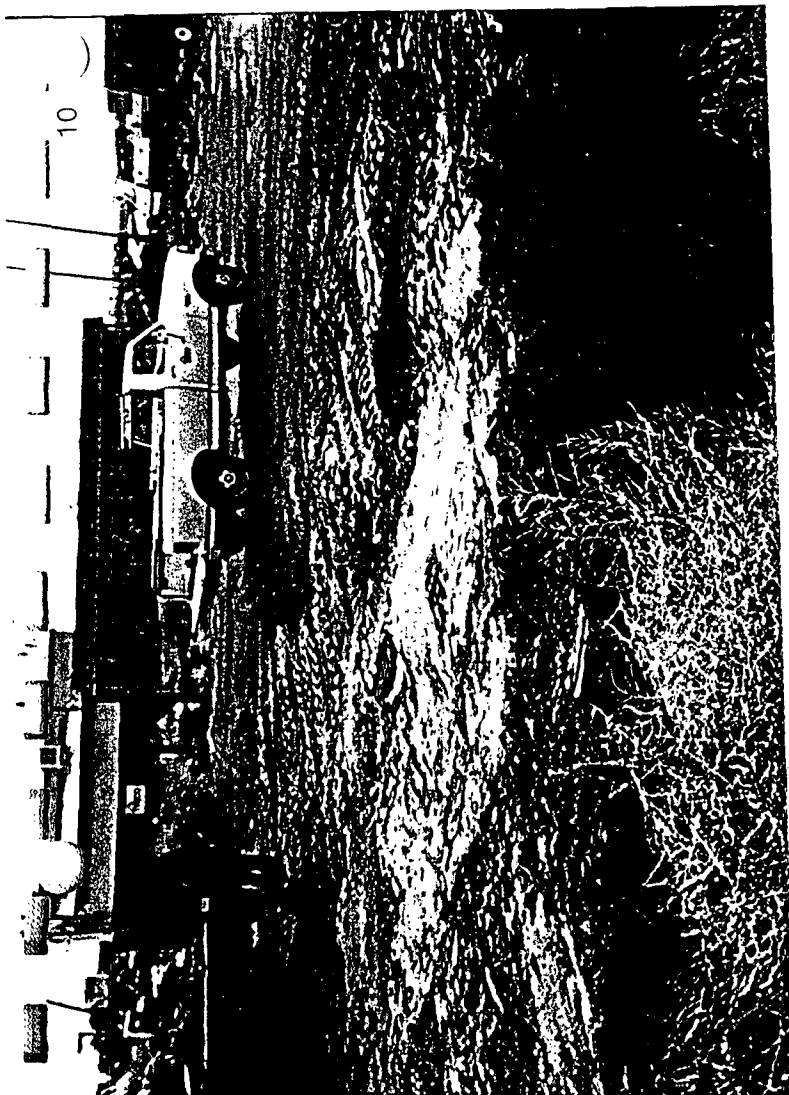
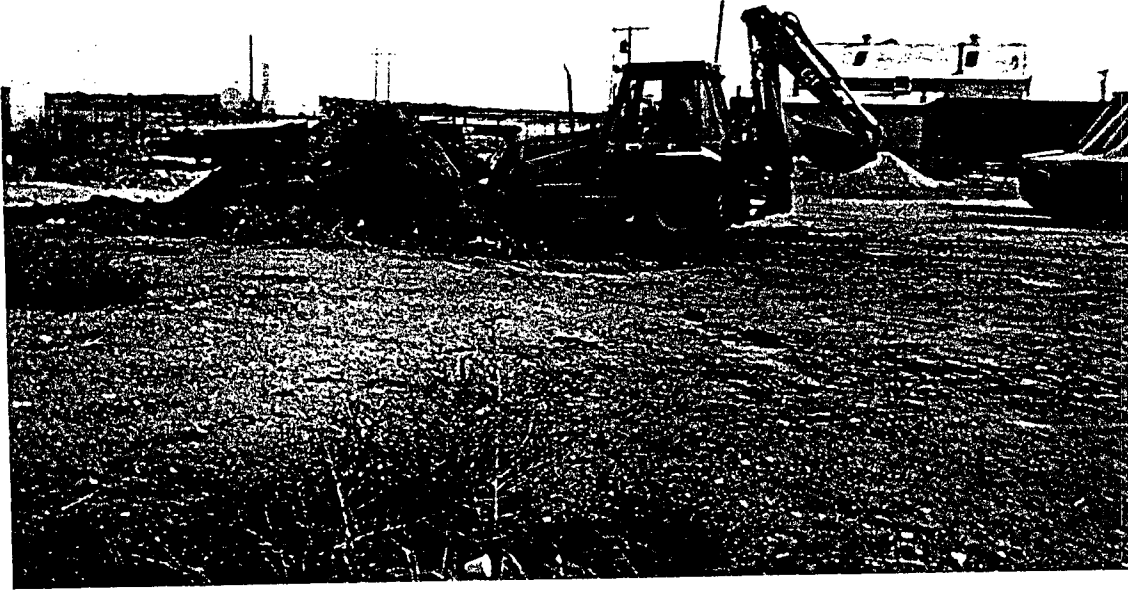
FIGURE 1

The two buildings present at the site were also inspected on October 21, 1993, and are shown in detail in Figure 1, the Site Plan. The building located on the west side of the site was used as an office and workshop, and the second building located on the east side of the site was apparently used for materials storage.

The office building/workshop is approximately 40 feet by 96 feet, and is constructed of steel structural frame members, with corrugated metal sides and roof, and a concrete slab floor. The building appears to be in generally good condition. The south end of the building consists of a reception/secretarial area, two offices, two restrooms, and a storage room (see Figure 1). The reception area has a ceramic tile floor, while the secretarial area and front office is carpeted. Interior office walls consist of paneling. The ceiling in the reception/secretarial area is textured sheetrock, with the ceiling in the second office consisting of spray-on acoustic texture. Lighting in this area and throughout the rest of the building is provided by fluorescent ceiling lights.

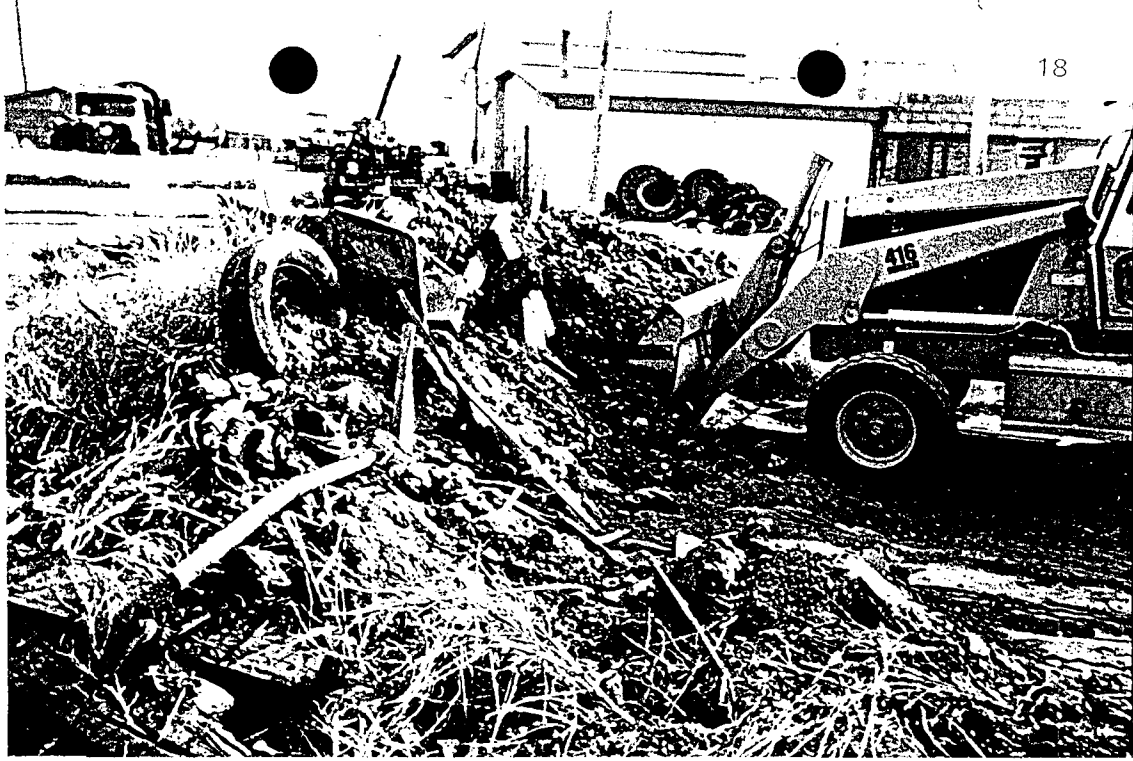
| 17 | Loading trash pile into end dumps for transportation to landfill. |
| 18 | View of debris pile while loading with backhoe. |
