Re: Notice of Groundwater Impact  
Amoco Production Company - McCoy GC D1  
SE/4 NE/4 Sec. 28 - T30N - R12W, San Juan County, NM

On behalf of Amoco Production Company, Blagg Engineering, Inc. (BEI) has conducted environmental monitoring at the subject location. A release of hydrocarbons to the environment was discovered by a private landowner during preparations for a residential home construction. The site was subsequently investigated and remediated by Amoco using excavation techniques. Following site reclamation groundwater monitoring points were installed to document residual water quality.

McCOY GC D # 1

**Location:** Lake Luther Estates  
New Home Site North bank of Animas River  
South of Old Beeline Refinery

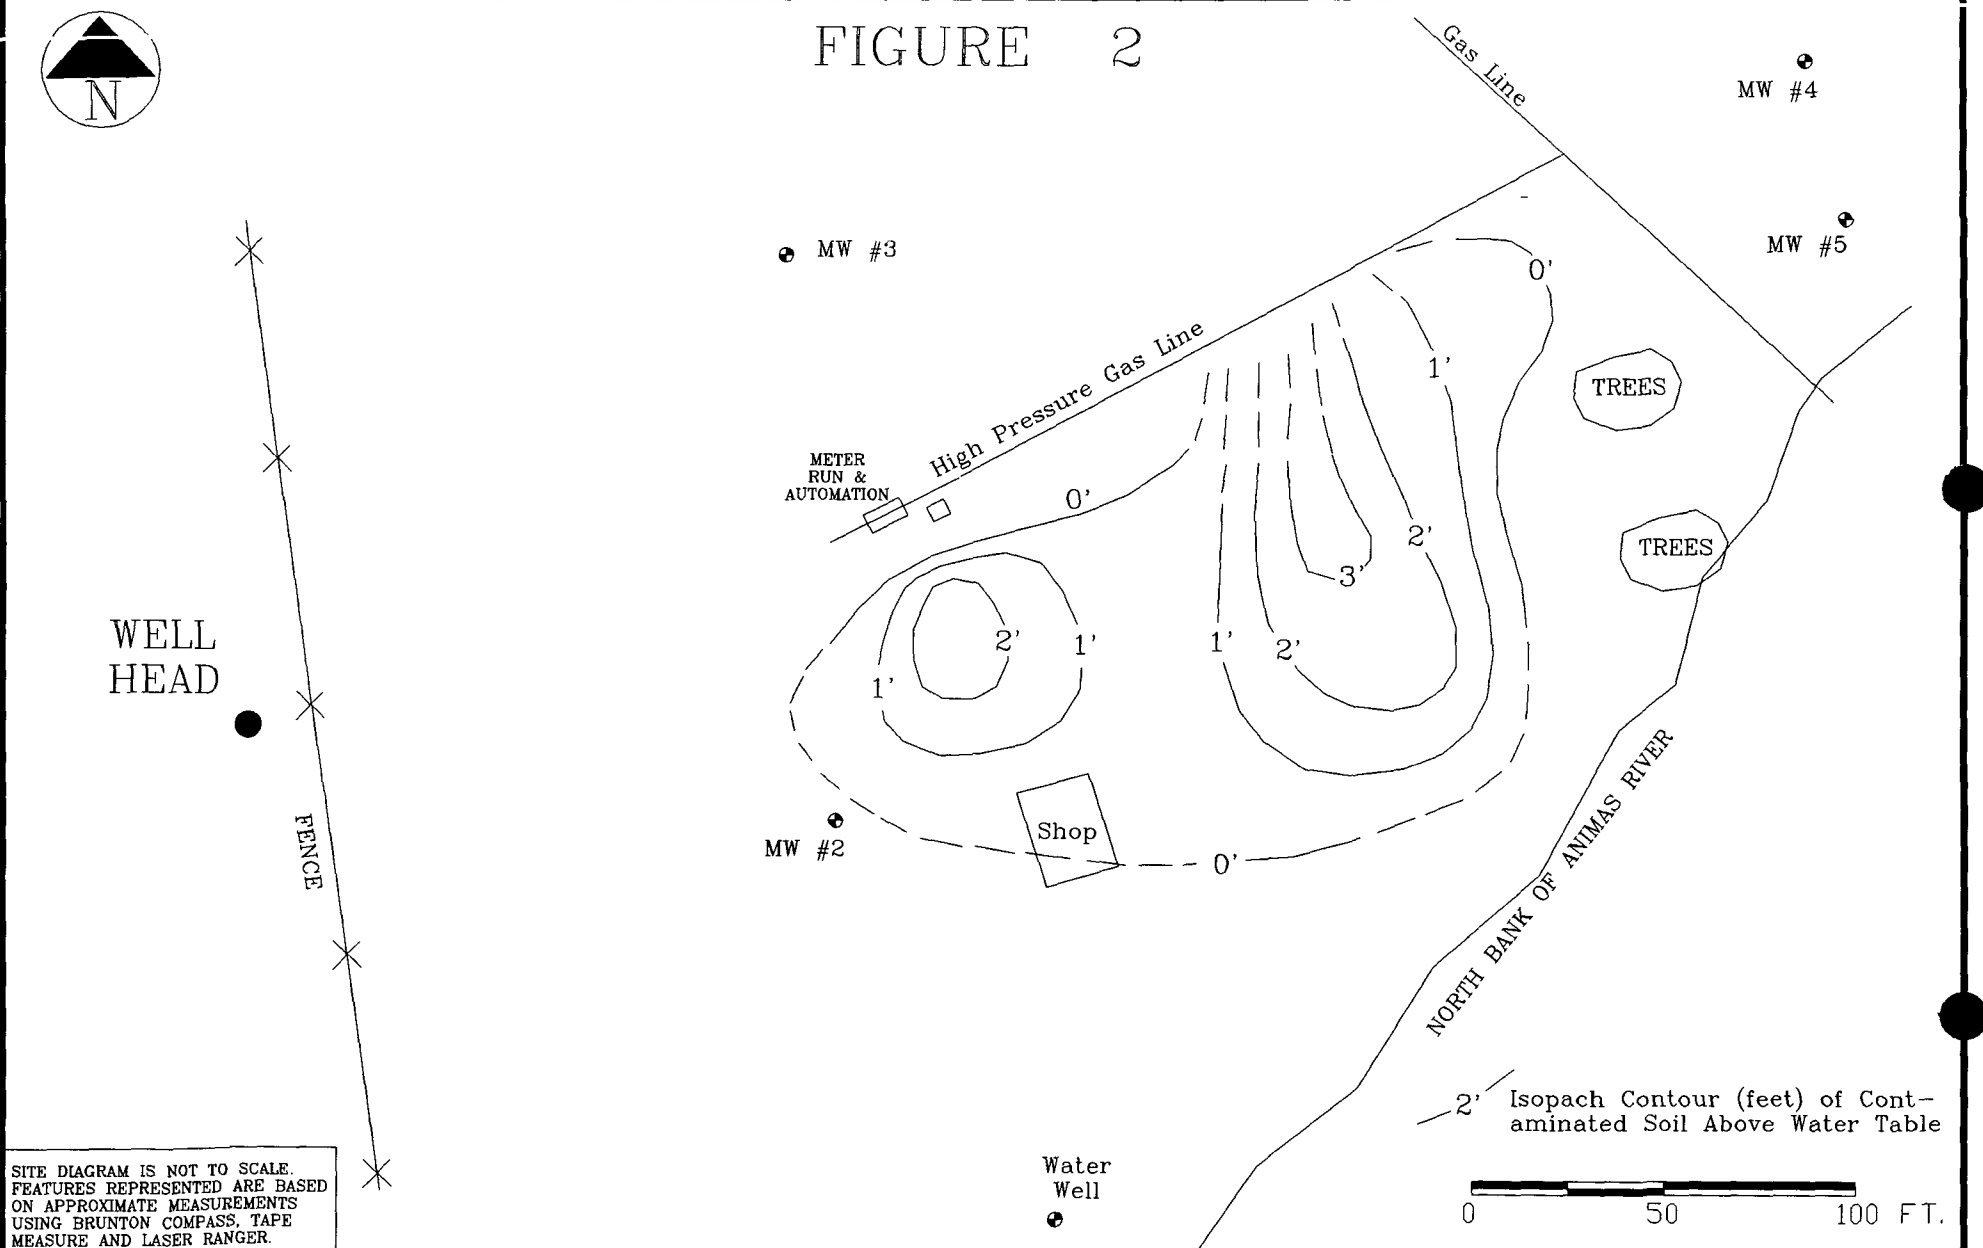
# FIGURE 2

CONTAMINATED  
SOIL ISOPACH

Attached, please find site diagrams indicating the areas remediated, contaminated soil thickness, area of engineered backfill (to accommodate the private landowner), groundwater gradient and groundwater quality. Also attached are laboratory water quality reports.

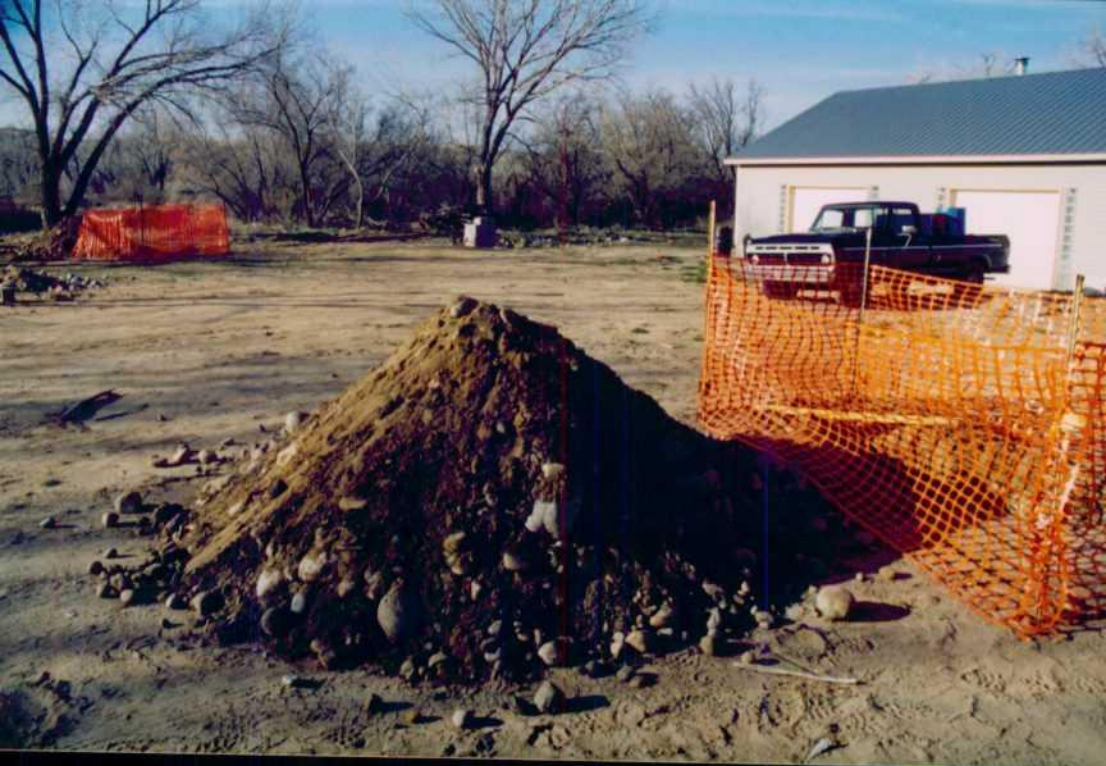
**Picture 1:** Contaminated soil from backhoe pit northeast of garage  
Future home site position.

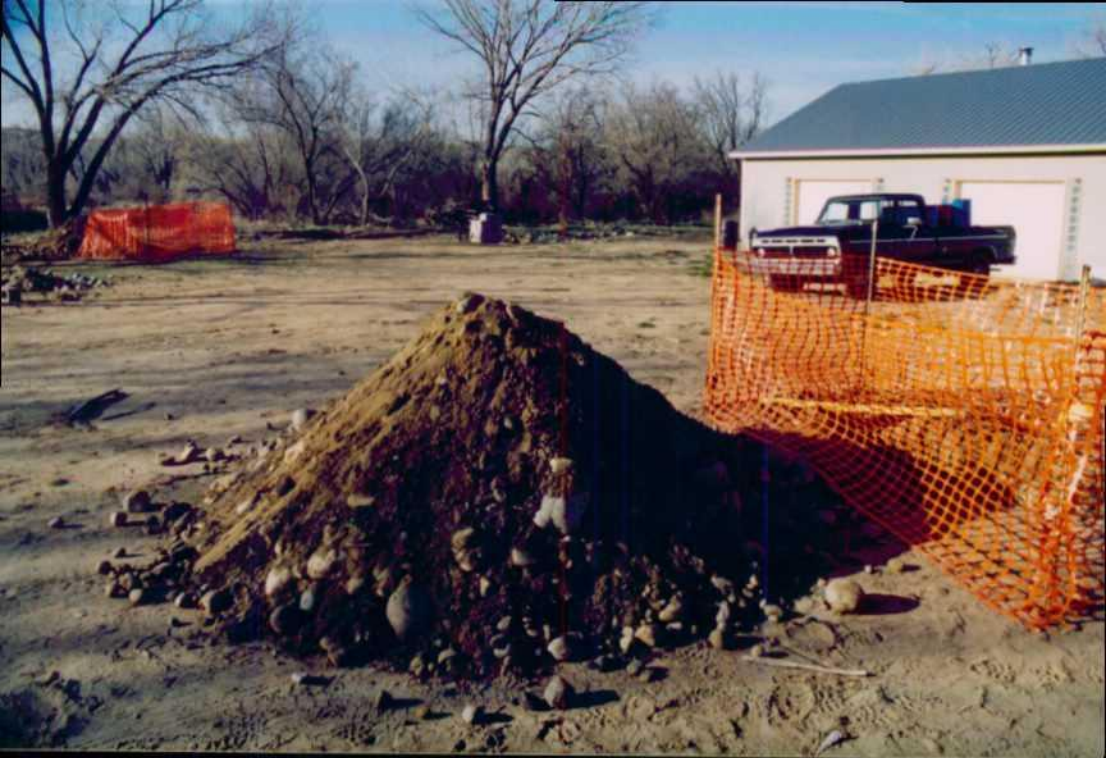
**Picture 1:** Contaminated soil from backhoe pit northeast of garage  
Future home site position.

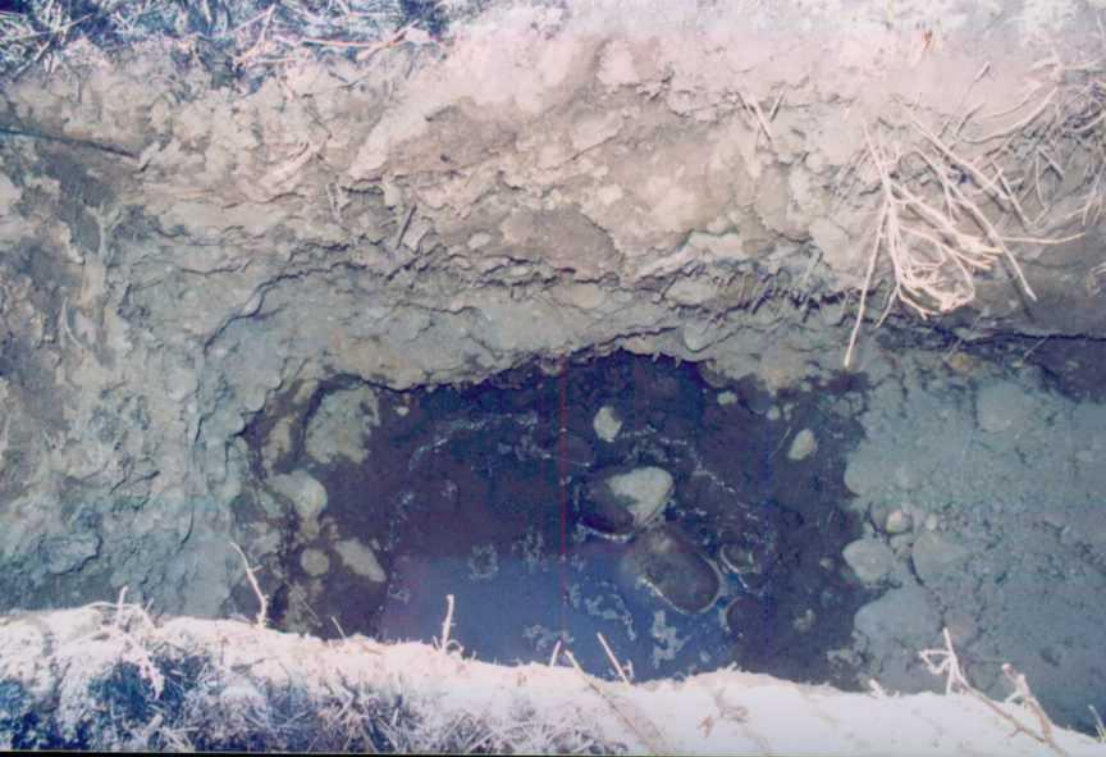
**Picture 2:** Contaminated soil and ground water approximately 6 feet bgs.  
backhoe pit north of garage  
between garage and Well in Unit H of Section 28, T 30 N, R 12 W.

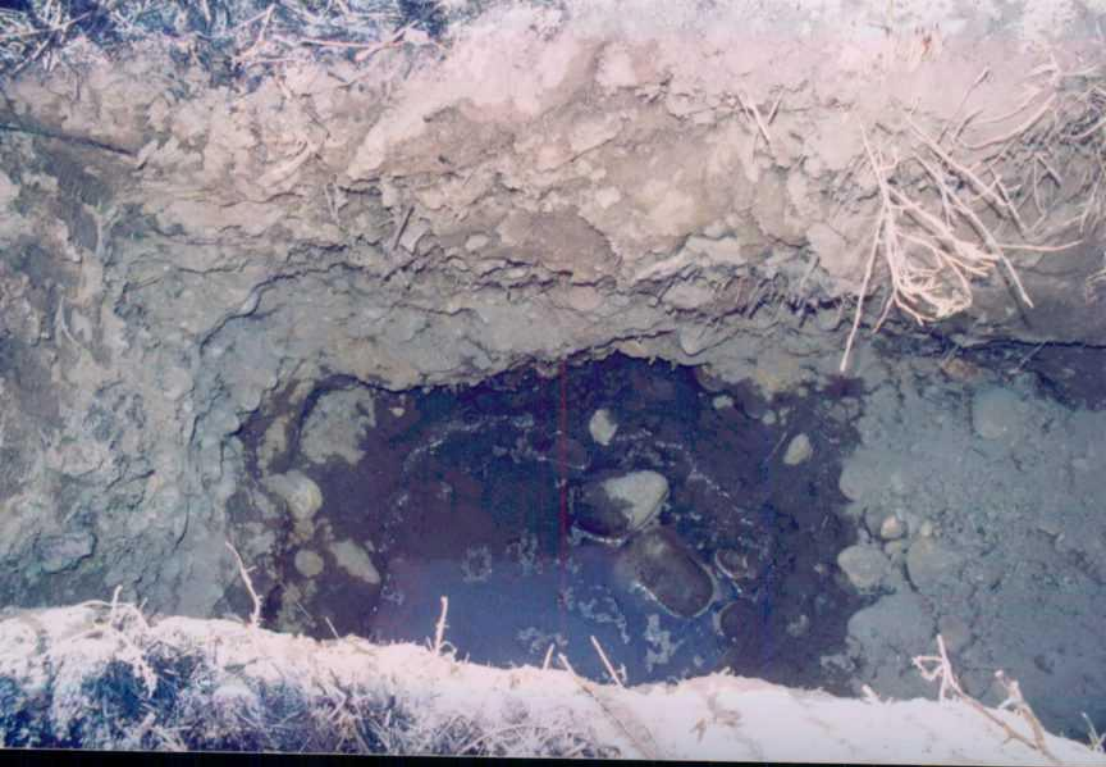
Picture 2: Contaminated soil and ground water approximately 6 feet bgs.  
backhoe pit north of garage  
between garage and Well in Unit H of Section 28, T 30 N, R 12 W.

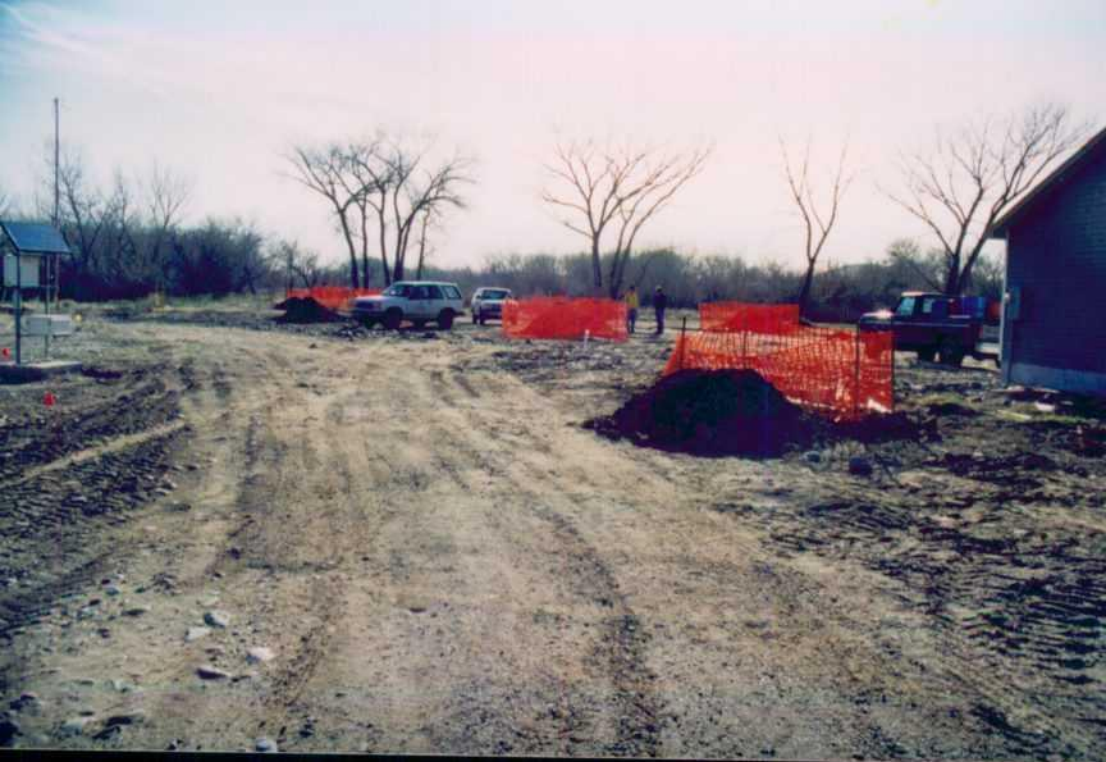
**Picture 3 :** Contaminated soil from backhoe pits from north of garage looking East (up river)  
Future home site position near OCD trucks and people.

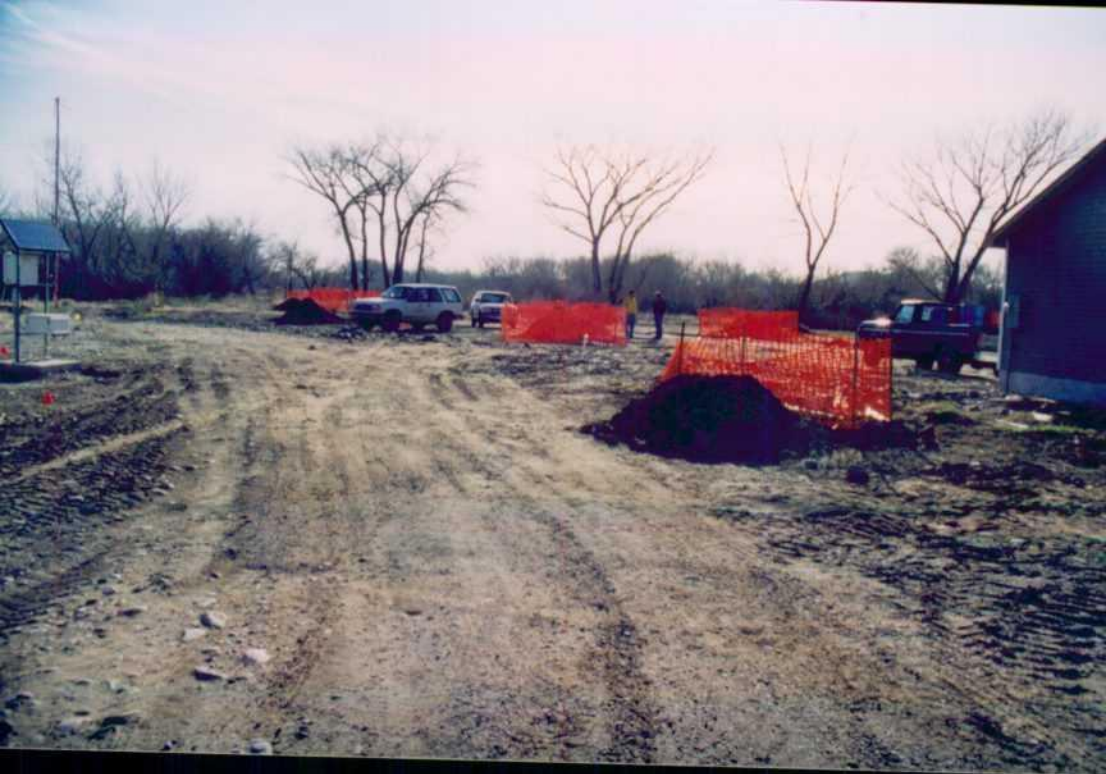
Picture 3 : Contaminated soil from backhoe pits from north of garage looking East (up river)  
Future home site position near OCD trucks and people.

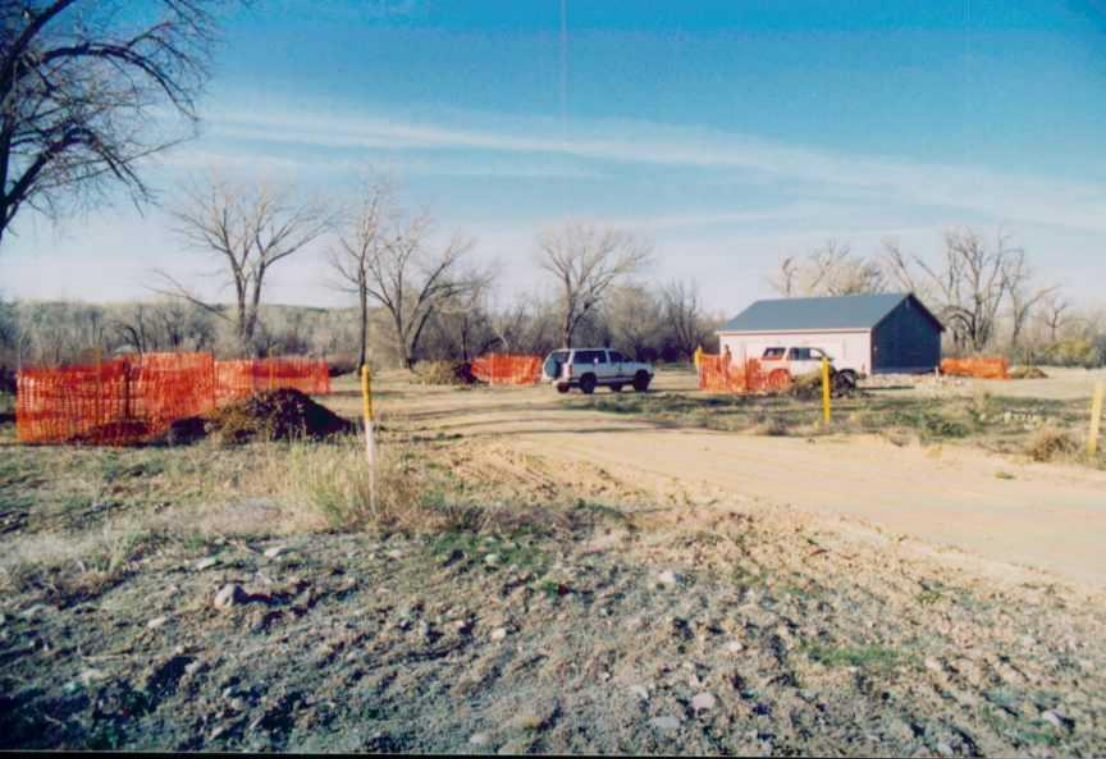
**Picture 4 :** Contaminated soil from backhoe pits looking southwest  
Future home site position near OCD trucks.  
Yellow poles mark buried pipe lines.

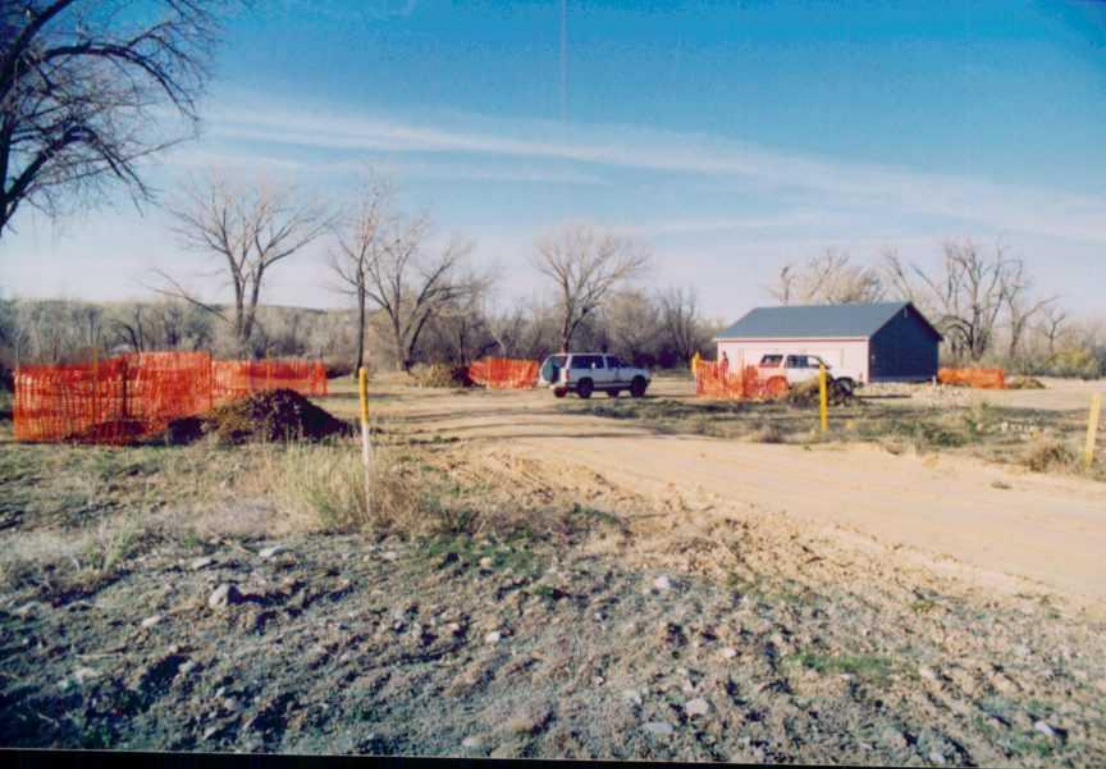
**Picture 4 :** Contaminated soil from backhoe pits looking southwest  
Future home site position near OCD trucks.  
Yellow poles mark buried pipe lines.

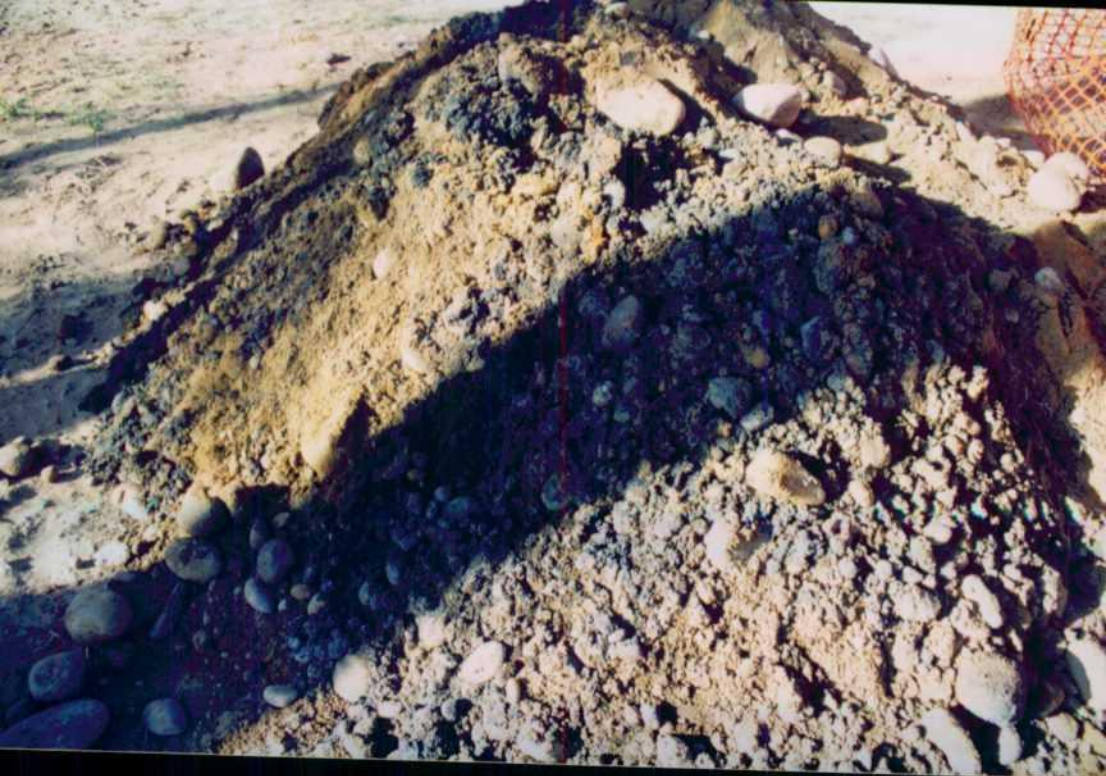
Picture 5 : Contaminated soil from backhoe pit furthest East and nearest the River  
Future home site position.

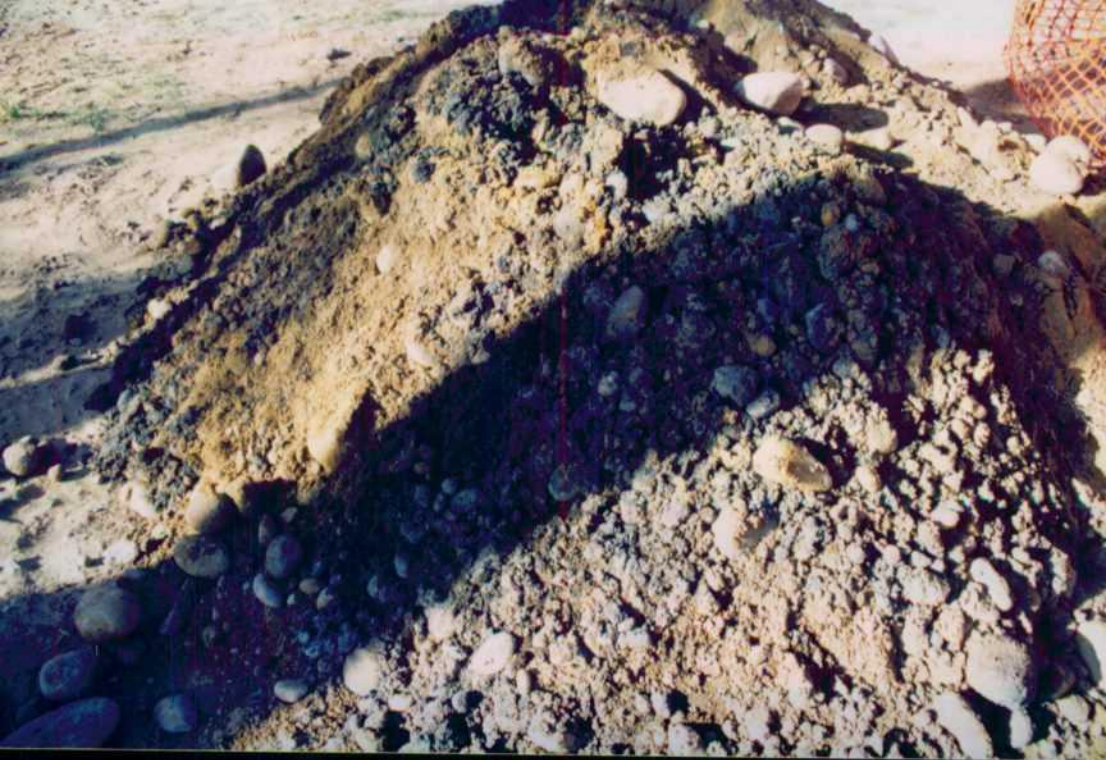
Picture 5 : Contaminated soil from backhoe pit furthest East and nearest the River  
Future home site position.

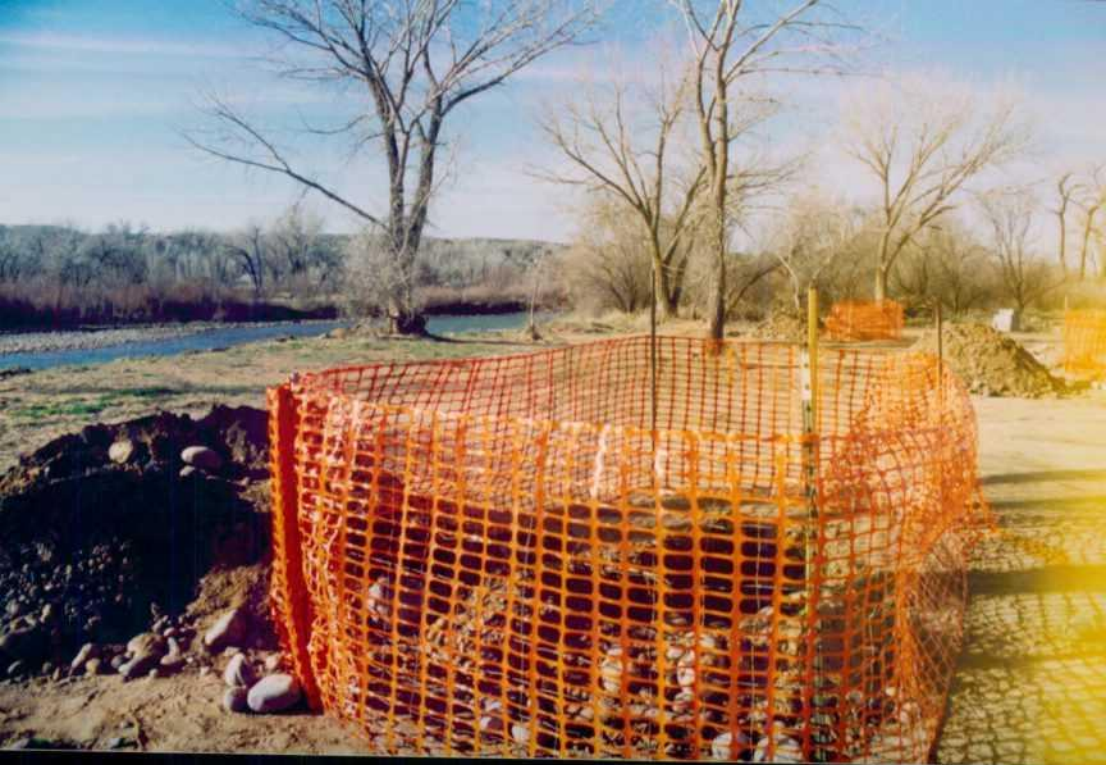
**Picture 6:** Contaminated soil from backhoe pit furthest East and nearest the River  
Pits to the West along river bank show visual contamination.

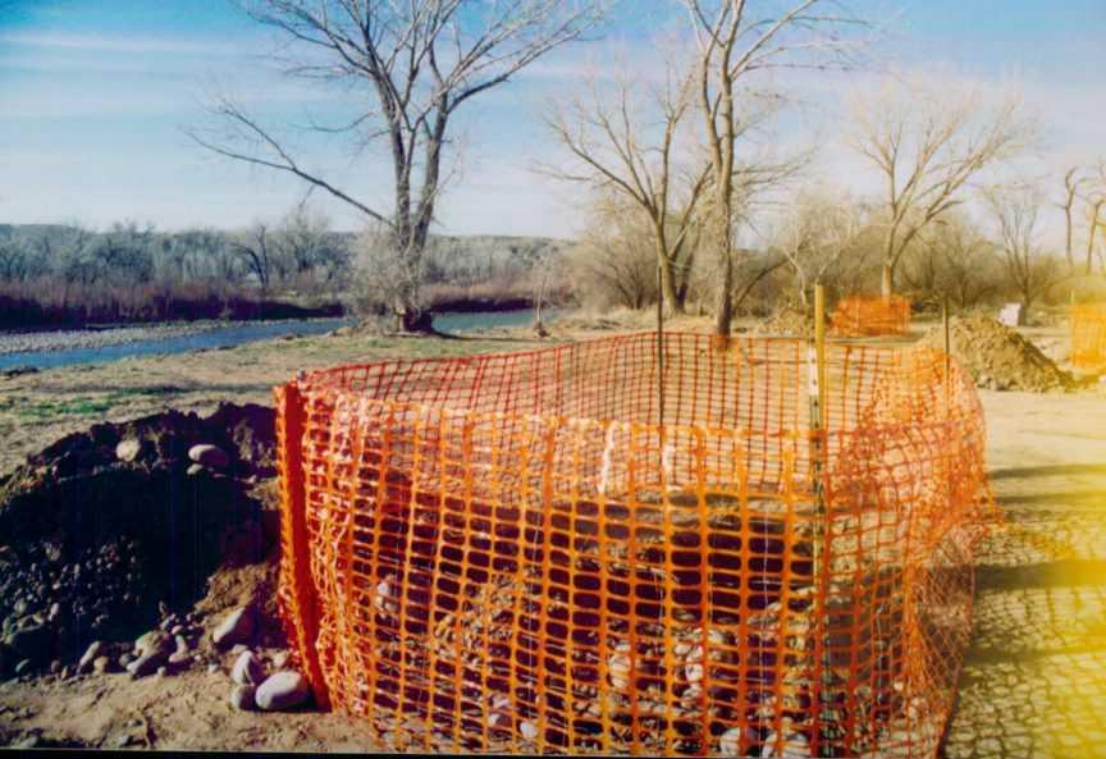
**Picture 6:** Contaminated soil from backhoe pit furthest East and nearest the River  
Pits to the West along river bank show visual contamination.

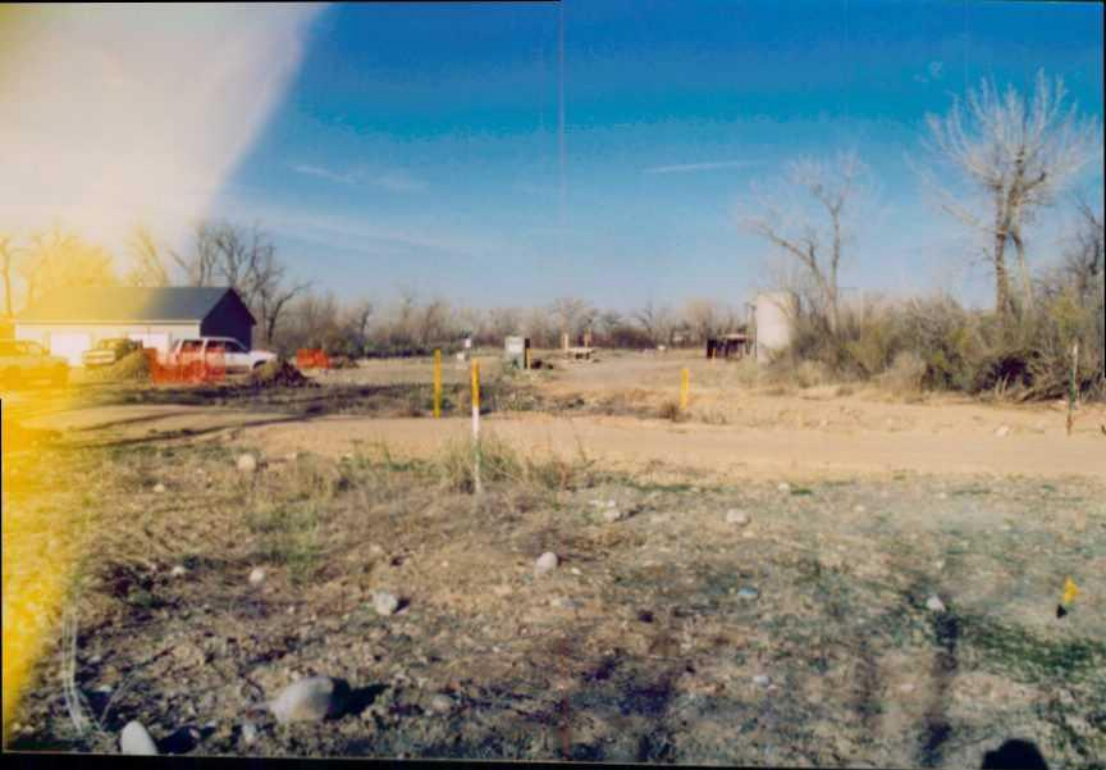
Picture 7 : Yellow pipe line markers and Well in Unit H of Section 28, T 30 N, R 12 W.  
North of future home site.

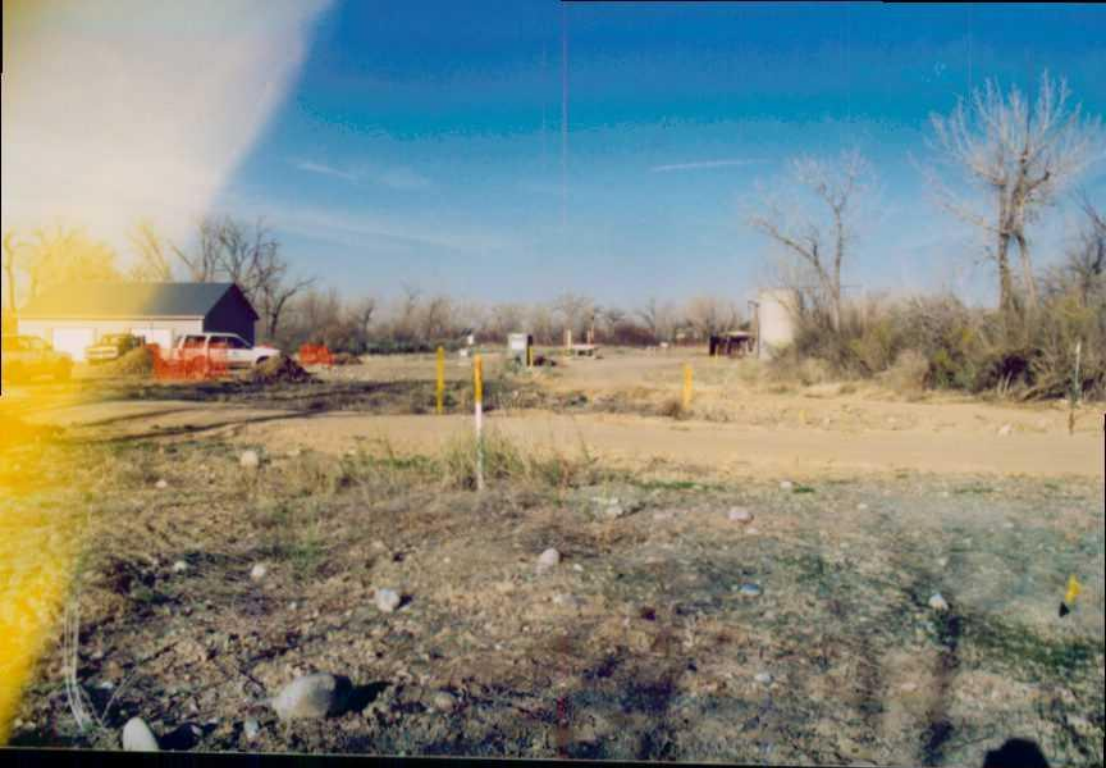
Picture 7 : Yellow pipe line markers and Well in Unit H of Section 28, T 30 N, R 12 W.  
North of future home site.

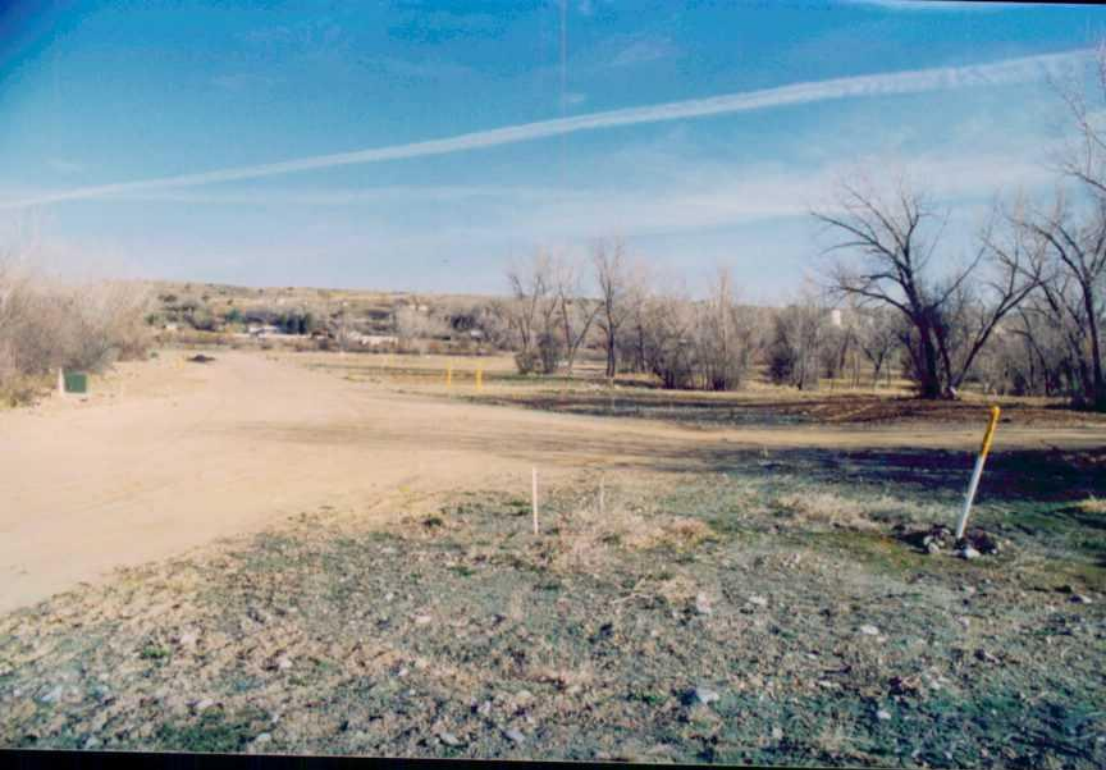
**Picture 8 :** Looking north; Yellow pipe line markers;  
And old Beeline Refinery (tanks on hill side through the trees right center of photo)

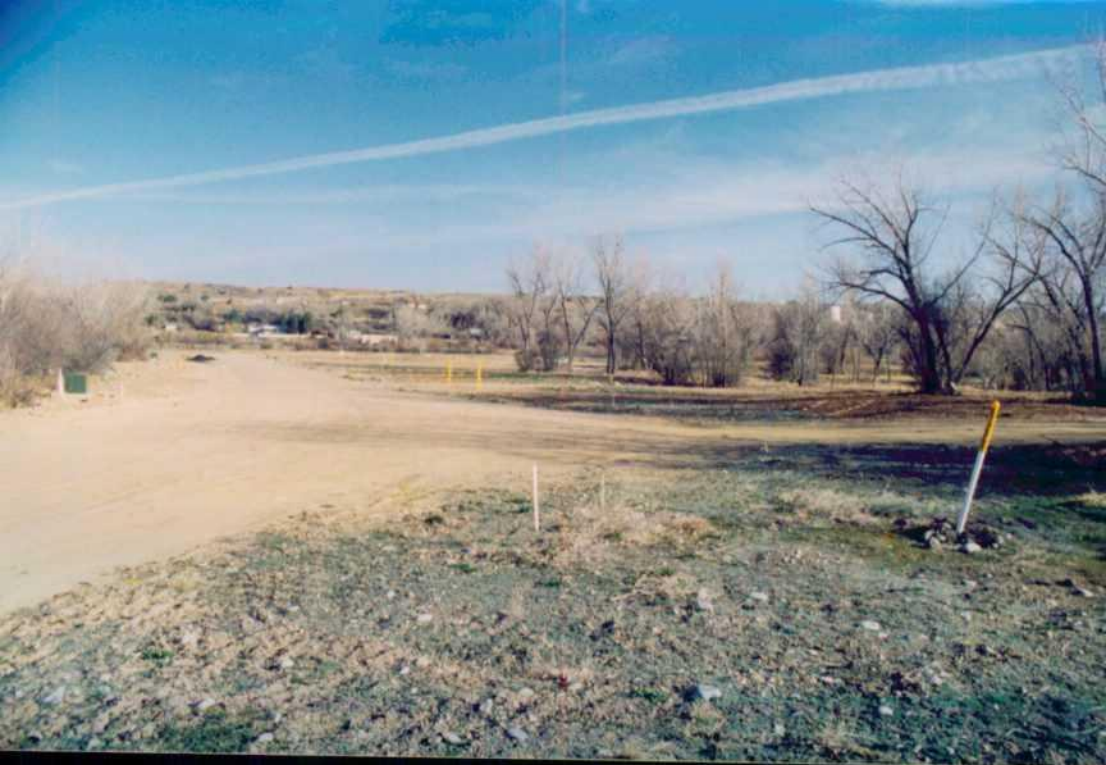
**Picture 8 :** Looking north; Yellow pipe line markers;  
And old Beeline Refinery (tanks on hill side through the trees right center of photo)
