**Remedial Activities
for the
Closure of the Jicarilla Evaporation Pond**

Prepared For: Apache Corporation
Prepared By: **INDIAN**
Fire & Safety, Inc.

Date Prepared: January 23, 1995
Report No: 94004-R1

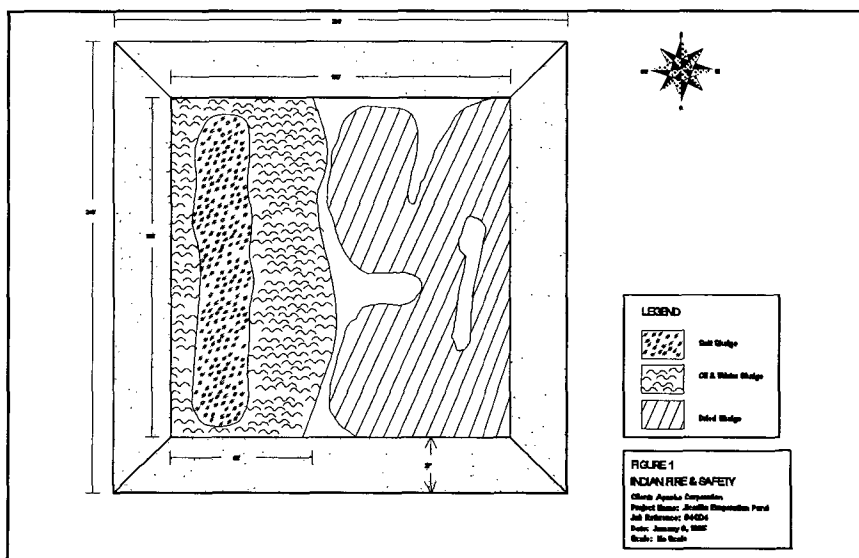
Activities began with a general site assessment and confirmation of pre-established goals. The impoundment was situated at the far west edge of the facility, within the fenced boundary of the established field office area. The pit measured 243 feet wide, 230 feet long, and 16 feet deep. Contents of the pit consisted of produced water, hydrocarbons and a mixture of hydrocarbons and blow sand which had dried into a viscous, non-flowing material that coated the sides and part of the bottom of the pit. A diagram (Figure 1) of the pit is been presented below as well as in Section Two for review.

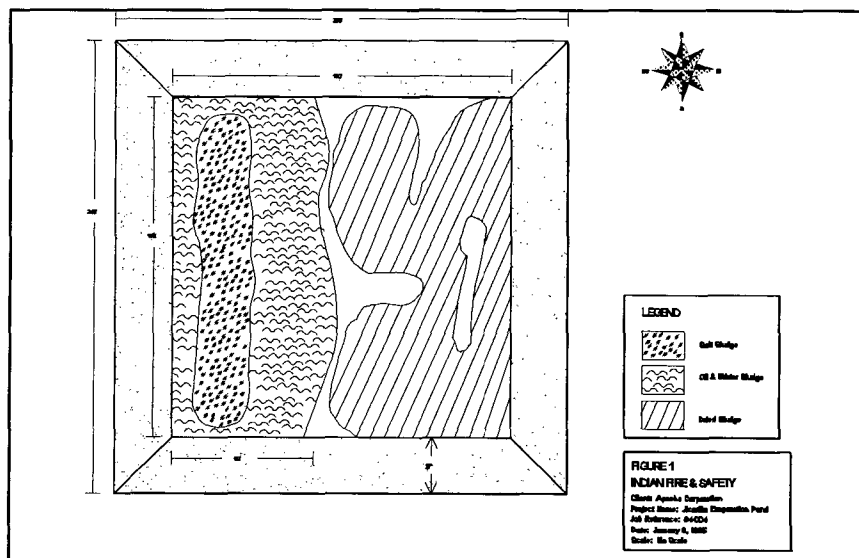
Activities began with a general site assessment and confirmation of pre-established goals. The impoundment was situated at the far west edge of the facility, within the fenced boundary of the established field office area. The pit measured 243 feet wide, 230 feet long, and 16 feet deep. Contents of the pit consisted of produced water, hydrocarbons and a mixture of hydrocarbons and blow sand which had dried into a viscous, non-flowing material that coated the sides and part of the bottom of the pit. A diagram (Figure 1) of the pit is been presented below as well as in Section Two for review.

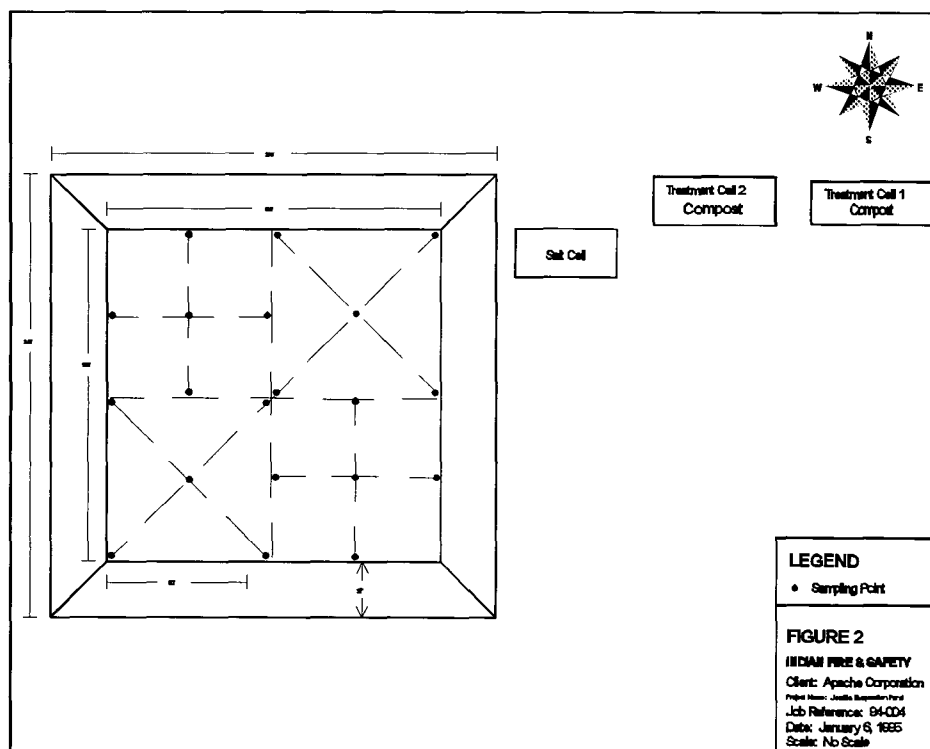
Once the sludge and liner had been completely removed, the impoundment was divided into four sections. Each section was numbered and labeled with respect to its directional bearing. A diagram (Figure 2) is provided below and in Section Two to illustrate the sections and sampling points.

From each section, a five part composite sample was taken and sent to Intermountain Laboratories in Farmington, New Mexico to be analyzed for Total Petroleum Hydrocarbons (TPH) using USEPA Method 8015, modified for diesel and Benzene, Toluene, Ethyl Benzene and Xylene (BTEX) using USEPA Method 8020. The results of the analyses are presented in Table I on the following page.

Site: Jicarilla Evaporation Pond		Laboratory: Intermountain Laboratories
Report Number: B9411621		Date of Analysis: 01/02/1995
Sample Number	Parameter	Result
Sec 1 (NE)	TPH	ND
Sec 1 (NE)	BTEX	ND
Sec 2 (SE)	TPH	16 mg/kg
Sec 2 (SE)	BTEX	ND
Sec 3 (NW)	TPH	ND
Sec 3 (NW)	BTEX	ND
Sec 4 (SW)	TPH	62 mg/kg
Sec 4 (SW)	BTEX	ND
ND = Not Detected		
Methodologies: TPH: EPA, 8015 Modified using a Diesel Standard		
BTEX: EPA, 8020

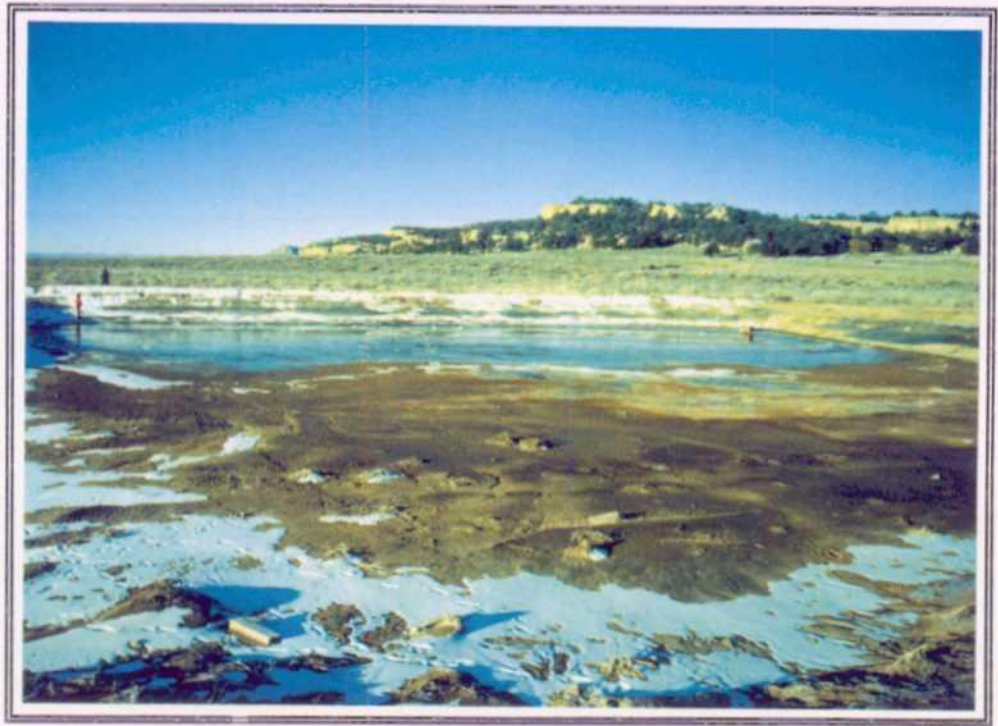
1. Northeast view of impoundment before removal of sludge.

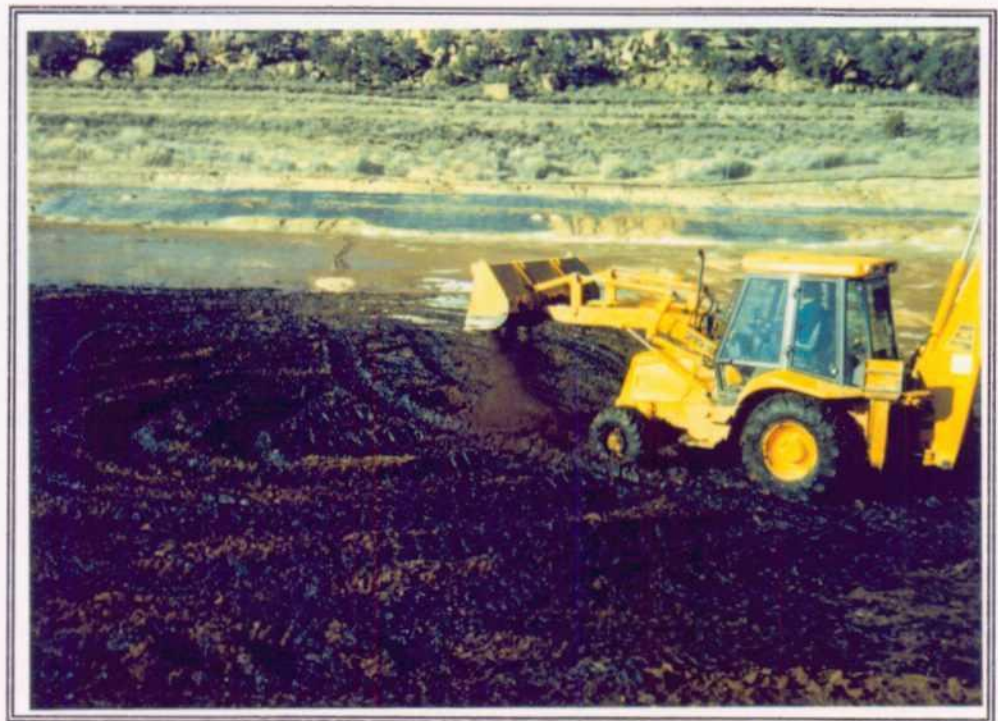
2. Mixing of compost material into the sludge before removal.

Treatment and removal of the sludge was achieved by mixing the dried material and compost with the sludge. The sludge was then removed and placed into a specially designed cell for treatment. Construction of the cell consisted of a single layer of 22 mil nylon reinforced PVC plastic liner placed into the bottom of the cell. After installation of the liner was completed, a layer of raw compost was placed on the top of the liner. Four ventilation lines consisting of 4 inch diameter perforated PVC pipe were laid at eight foot intervals traversing the entire length of the treatment cell. After the ventilation lines had been installed, the cell was filled with 2 to 2.5 feet of treated material. Once the cell had been filled, the ventilation lines were extended upward and the cell was covered with two layers of 6 mil plastic and anchored.

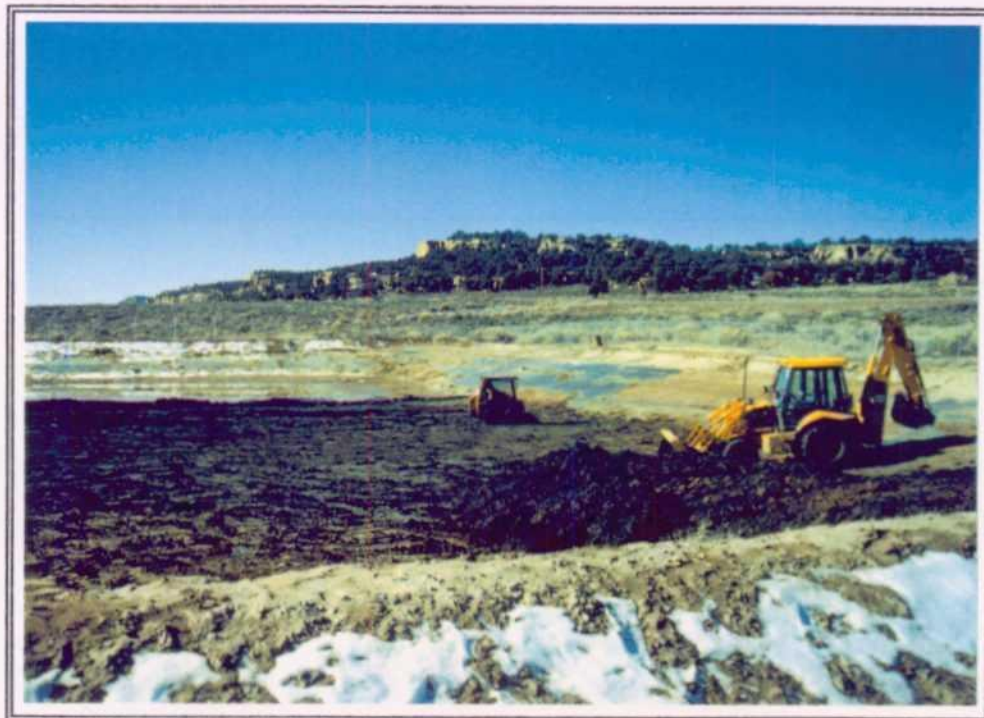
3. Treated sludge has been stockpiled in the corners of the cell and the liner is being prepared for removal and placement into a treatment cell.

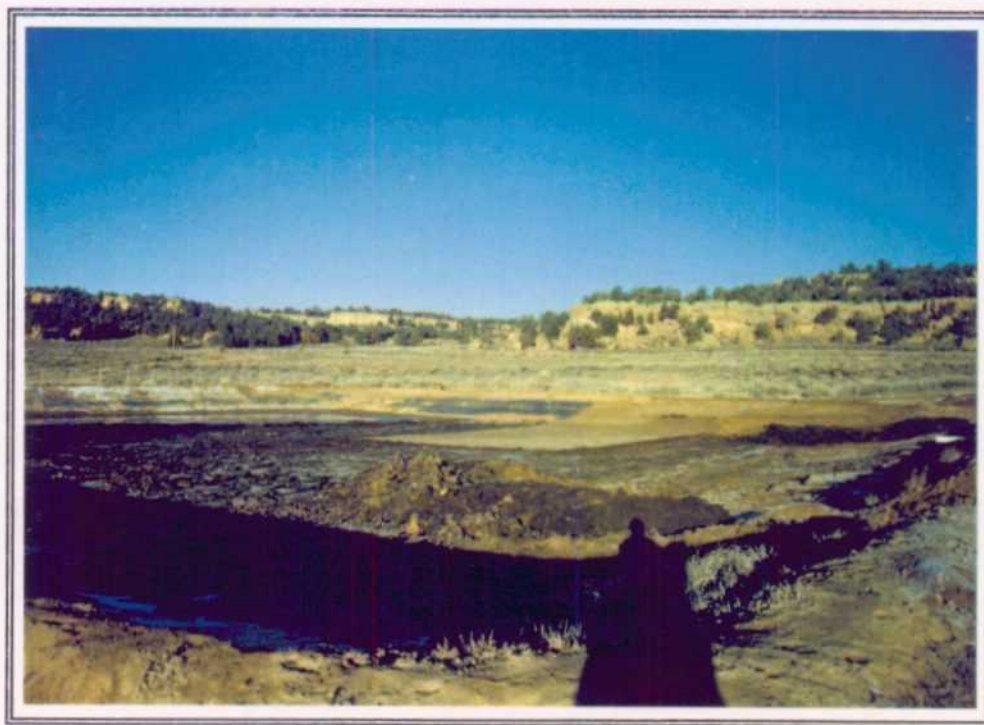
4. A section of the liner has been removed for placement.

Removal of the liner was performed concurrently with the removal of the sludge. The mixtures were thickened then pushed aside to allow access to the liner. The cleared liner was then cut and removed in sections. This was repeated until all liner that could be salvaged was used. After that, the liner was removed and stockpiled adjacent to the Salt Cell.

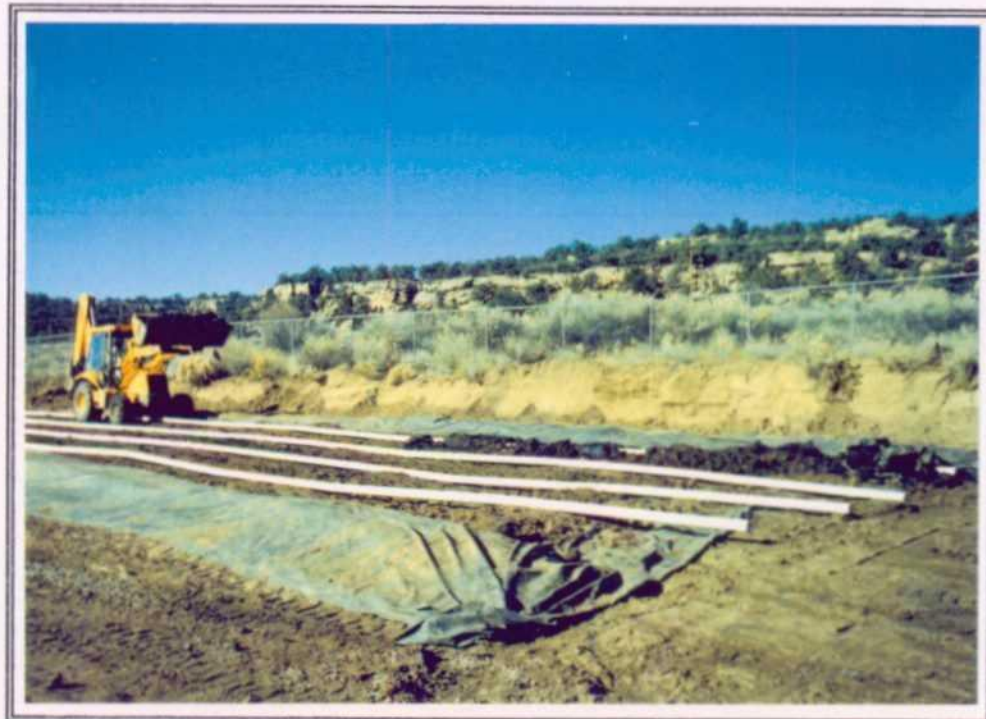
5. Constructed treatment cell with lower ventilation lines in place and the treated material being placed into the cell.

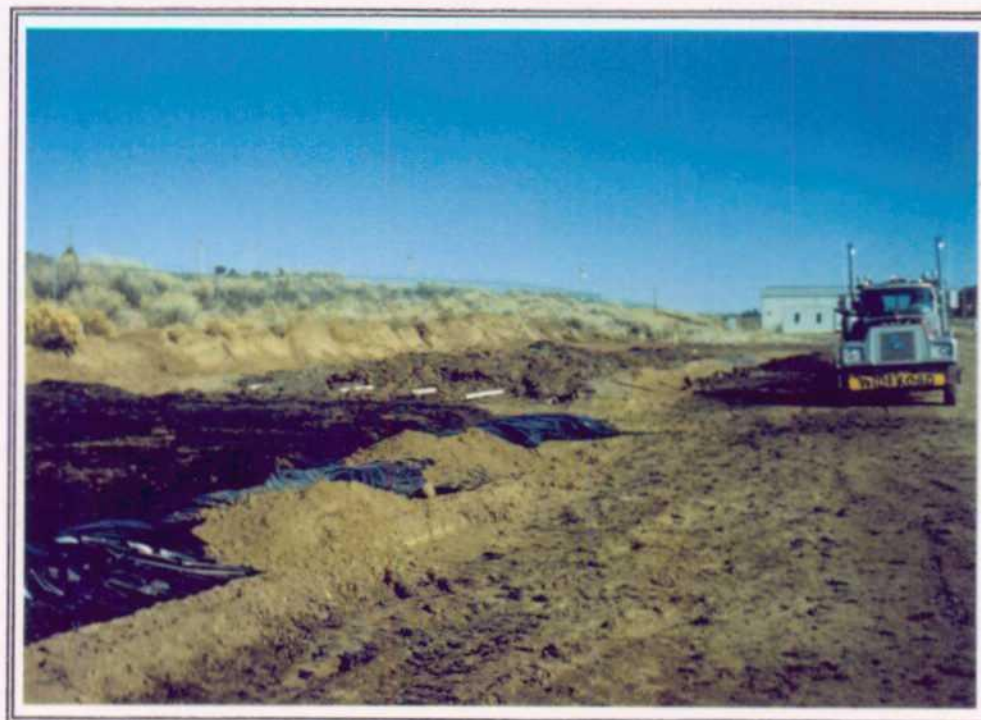
6. Northeast view of treatment cell number one after filling and awaiting covering. Treatment cell number two is in the foreground and still being filled.

The composting and removal of the sludge resulted in the construction of two treatment cells, which were designated as treatment cells one and two. These cells are approximately 100 feet long, 40 feet wide and contain 550 to 600 yds³ of treated material. It is the intention of the Client to allow the material in the cells to sit through the winter in their present covered state. Once winter has passed, the material will be uncovered, rolled and the degradation process allowed to continue until the hydrocarbon levels reduce to satisfactory levels.

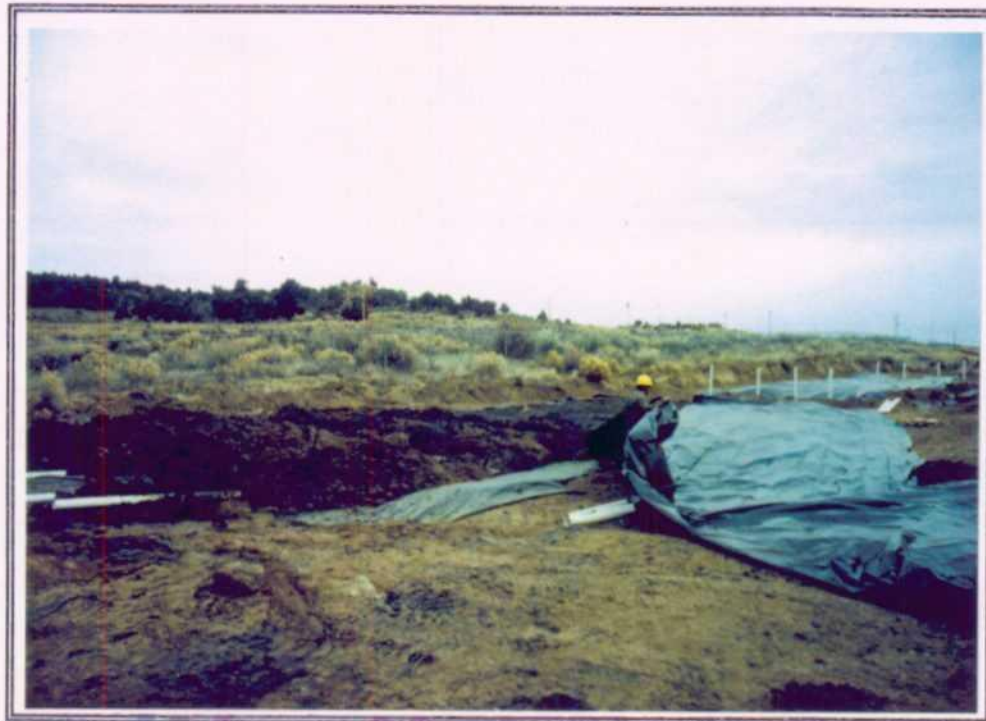
7. Northeast view of the treatment cells in the process of being covered with PVC liners. Treatment cell number one is in the background and has been covered with vertical vents in place.

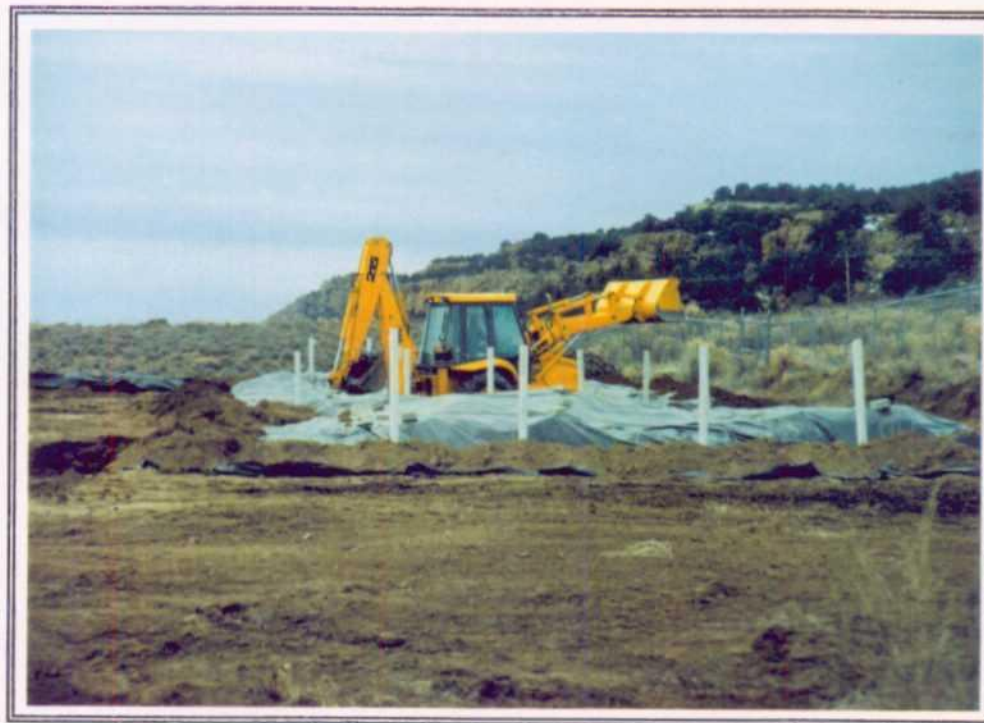
8. Northwest view with the treatment cells filled, covered and the covers in the process of being anchored. The salt cell can be seen in the background.

The removal of the salt slurry was achieved by mixing native soil with the material until it had thickened to a state where it could be mechanically removed. The salt/soil mixture was then transferred to a interim storage area until a treatment cell could be constructed that will leach the salt out of the mixture. This storage area is referred to the Salt Cell and contains approximately 395 yds³ of salt/soil mixture.

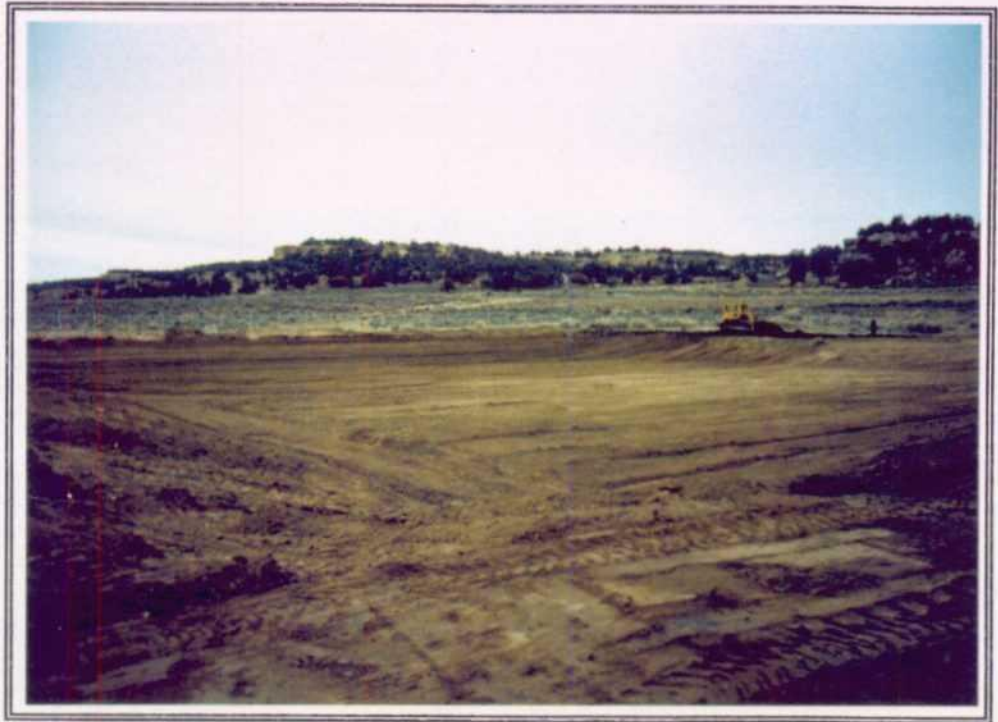
9. Northwest view of the site after the removal of all liner and sludge.
