NMOCD INSPECTION REPORT

SITE: El Paso Natural Gas (EPNG) Aztec Yard

INSPECTED BY: Bill Olson and Ed Martin

INSPECTION DATE: January 27, 2003, 3:00 pm – 3:30 pm

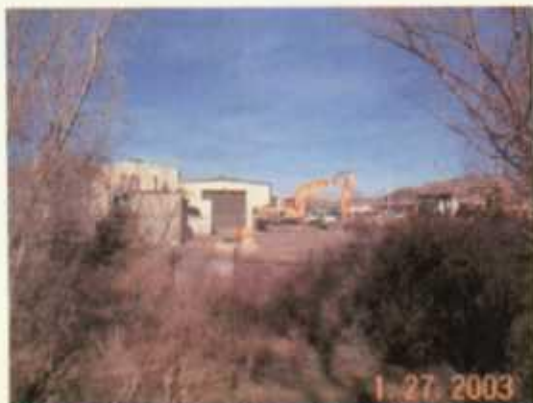
El Paso Aztec Yard. Currently Sunland Construction. View of yard looking North from South side of arroyo.

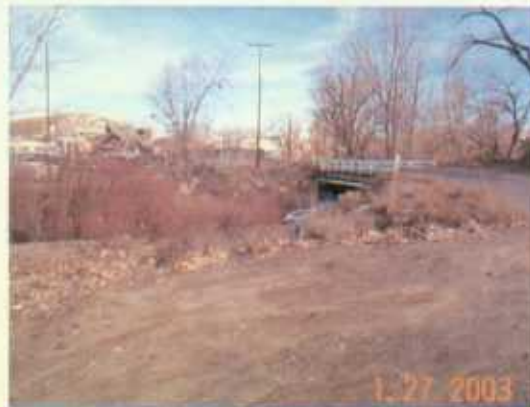
El Paso Aztec Yard. Currently Sunland Construction. View looking East along arroyo.

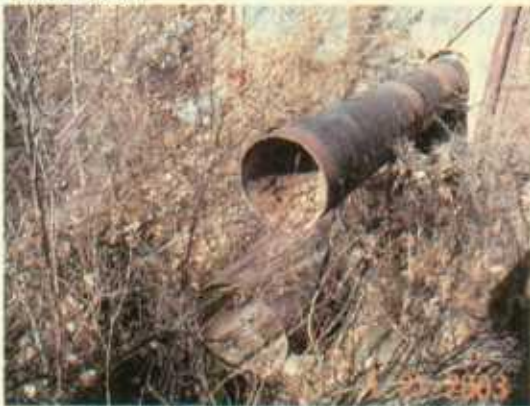
El Paso Aztec Yard. Currently Sunland Construction. View of drain line showing oily residue.

Request that EPNG give OCD a written response to the allegations in the Earthjustice petition to EPA and submit a work plan to investigate potential contamination at the one discharge pipe.

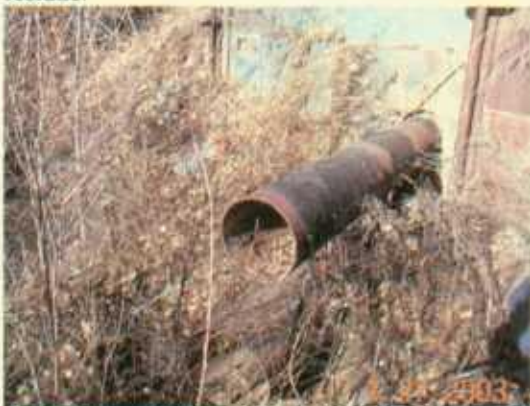
El Paso Aztec Yard. Currently Sunland Construction. View of drain line showing oily residue.

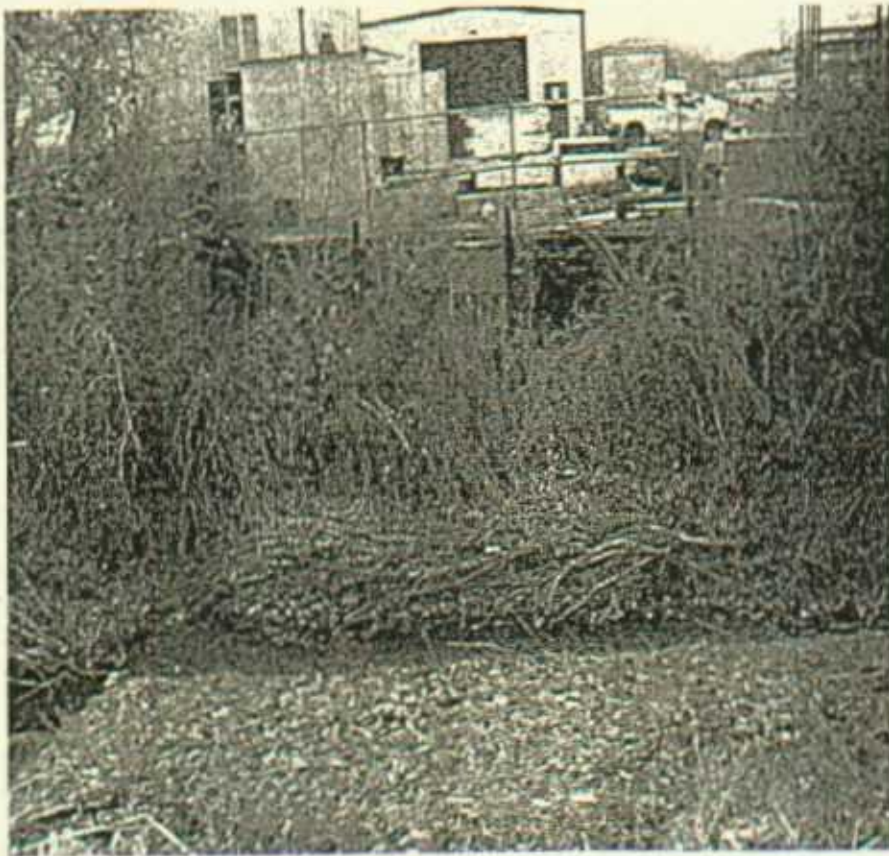
Exhibit A

This site is located next to the Hampton Arroyo, which drains into the Animas River. It is near the McCoy Elementary School. The site was formerly owned by El Paso Natural Gas and was recently sold to Sunland Construction.

When El Paso was the owner and operator of the site, it was used as a shop for oil field service trucks. At that time, mercury was used in well meters. Field workers periodically recalibrated these meters by adding new mercury. Any mercury that was spilled in the field trucks during the recalibration process was rinsed out at the shop into a sump pit that drained directly into the Hampton Arroyo. This was done for many years. The sump pit was later cemented over without any reclamation.

The Hampton Arroyo flows year round and because this specific stretch of the Arroyo is close to the McCoy Elementary School, it is a favorite place for children to play in the water. Because mercury was routinely washed into the Arroyo here where children play, and because there is an old mercury-containing pit in the direct path of drainage into the Arroyo, this site clearly poses a potential health hazard to the local population.
