**STAGE 1 & 2
WORKPLANS**

**STAGE 2 ABATEMENT PLAN
FORMER BRICKLAND REFINERY SITE
HUNTSMAN POLYMERS CORPORATION**

August 14, 1998

Huntsman Polymers Corporation
2400 S. Grandview Ave.
Odessa, Texas 79760

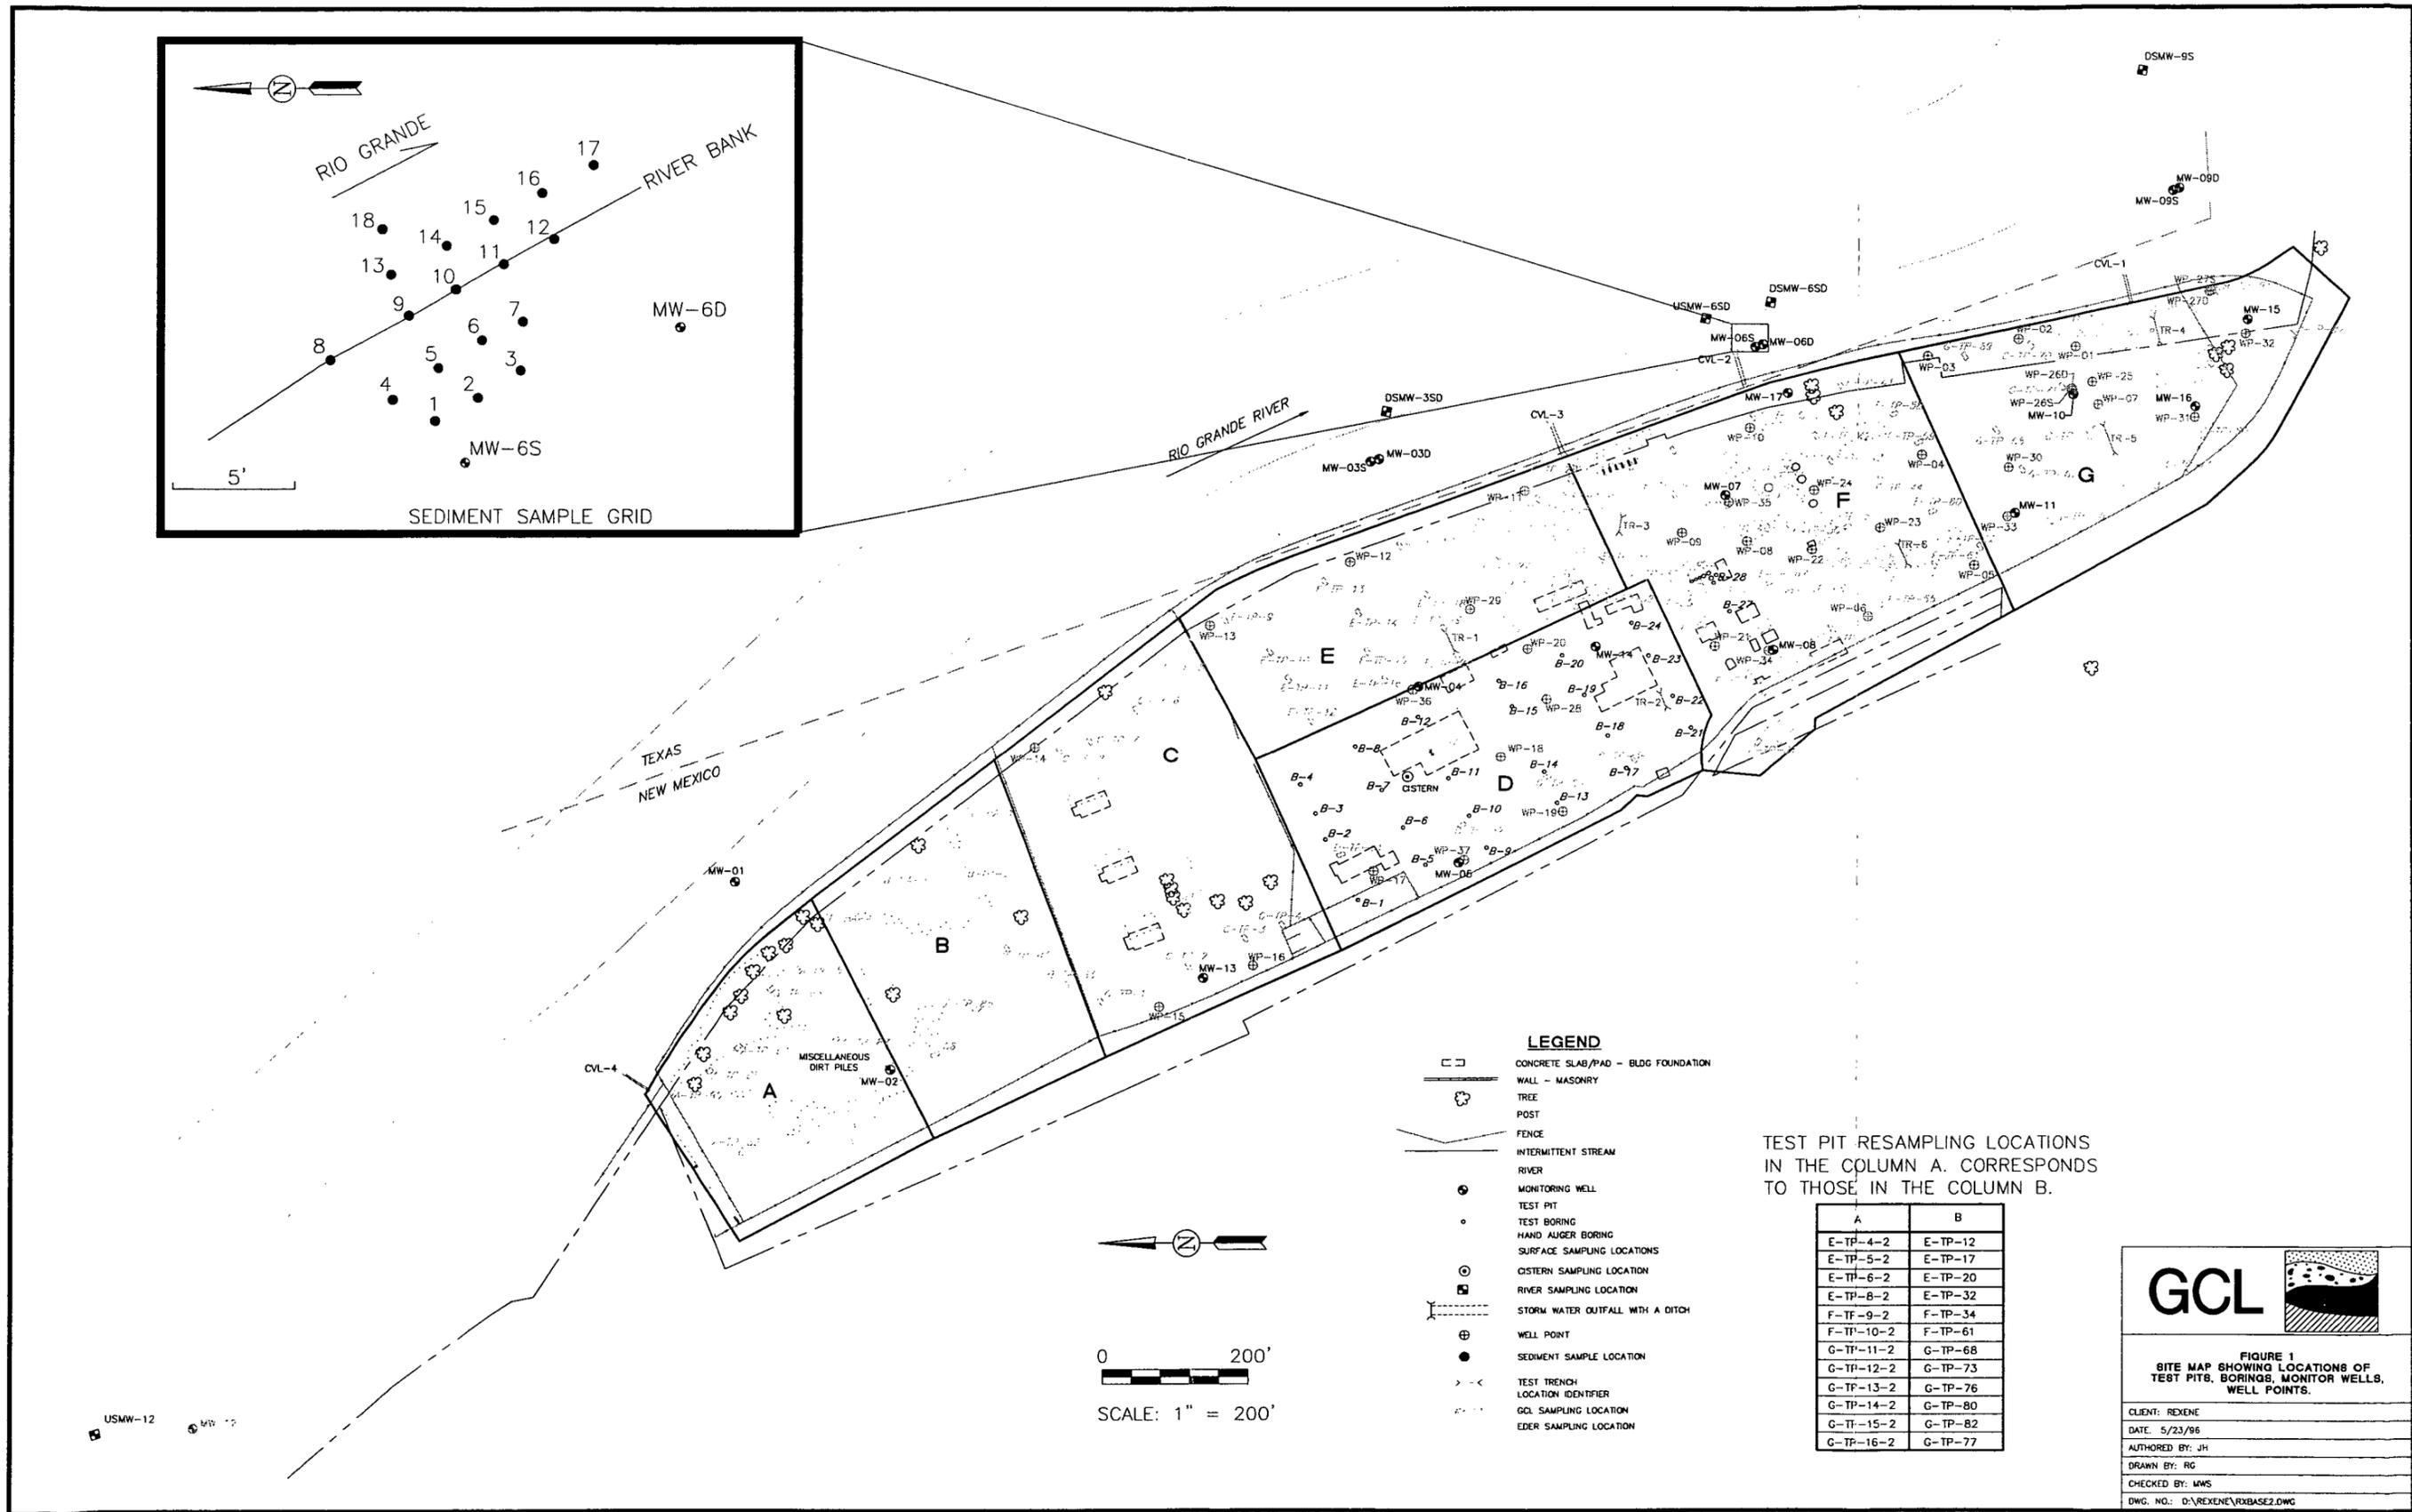
The Brickland Refinery site consists of 33 acres located in Sunland Park, Doña Ana County, New Mexico (Figure 1). The former petroleum refinery operated from 1933 to 1958 and was subsequently dismantled. The site is adjacent to the Rio Grande and has been vacant except for foundations from former refinery structures. Some construction and demolition debris is present on the site, including concrete from the refinery structures and rubble from road construction. Native vegetation grows over most of the site, but is more concentrated at the northern portion of the property.

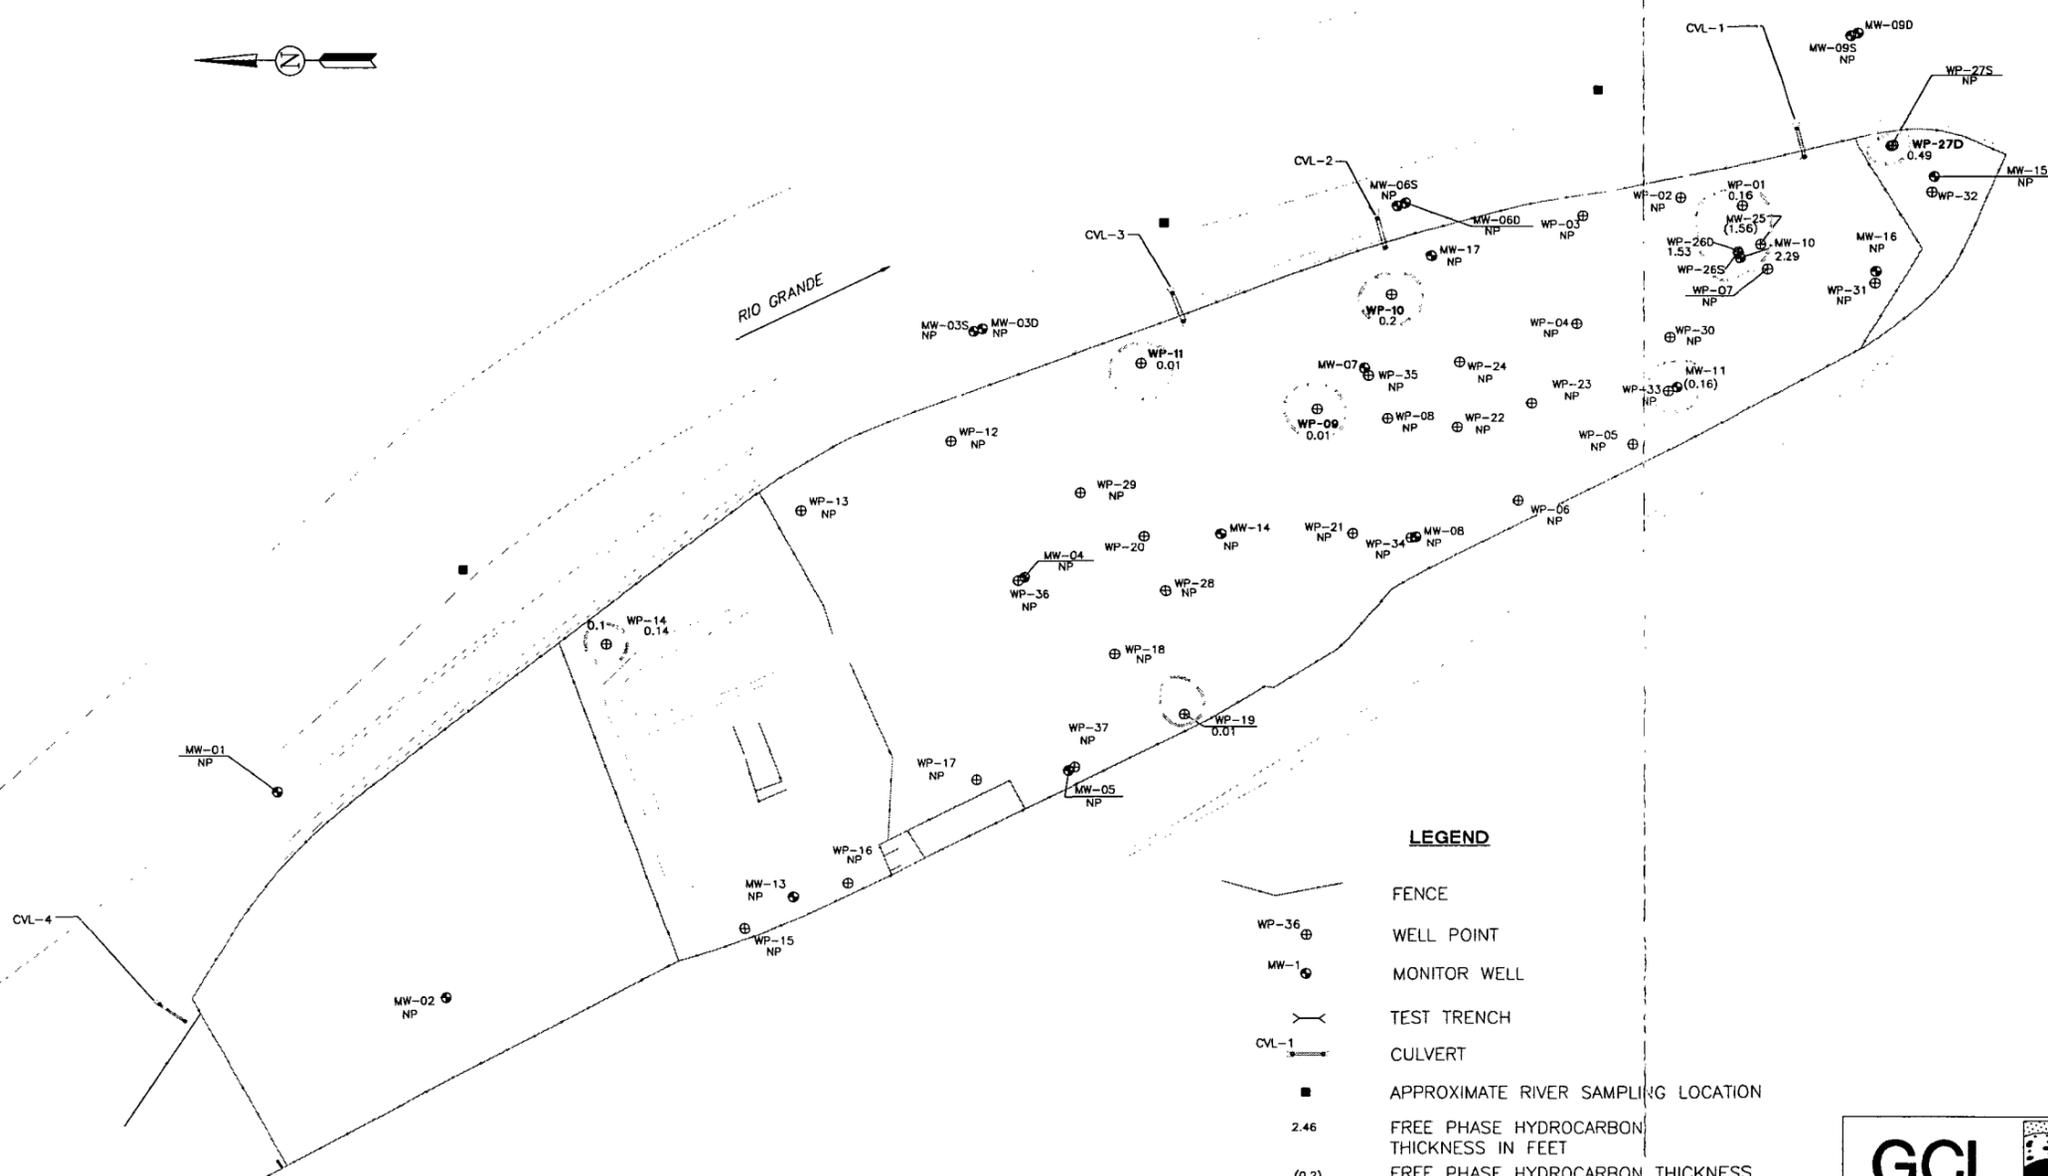
- FENCE
- ⊕ WP-36 WELL POINT
- ⊕ MW-1 MONITOR WELL
- TEST TRENCH
- CVL-1 CULVERT
- APPROXIMATE RIVER SAMPLING LOCATION
- 2.46 FREE PHASE HYDROCARBON THICKNESS IN FEET
- (0.2) FREE PHASE HYDROCARBON THICKNESS IN PARENTHESES FOR WELLS WITH DEEPER SCREENED INTERVAL
- ZERO CONTOUR

- Free-phase hydrocarbons have been observed in on-site monitor wells MW-10, MW-11, and several on-site well points. The investigation determined that this free-phase hydrocarbon occurs locally in discontinuous pockets associated with thin, discontinuous sand lenses. No free-phase hydrocarbons have been observed in off-site wells.

Based on the final site investigation, dissolved-phase hydrocarbons occur in groundwater and limited free-phase product occurs locally beneath the site (Figure 3). Dissolved-phase hydrocarbons have been observed off site in only one monitor well, MW-6S. In that well, benzene was the only hydrocarbon compound detected above WQCC standards. This limited off-site occurrence indicates that, with the exception of MW-6S, hydrocarbons above WQCC standards are restricted to the site, and migration is attenuated on site by the interbedded silty/clayey sediments as discussed in the FSI Report. Various abatement options were examined and are presented in the following sections.

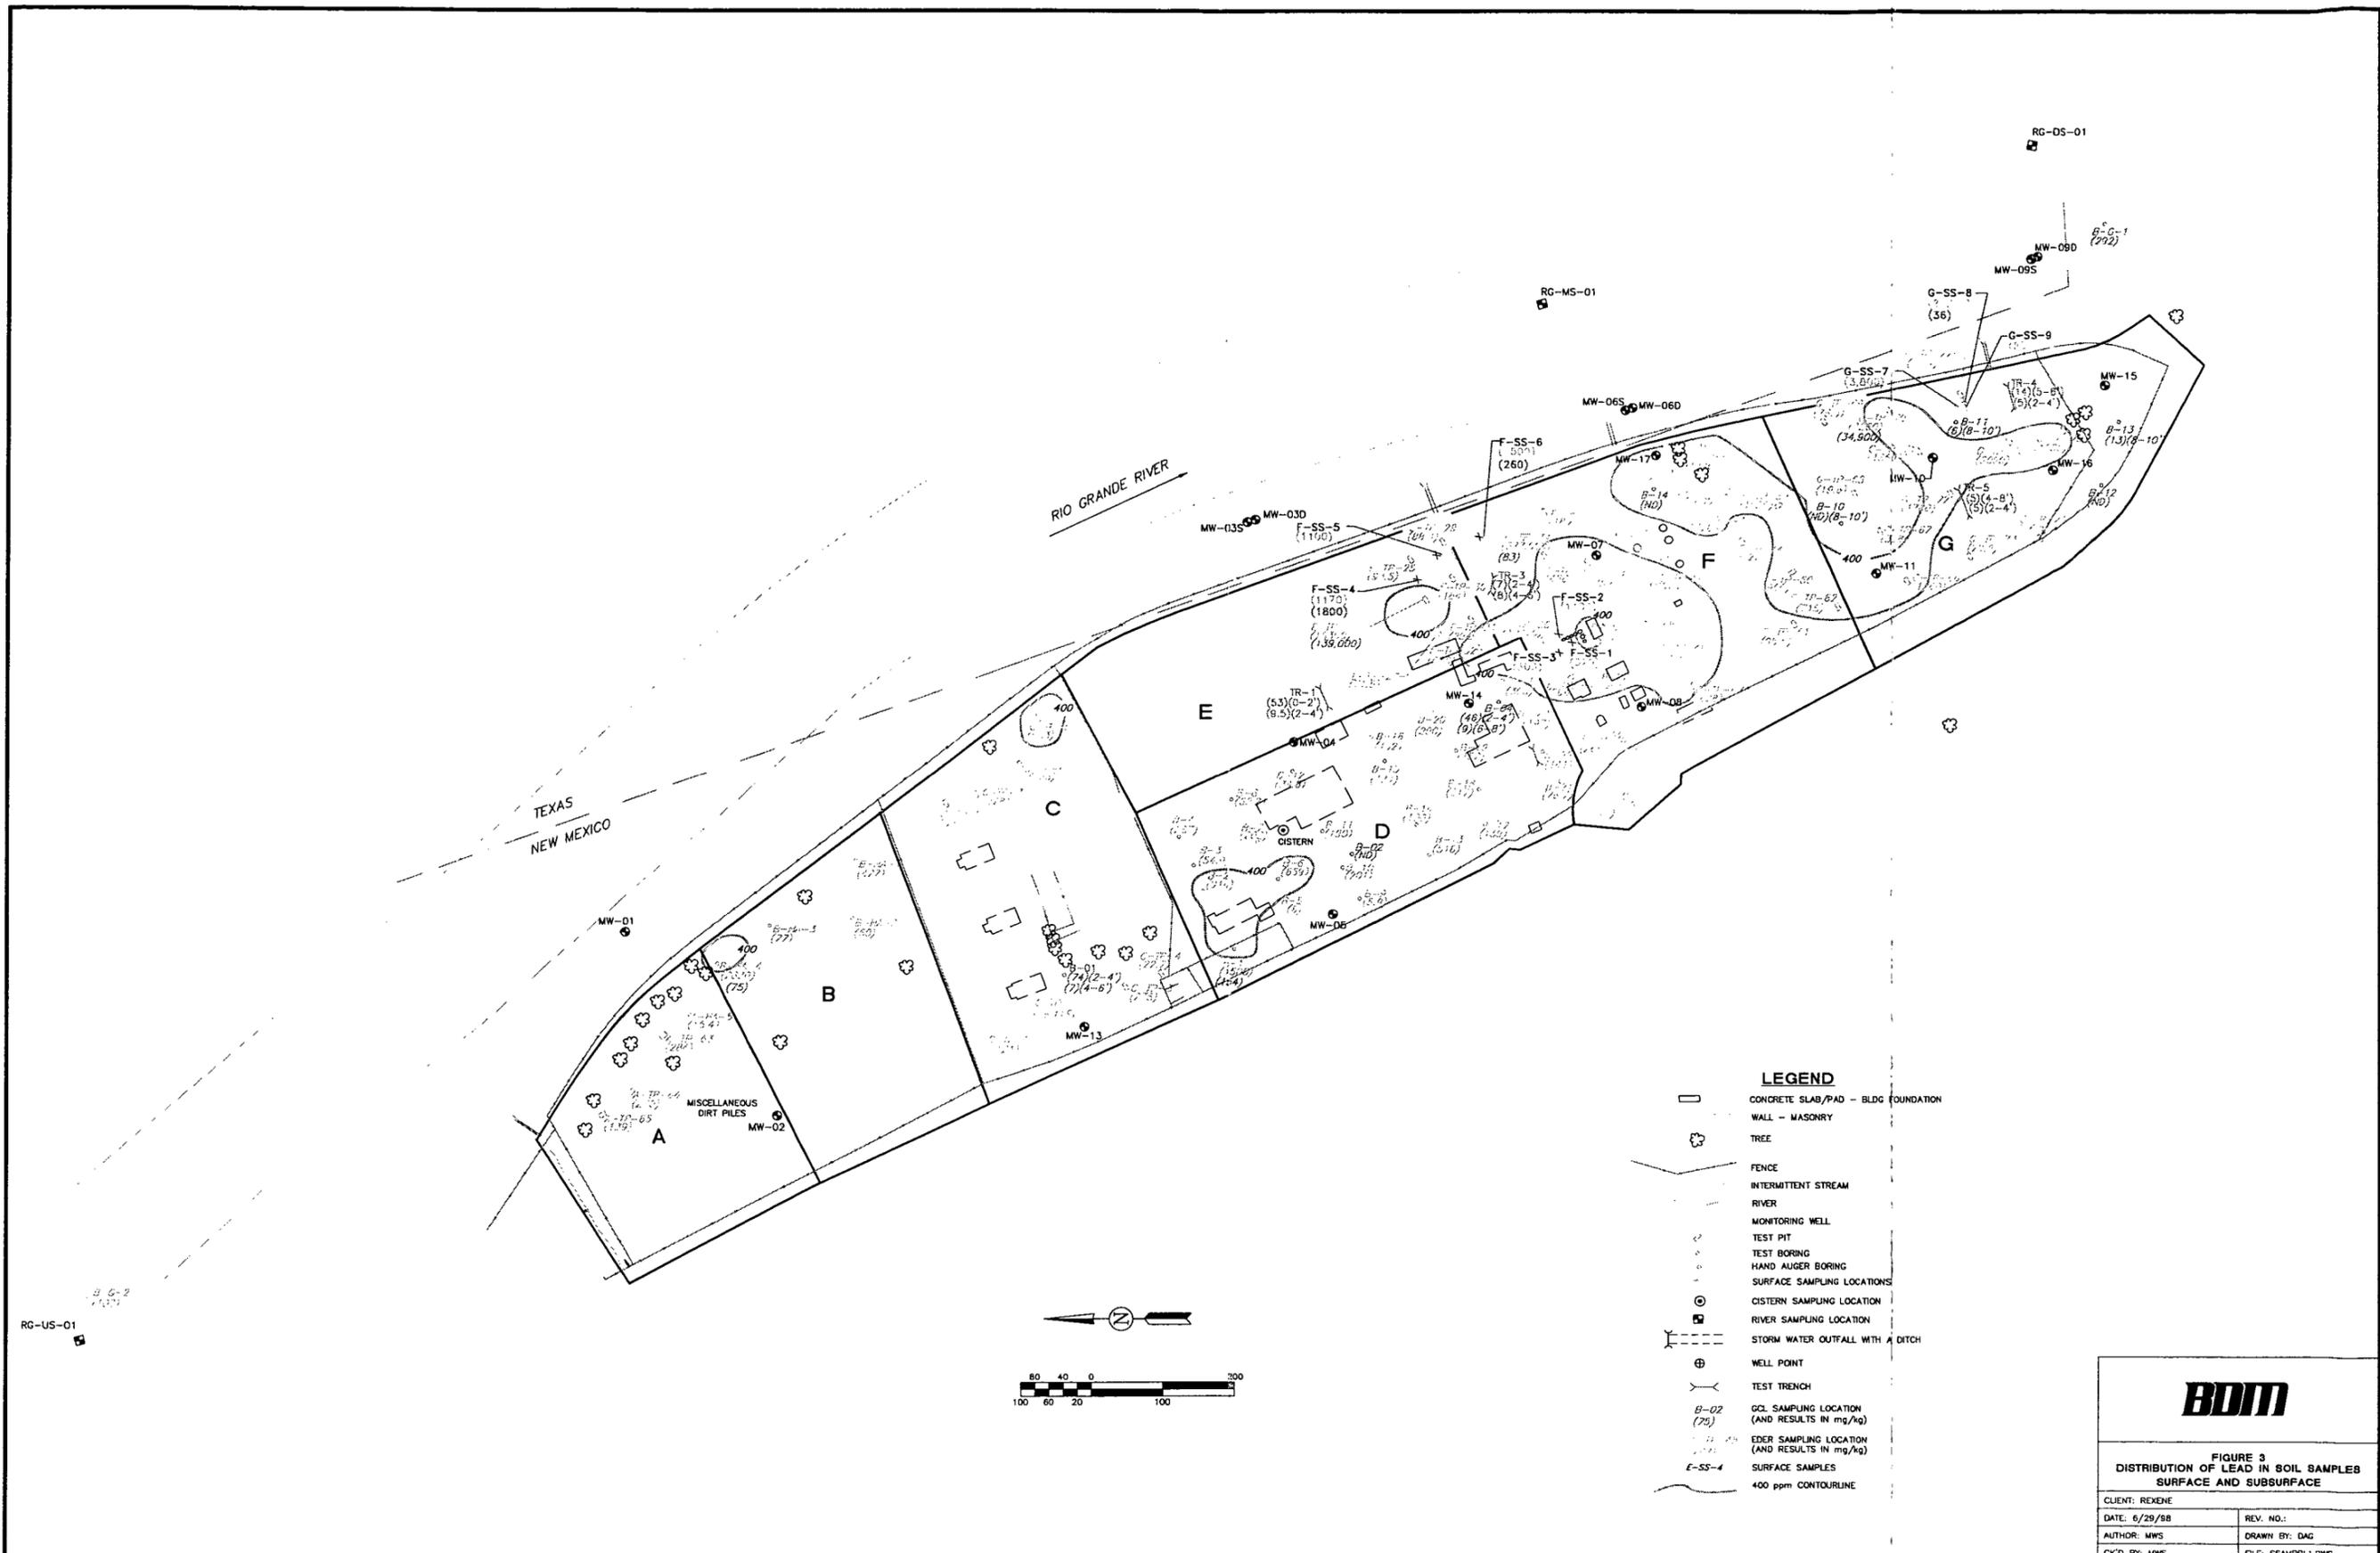
- LEGEND**
- CONCRETE SLAB/PAD - BLDG FOUNDATION
 - ▬ WALL - MASONRY
 - ⊕ TREE
 - FENCE
 - ~ INTERMITTENT STREAM
 - RIVER
 - MONITORING WELL
 - ⊙ TEST PIT
 - ⊙ TEST BORING
 - ⊙ HAND AUGER BORING
 - ⊙ SURFACE SAMPLING LOCATIONS
 - ⊙ CISTERN SAMPLING LOCATION
 - ⊙ RIVER SAMPLING LOCATION
 - ⊙ STORM WATER OUTFALL WITH A DITCH
 - ⊙ WELL POINT
 - TEST TRENCH
 - B-02 (75) GCL SAMPLING LOCATION (AND RESULTS IN mg/kg)
 - B-01 (75) EDER SAMPLING LOCATION (AND RESULTS IN mg/kg)
 - F-SS-4 SURFACE SAMPLES
 - 400 400 ppm CONTOURLINE

Lead concentrations above screening levels are found in shallow soil at the site, primarily in the southern half. The lead is apparently bound in soil, since no lead has been detected in groundwater beneath the site. Although the lead poses no threat to groundwater based on the FSI, it presents a potential human exposure pathway at the ground surface, where the soil could possibly be accessed directly by people traversing the site, or could be blown by wind or carried by rainfall runoff to a place where people could be exposed. To eliminate these possible pathways, the site will be securely fenced to keep people out, and the culverts will remain closed to prevent surface water from running off site. There are no plans for future use of the site by Huntsman. The City of Sunland Park has discussed its desire to construct a sewage treatment plant on the northern portion of the site. Deed restrictions from Huntsman will prohibit the installation of any water wells or any constructed site improvements that would interfere with the proposed abatement for the site. An existing agreement

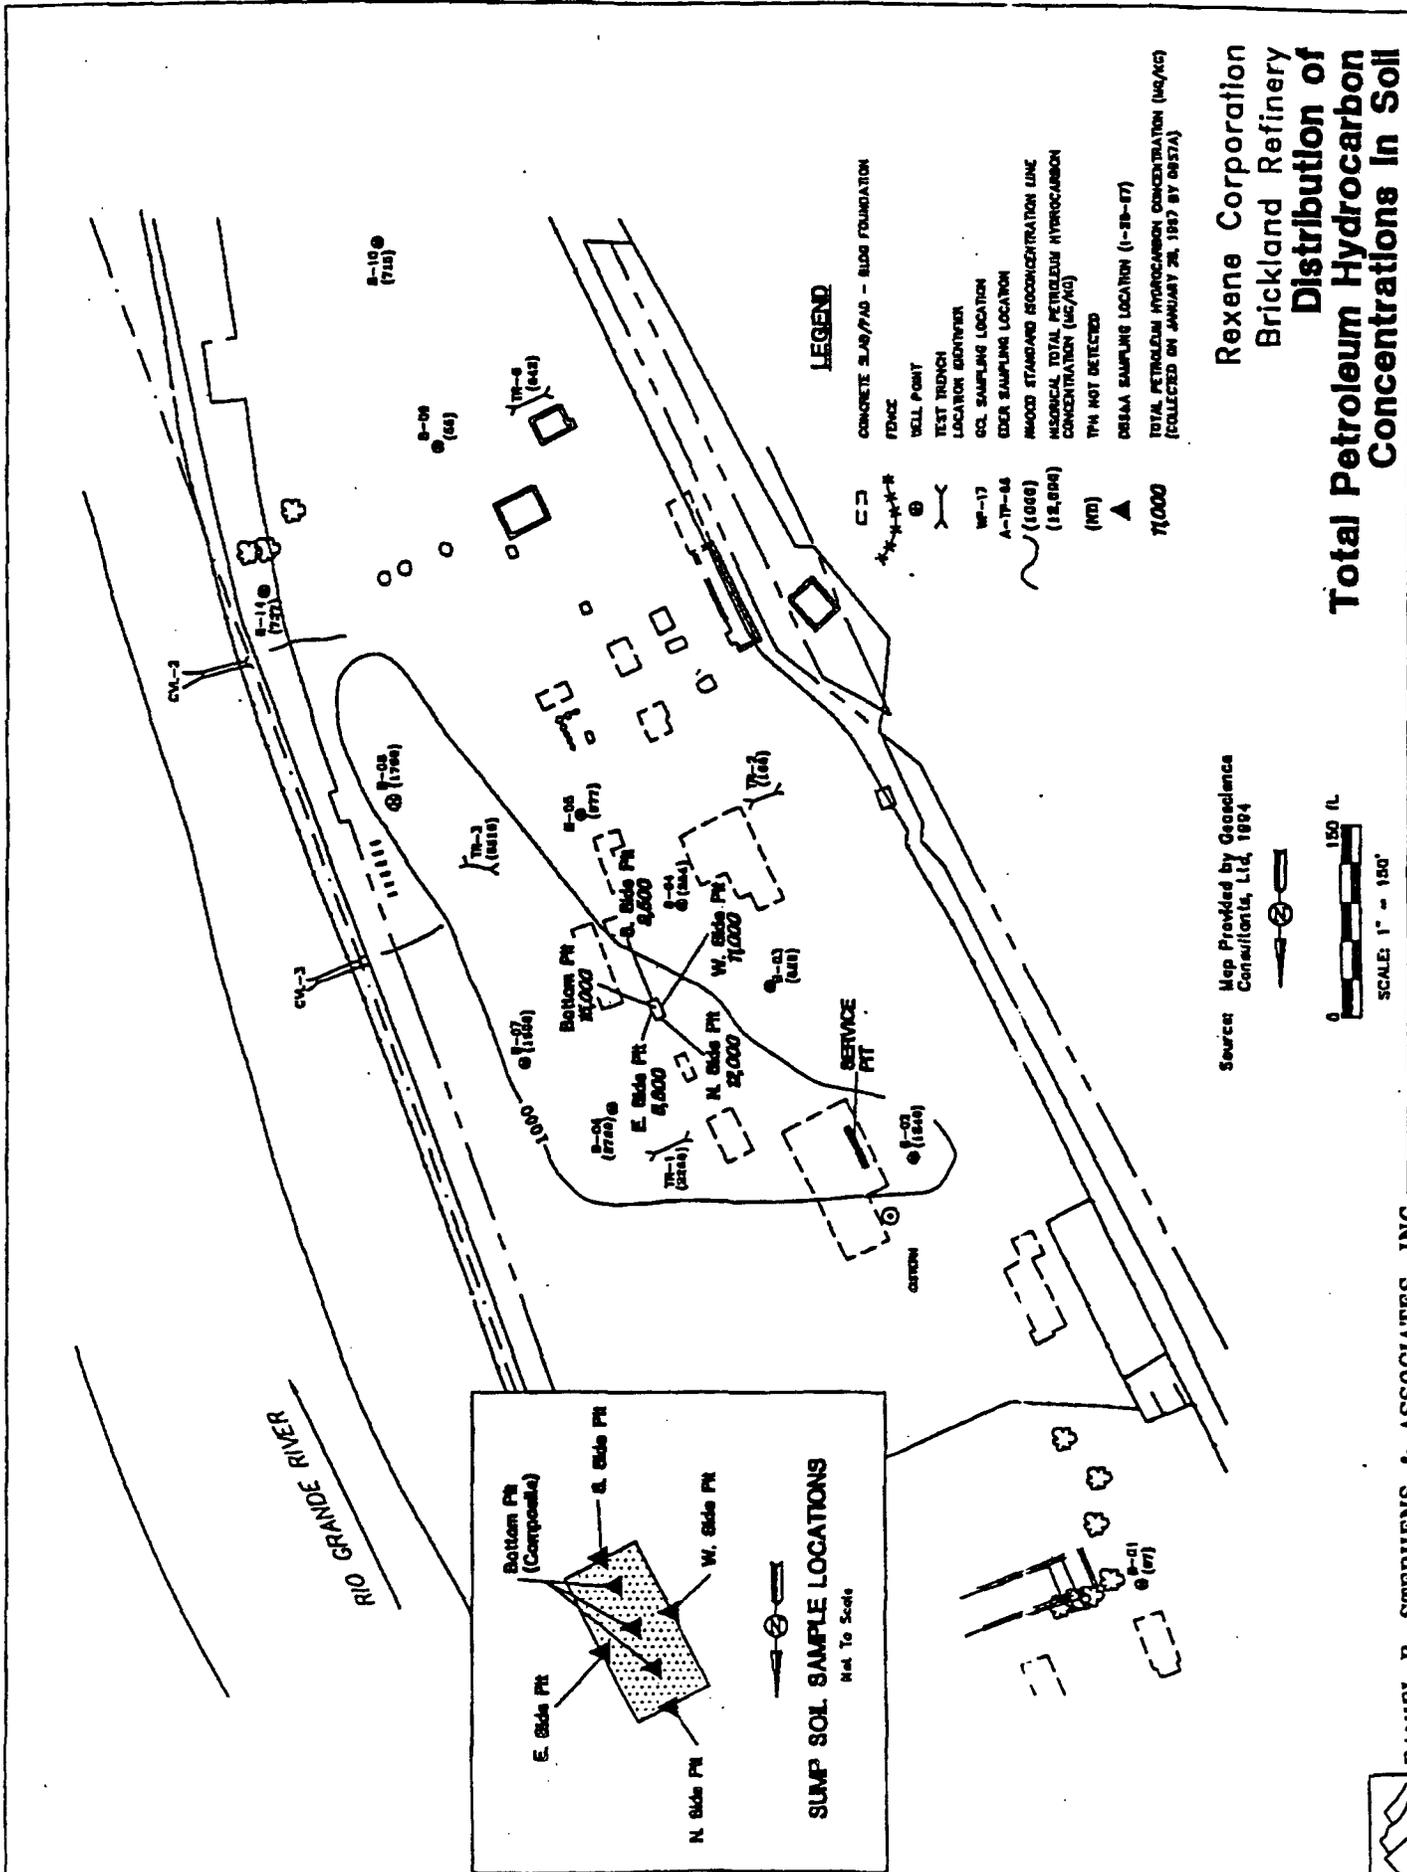
Flaira 2

**Rexene Corporation
Brickland Refinery
Distribution of
Total Petroleum Hydrocarbon
Concentrations in Soil**

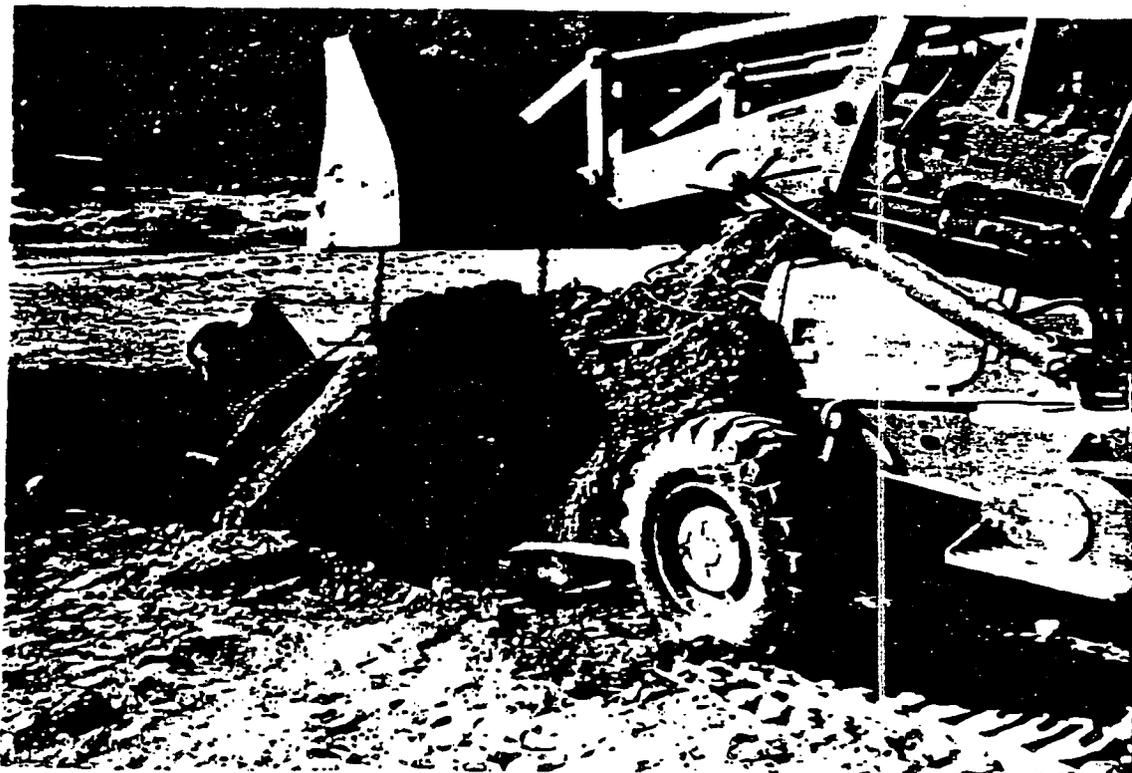
6: View looking southwest; lifting sump from tankhold.

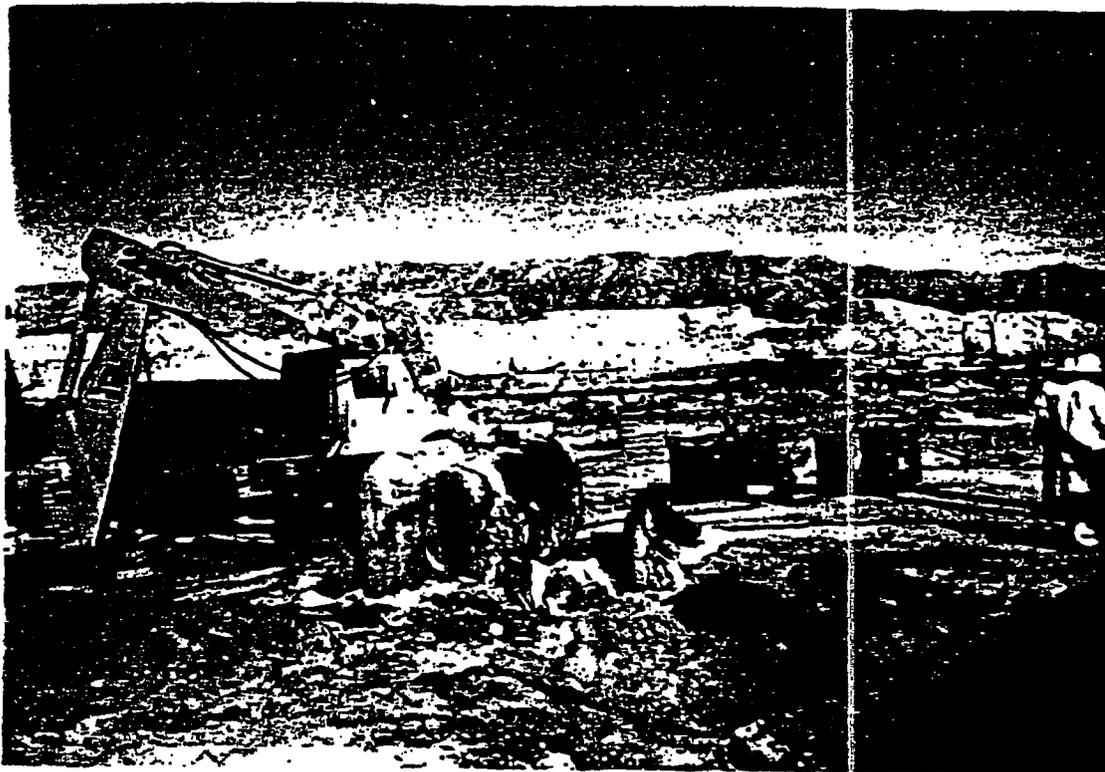
9: Jackhammer on backhoe used to remove concrete from metal tank.

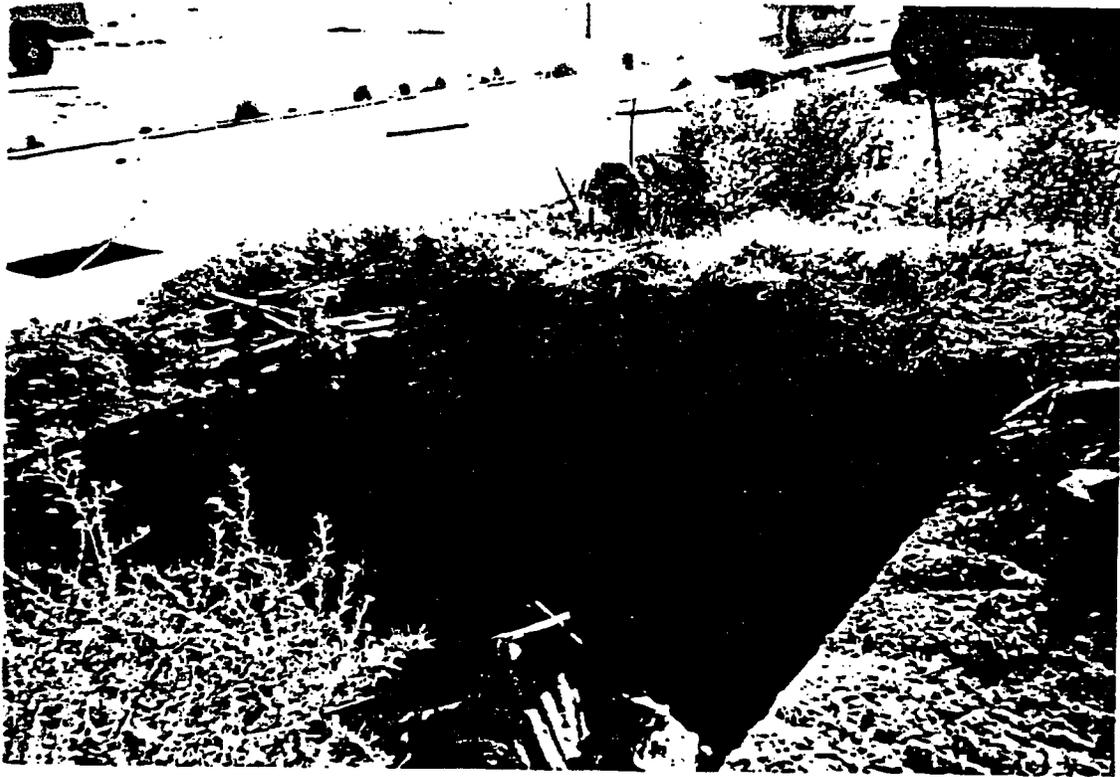
1: View looking southeast; lid pushed in on wash water collection sump.

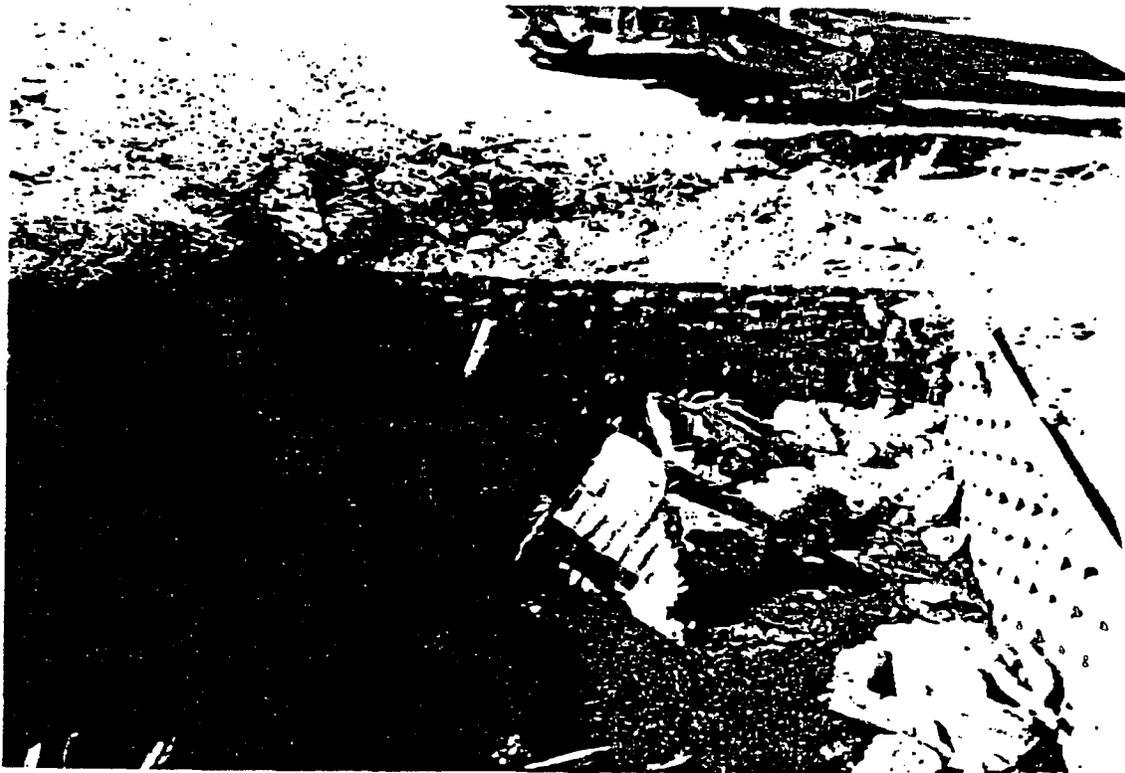
2: View looking west at wash water collection sump.

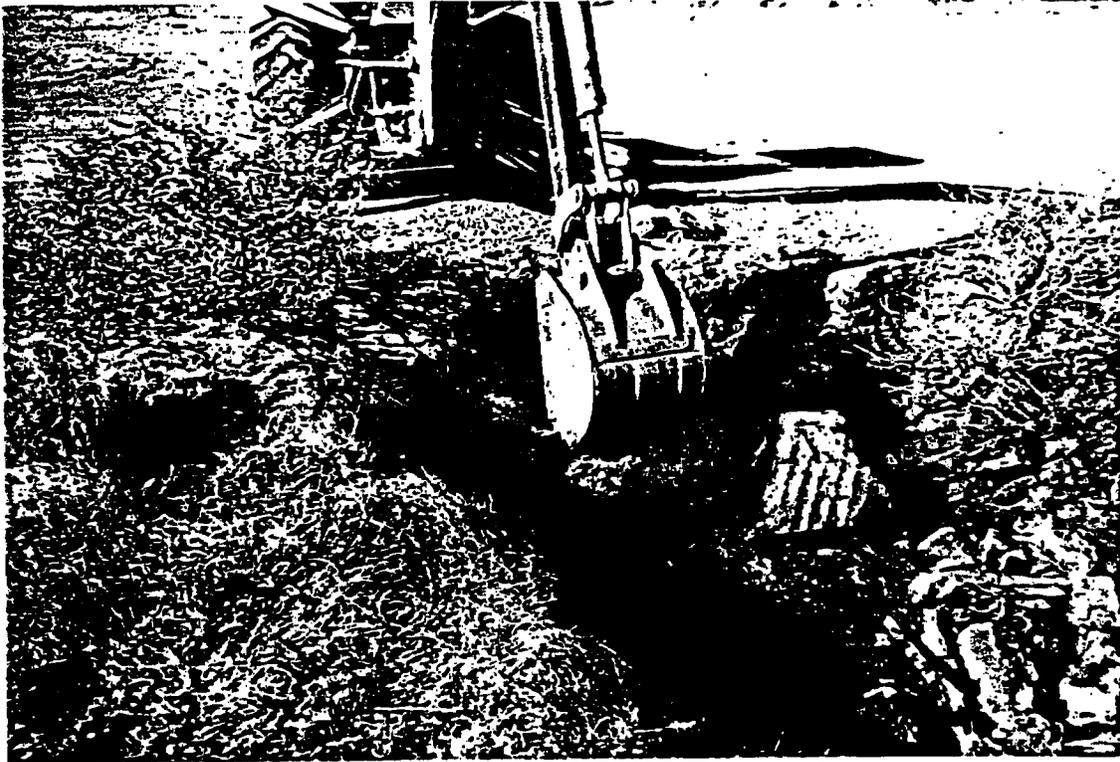
3: View looking northwest: pushing in sides of wash water collection sump.

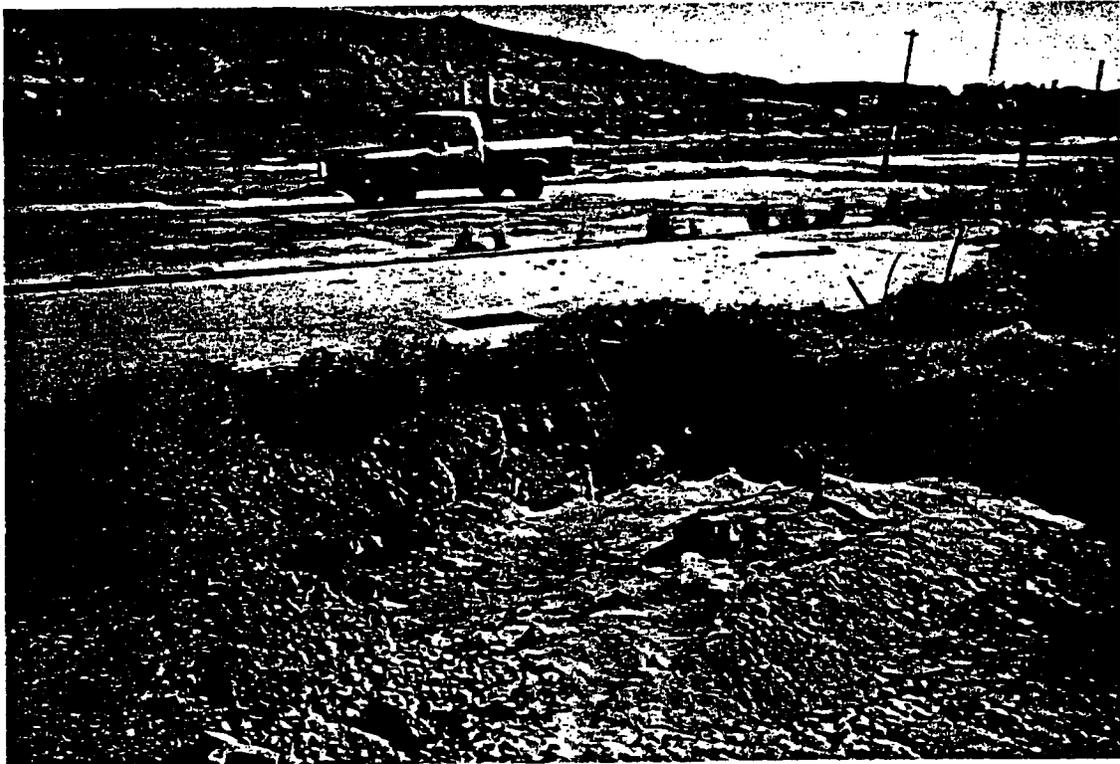
4: View looking east; backfilling wash water collection sump.

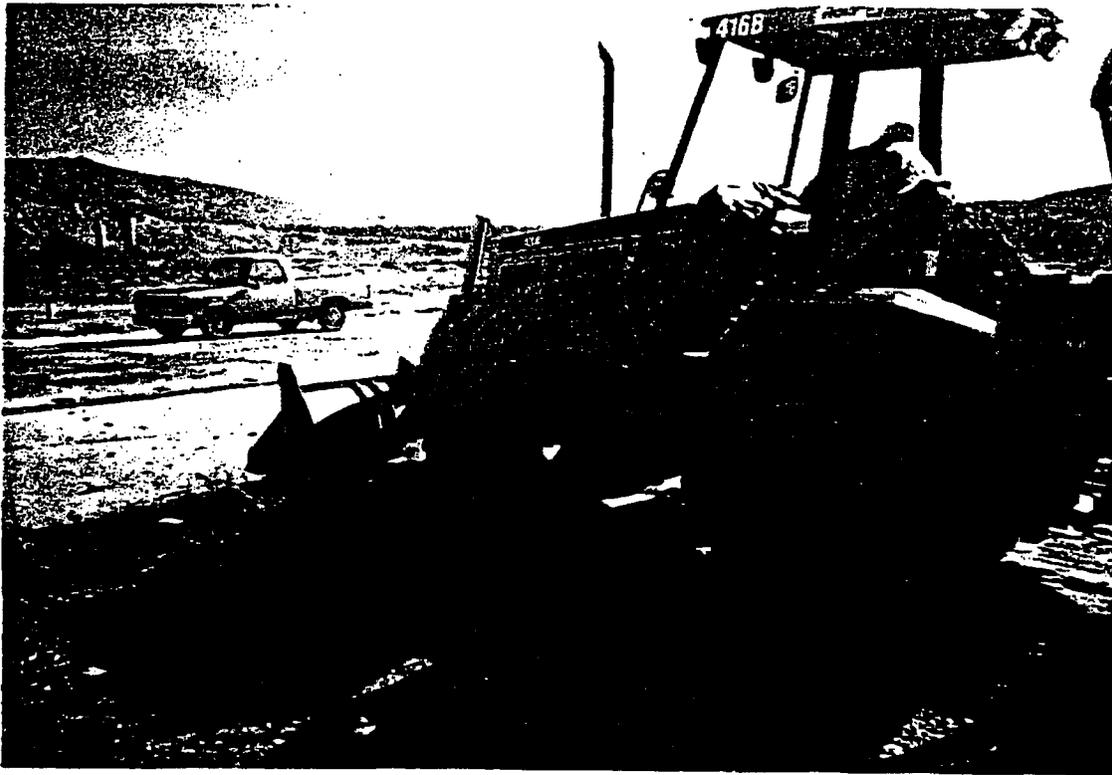
5: Compacting backfill in wash water collection sump by wheel rolling with backhoe.

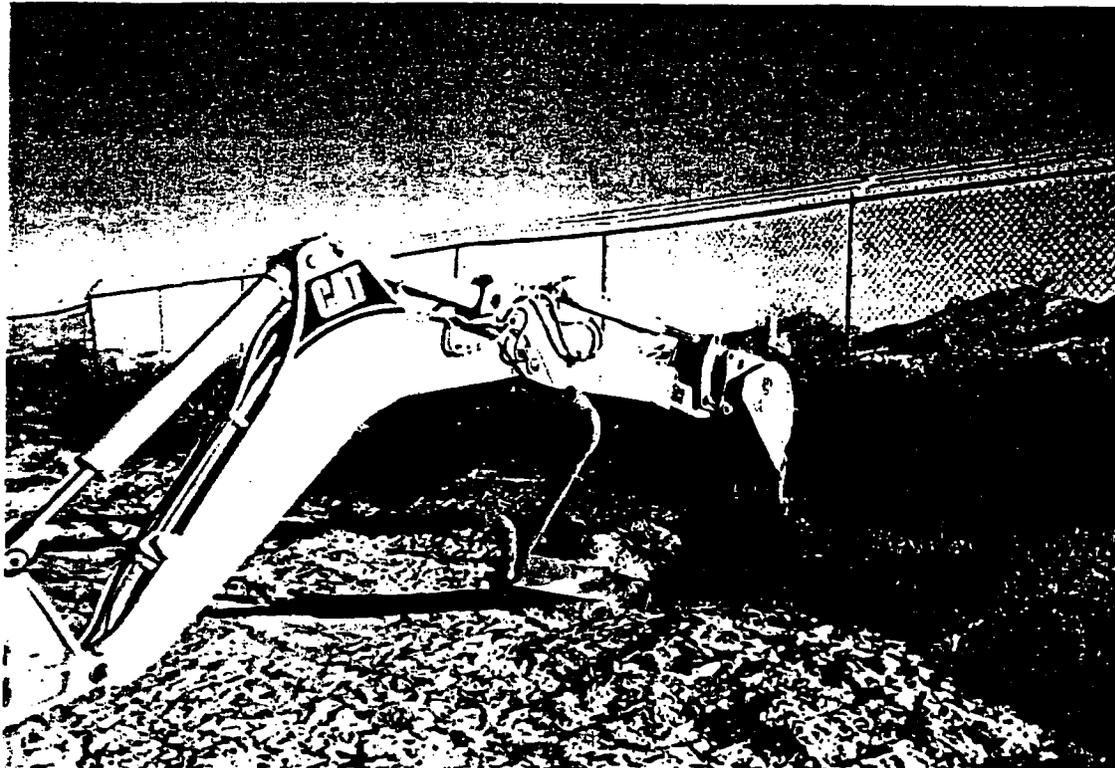
6: Excavating into levee around ten-inch conduit.

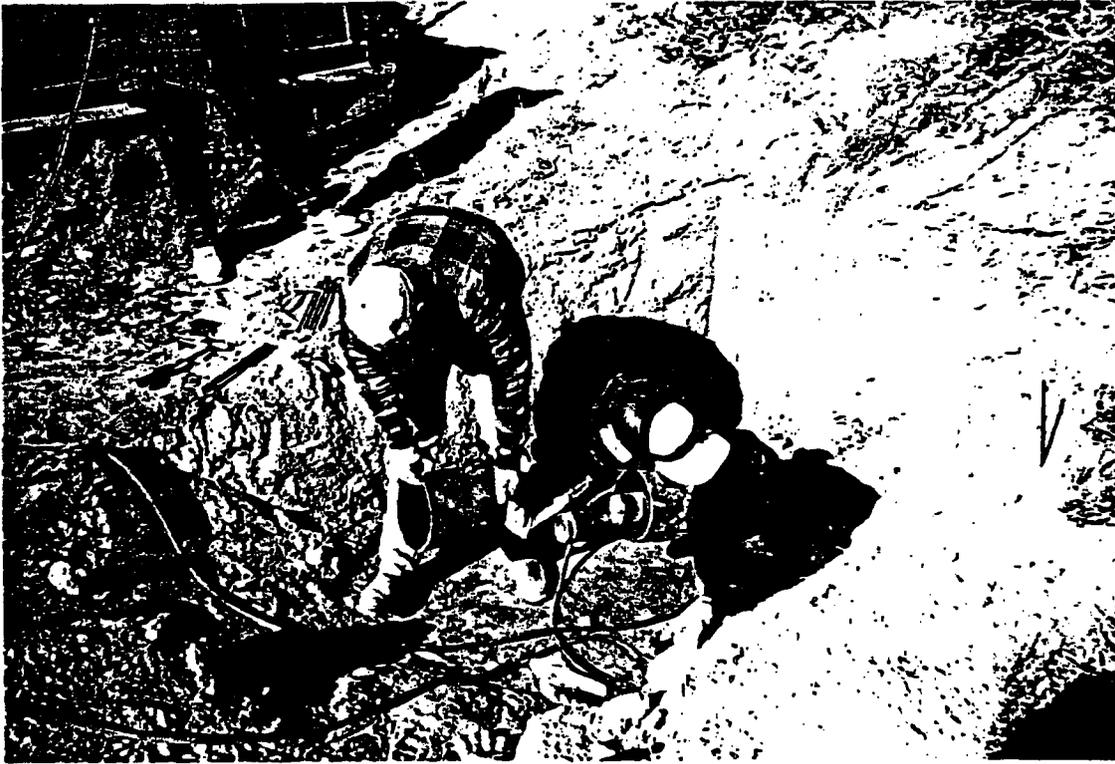
7: Three-inch pipes cut and capped; placing cap on ten-inch conduit.

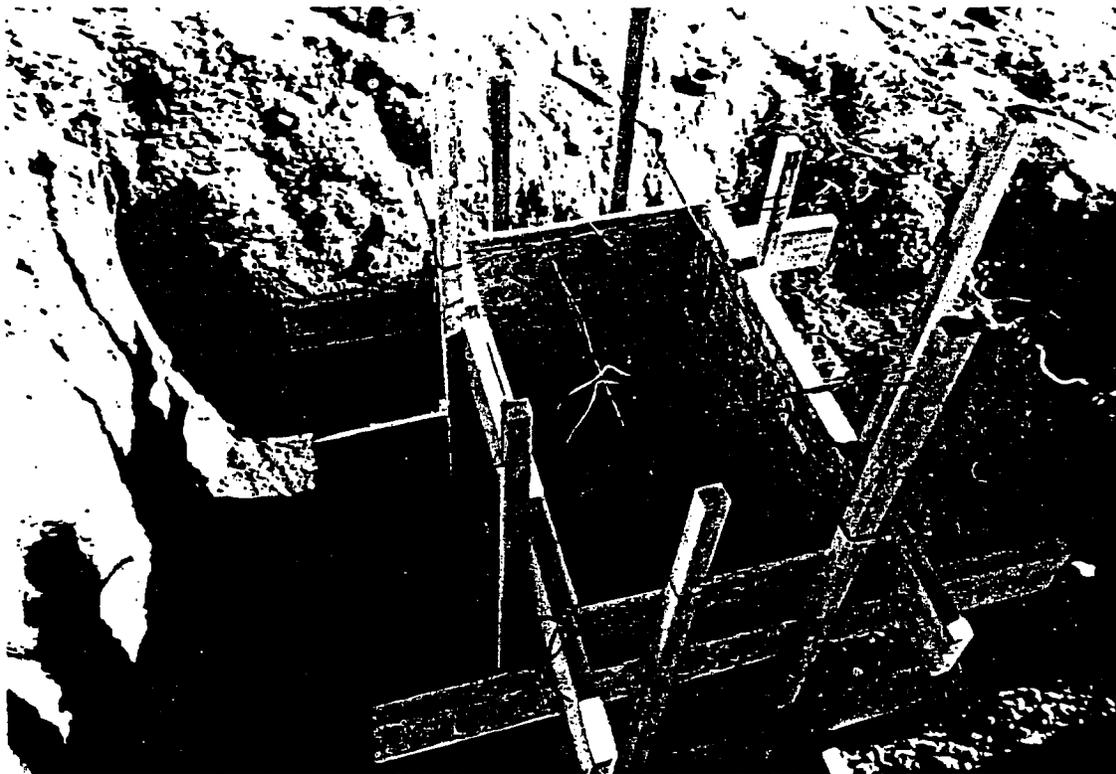
9: Forms set to pour monument and seal conduit.

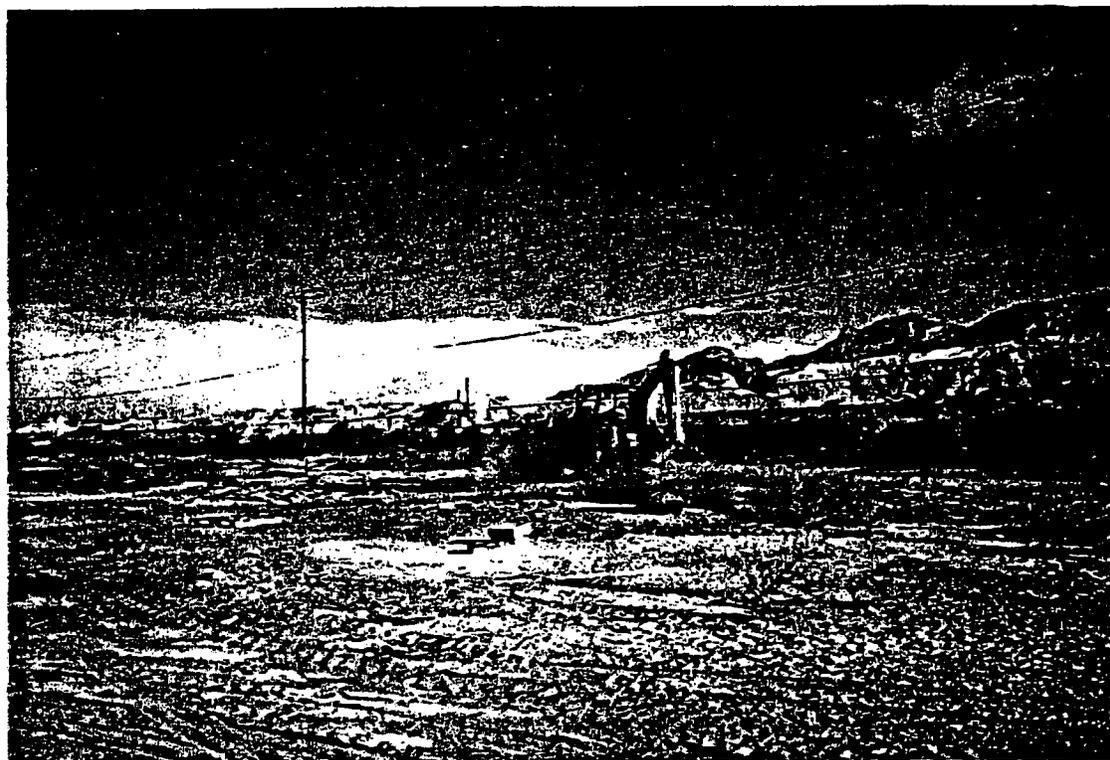
12: Cutting trench around south asphalt spill area.
