**STAGE 1 & 2
WORKPLANS**

**STAGE 2 ABATEMENT PLAN
FORMER BRICKLAND REFINERY SITE
HUNTSMAN POLYMERS CORPORATION**

August 14, 1998

Huntsman Polymers Corporation
2400 S. Grandview Ave.
Odessa, Texas 79760

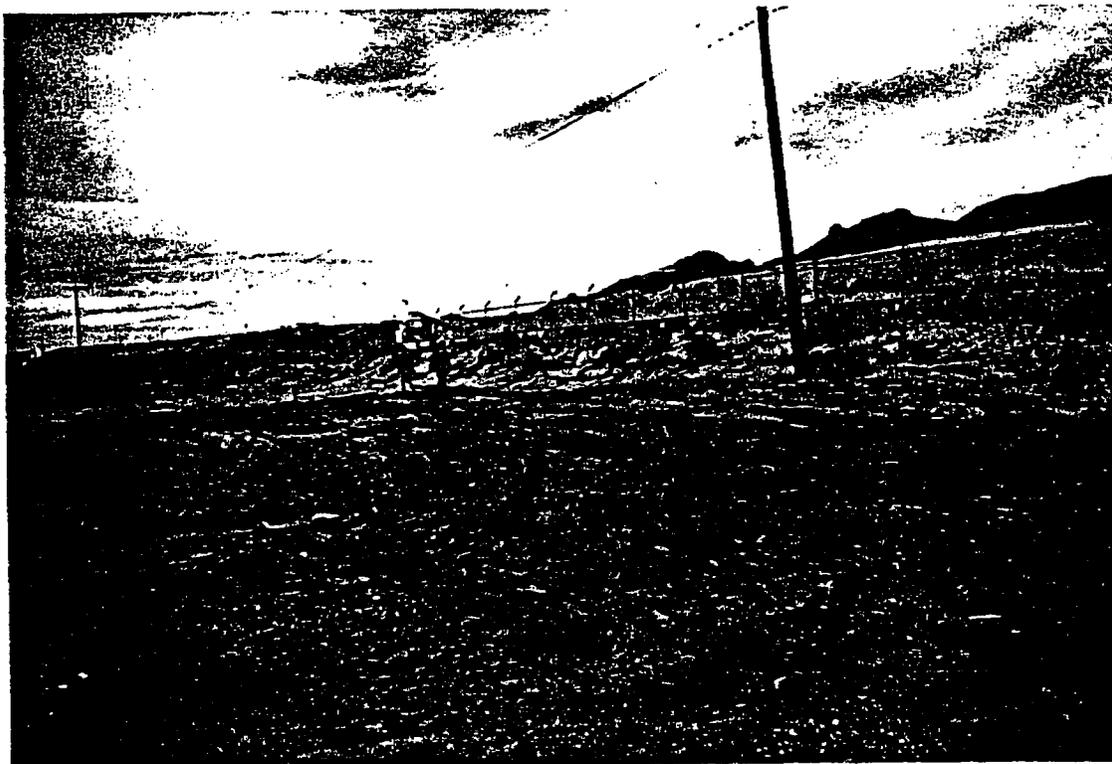
13: View looking north at south asphalt spill area.

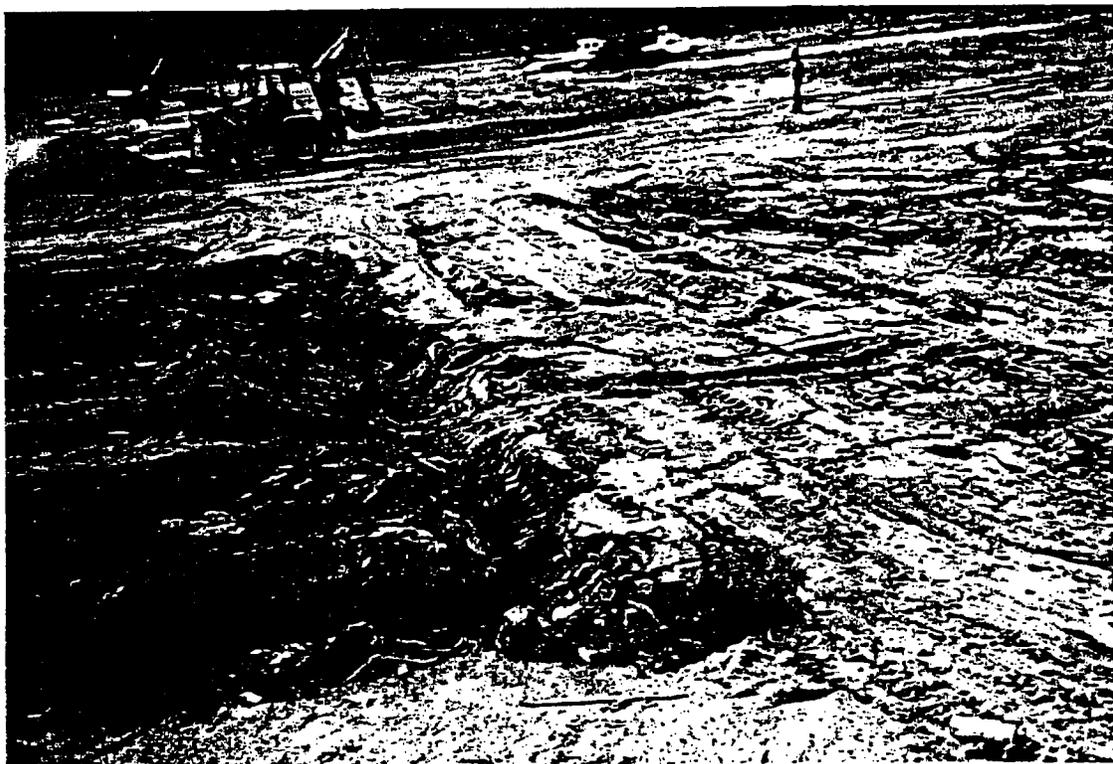
14: View looking west at trench around south asphalt spill area; clean fill material located in left background.

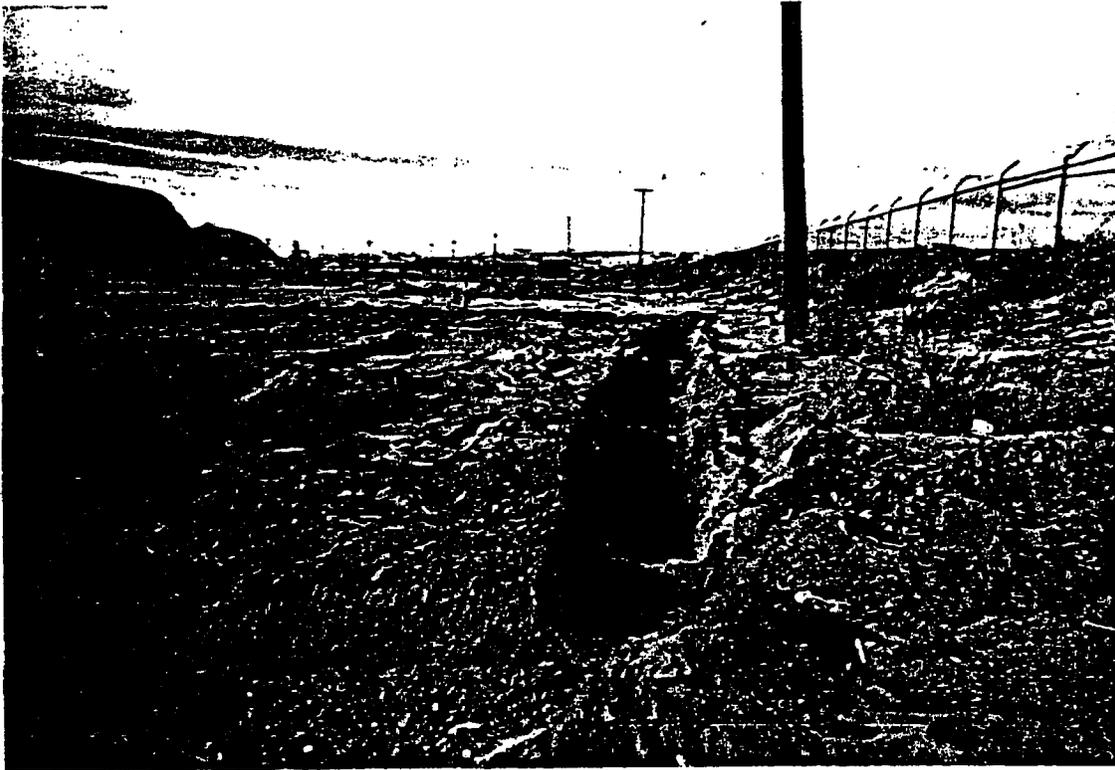
15: View looking north at trench around south asphalt spill area.

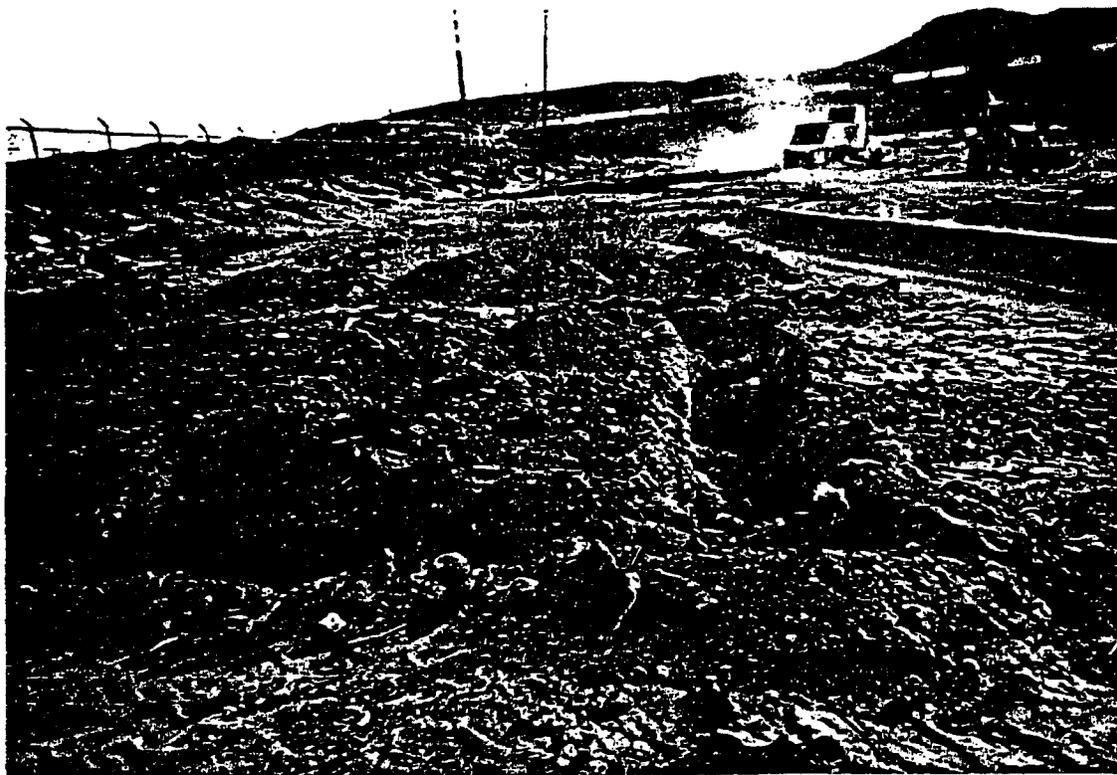
16: View looking south at trench around north asphalt spill area; south asphalt spill area in background; clean fill material on the right.

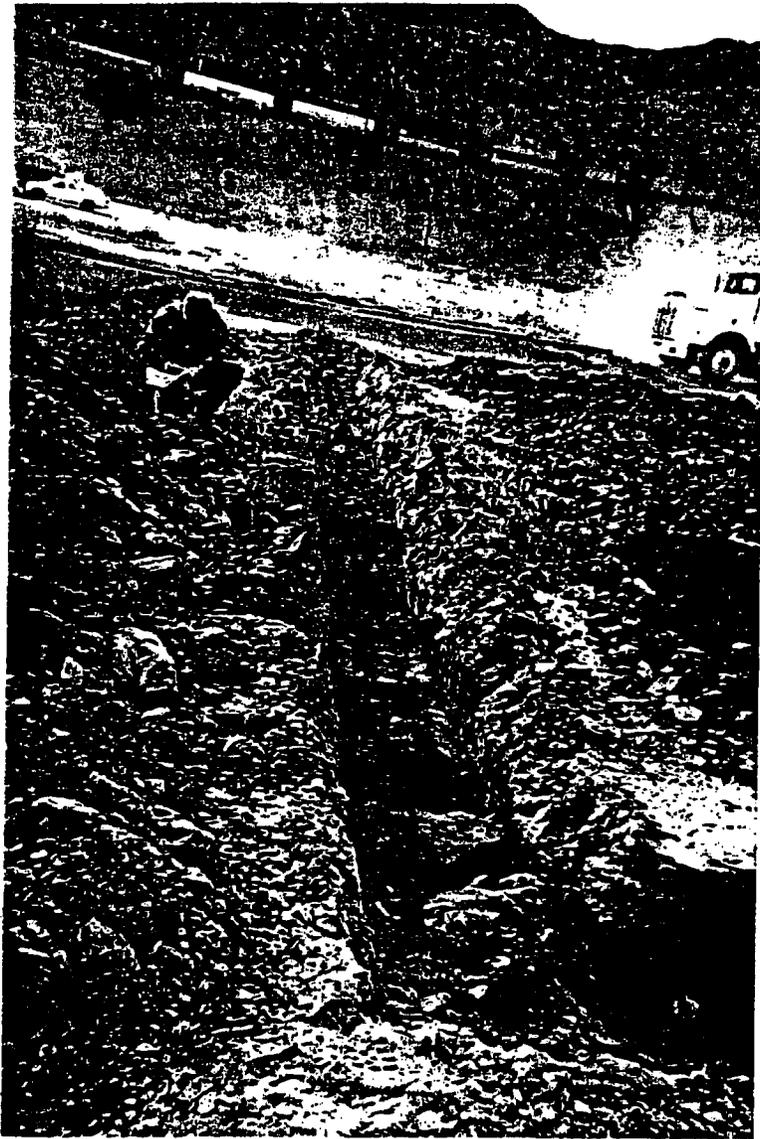
17: View looking west at north asphalt spill area; clean fill material in the background.

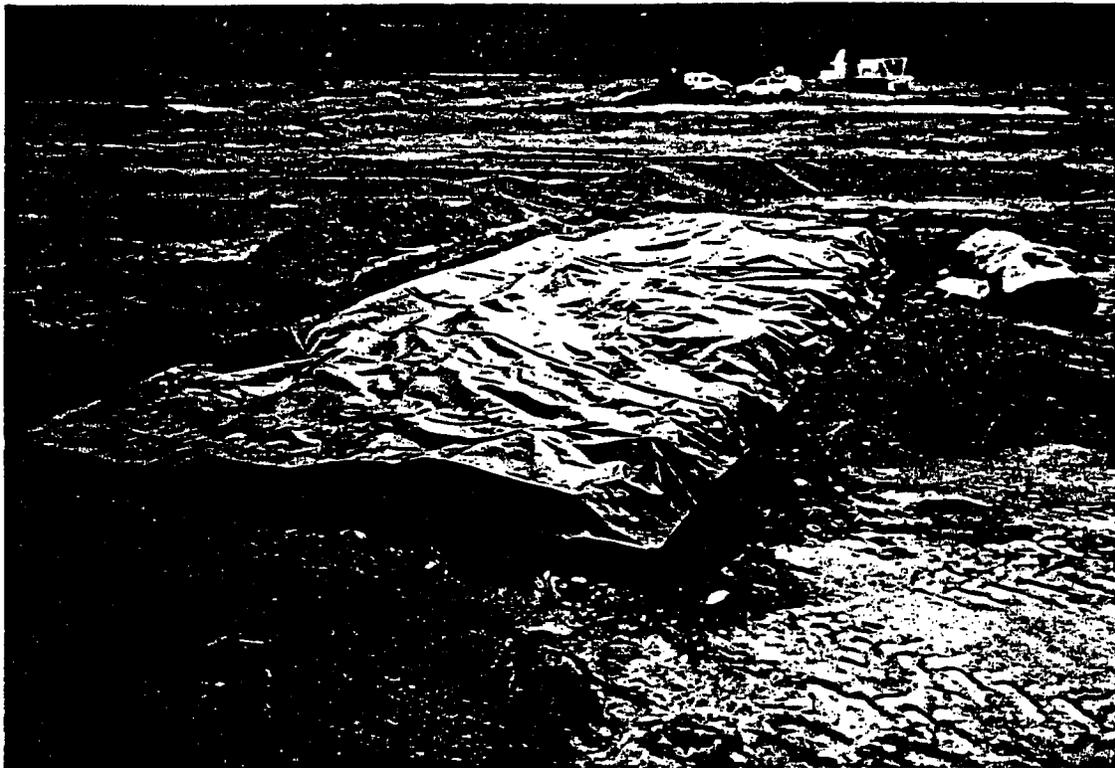
21: View looking west; HDPE covering north asphalt spill area.

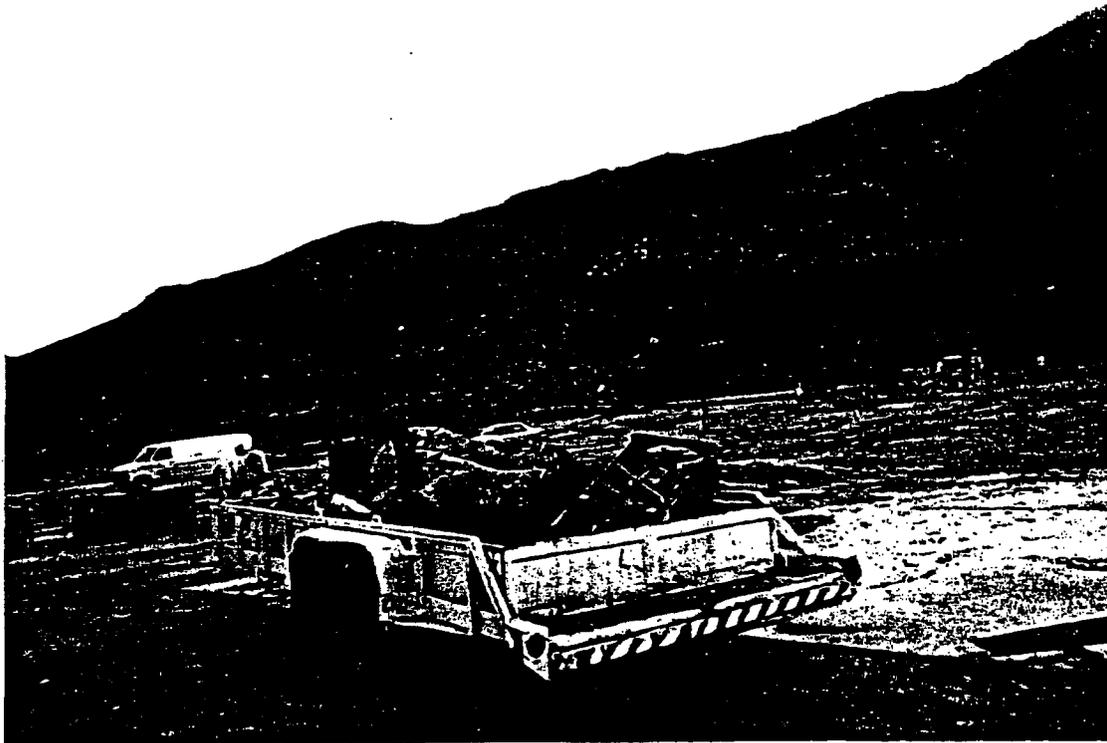
25: Dispenser loaded on trailer and ready for transportation to Rhino Environmental Facility for disposal.

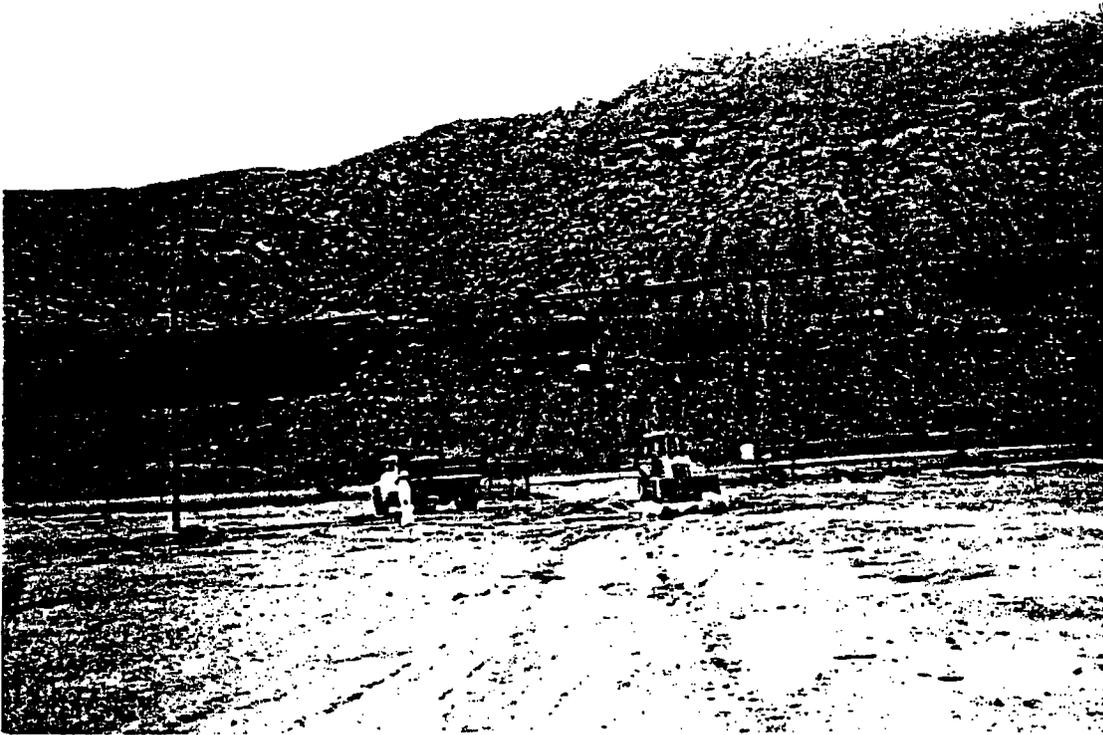
26: Removing concrete pump island.

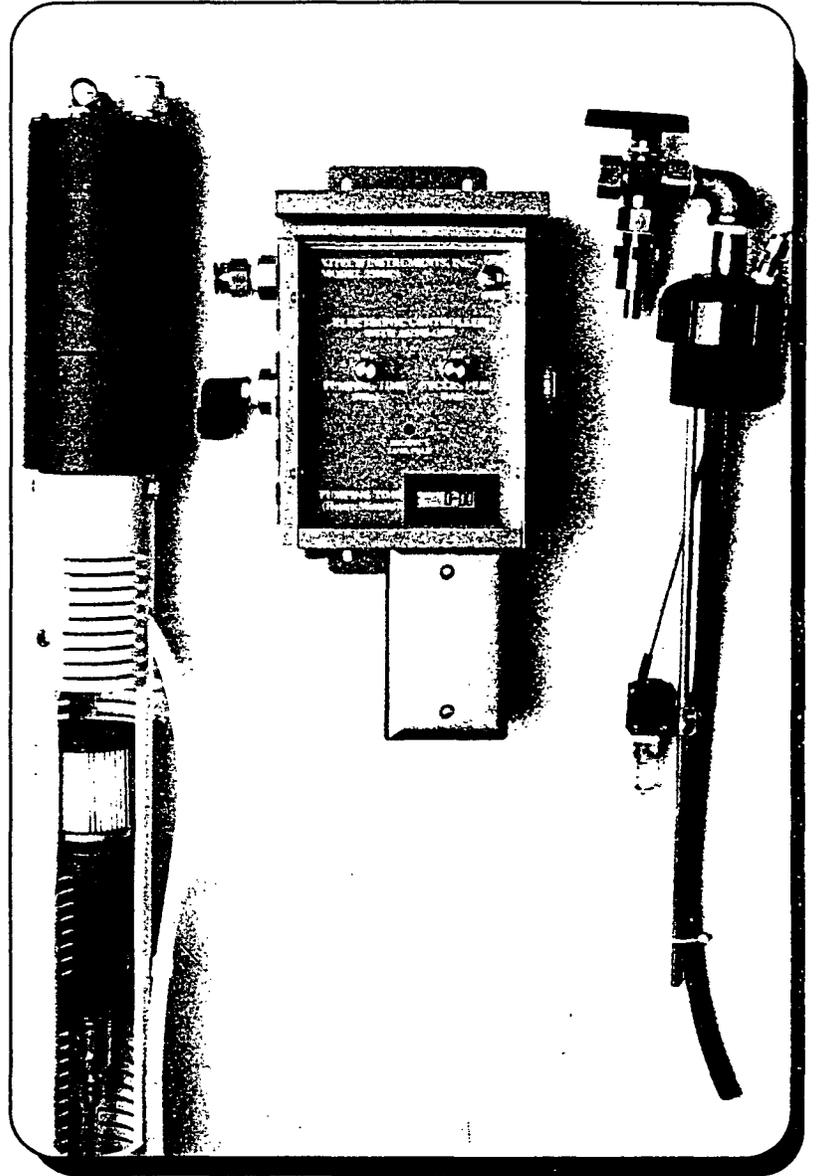
Smart Skimmer

The Product Recovery System can operate without the use of AC power, remove product ONLY down to a sheen, operate on bottled gas, and can be installed in less than 2 hours. The Xitech Product Recovery System consists of a pneumatically operated Smart skimmer, electronic timer, and electronic high level product tank shutoff. The Smart skimmer requires no above ground controls to operate, has 30 inches of float travel, uses a high volume hydrophobic filter, pumps over 25GPH, and consumes less than .5CFM of air. The electronic timer provides intermittent pumping control for several Smart skimmers, provides continuous monitoring of the high level tank shutoff sensor, displays total run time of system, and operates on 12DC/120AC/220AC. The electronic high level shutoff assembly has a three way product inlet switching valve, double wall tubing fitting for the product line, and an infrared electronic liquid level sensor that is intrinsically safe.

Pumping range from 5-25 GPH
Skimmer float travel: 30 inches
Operating pressure range: 35-125 PSIG
Maximum operating well depth: 200 feet
Maximum air requirements: .5 CFM @ 125 PSIG
Air quality requirements: 5-10 Microns
Weight: 8 LBS
Size: 3-1/2" DIA. X 48" long
Materials: PVC, sst, viton, Buna, Aluminum
Order No. ADJ 1000

The proposed recovery system would consist of a Xitech pneumatically operated skimmer pump (or equivalent) with an electronic timer and a high-level product tank shutoff, a 55-gallon free-phase product holding tank in a secondary containment lined-dike, and a solar panel and storage battery for power delivery. If electric power can be cost effectively supplied to the site, it will replace the solar panel and associated equipment. Product literature for this system is included as Appendix E.

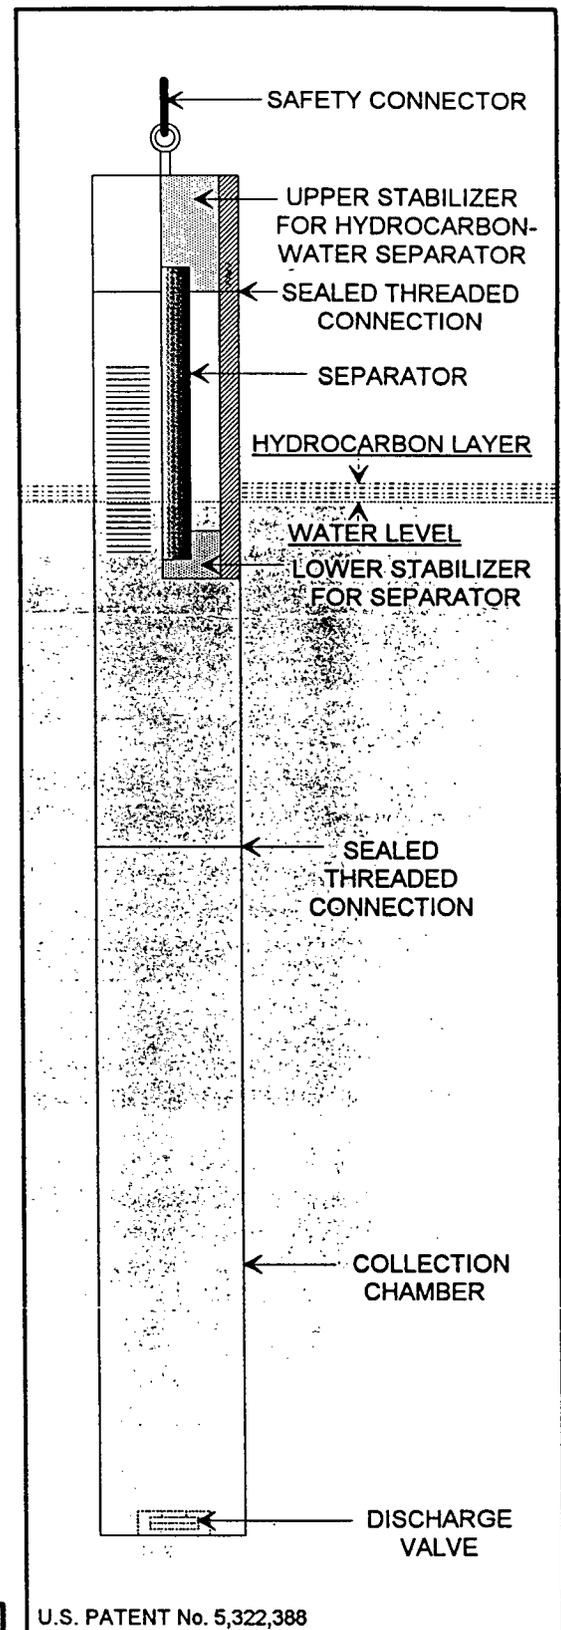
- ✓ **FILTER ELEMENT** easily cleaned or changed by a field technician to prevent cross contamination and improve the efficiency of the **HYDRO-SKIMMER**
- ✓ **NO HYDROCARBON BASED (PVC) GLUES** that will leach in water thus giving off contaminants that will set off hydrocarbon detection equipment.
- ✓ **NO MOVING PARTS:** Eliminates springy collection tubes that eventually impede flotation. Eliminates need for vent tubes.
- ✓ **ACCESSORY EQUIPMENT** can be added to make the basic **HYDRO-SKIMMER** a continuous or active system.
- ✓ **THREADED CONNECTIONS** allow you to add or remove an extra collection chamber as needed.

WELL DIAMETER	ASSEMBLY LENGTHS		
	64 INCH	96 INCH	128 INCH
2" OR LARGER	.29 GALLON MODEL 201	.51 GALLON MODEL 202	.72 GALLON MODEL 203
3" OR LARGER	.57 GALLON MODEL 301	1.02 GALLON MODEL 302	1.47 GALLON MODEL 303
4" OR LARGER	1.33 GALLON MODEL 401	2.34 GALLON MODEL 402	3.36 GALLON MODEL 403
