Brickland Refinery Site Cover Installation Report

**New Mexico Oil Conservation Division
August 20, 1999**

Brickland Refinery Site – Cover Installation Report
Huntsman Polymers Corporation
Odessa, TX

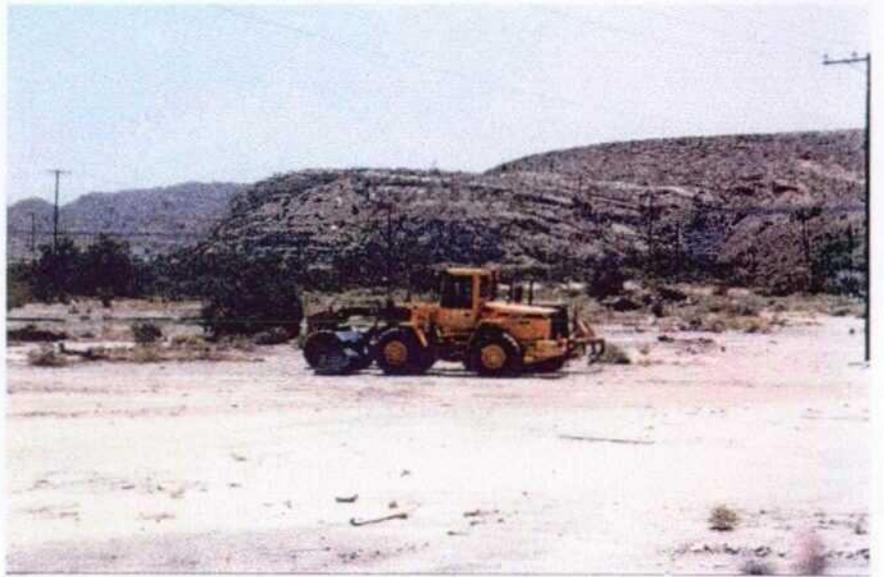
PHOTO NUMBER	DESCRIPTION
1.	View showing the mobilization of equipment on site.
2.	View of equipment staging area and general site conditions.
3.	Site conditions at project start, looking towards the south end of the site.

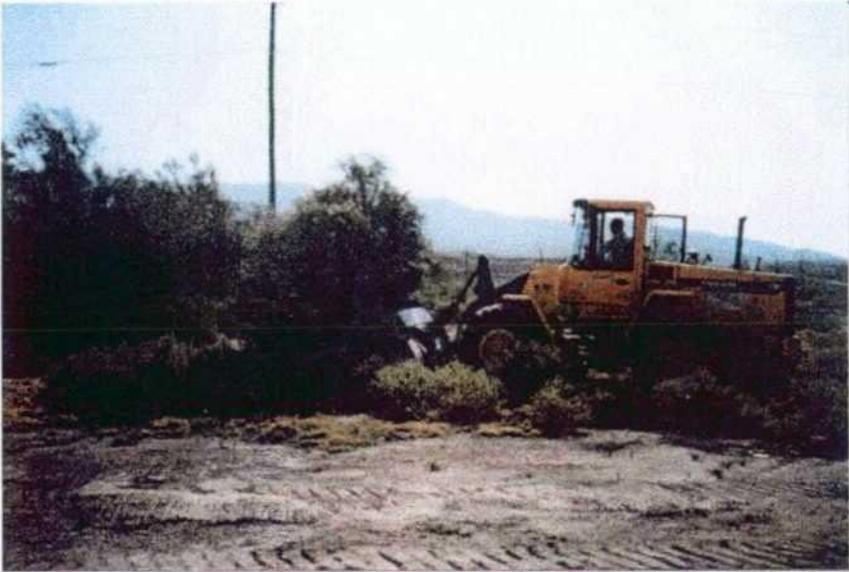
4.	Site conditions at project start, looking southwest.
5.	Clearing operations starting on southeast corner.
6.	Clearing debris and brush along east side.

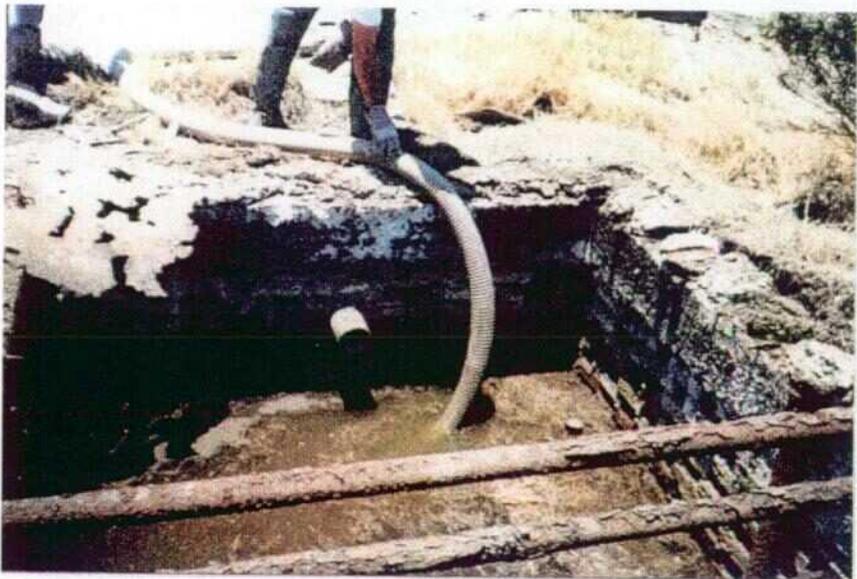
Two sumps were found on the site. One was located in Area C, near the foundations of the old houses. The second was at the northeast corner of a large concrete foundation in Area D. This slab was the building foundation for a large Quonset hut, which was used for trucking and other vehicles. The location of these two sub-surface structures is indicated in the attached appendix. (Appendix 15)

20.	Clearing operations completed view, east side.
21.	Sump "A" after removal of cover.
22.	Sump "A" during liquids removal.
23.	Sump "A" after liquids removal.

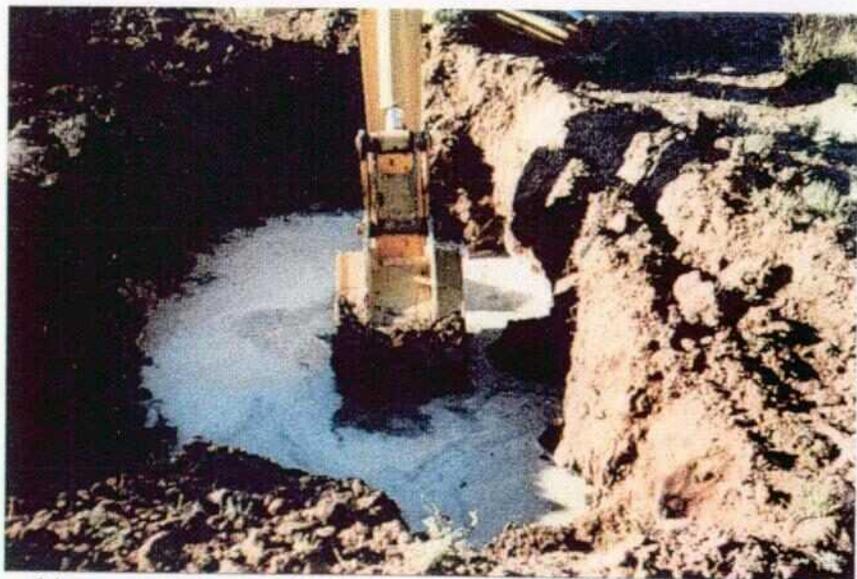
24.	Uncovering of Sump "B"
25.	Area "C", soft spot during leveling operations.
26.	Area "C" with equipment stuck.
27.	Area "C" after removal of equipment. Water can be observed migrating back into the tire tracks.

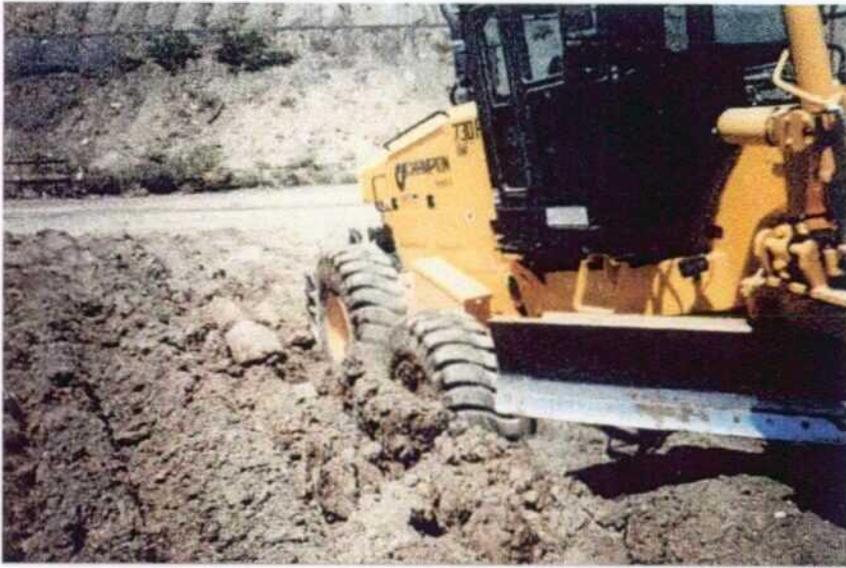
25.

Area C was not tested because compaction was not performed in the area. This was due to "pumping" of the soils when heavy equipment was used. This action allows for cracks in the cover as machinery is passed over the area. Its root cause is due to close-to-the-surface water in the area and the presence of an old septic system's leaching field. In order to compensate for this, the contractor conducted a stabilization test using portland cement. Initial results did not show improvement and heavy equipment became stuck in the area. The second approach was to place an additional one (1) foot of cover, grade, and leave uncompacted. A crown on this cover segment was installed in order to promote drainage and water runoff. This method allowed for a continuous cover and met more than the six-inch requirement for the installation. It is expected that the additional basecourse will firm over time and provide for a stable cover. Later checks of the area indicated that it did indeed firm as it weathered.

Further investigation in to the area in Section "C" that is pumping has found that there is a distinct layer of pea gravel approximately 1-2' below the surface. This layer extends vertically for approximately 1 foot and is situated directly down gradient of Sump Number 2. It is believed that this may be an old leach field attached to the sump and encompasses an area of approximately 30,000 square feet.
